Current State of Modern Rammed Construction: A Case Study of First Peoples House After 7 Years Exposure

# Current State of Modern Rammed Construction: A Case Study of First Peoples House After 7 Years Exposure

Allan Kailey<sup>1, a</sup> and Gupta Rishi<sup>1, b</sup>

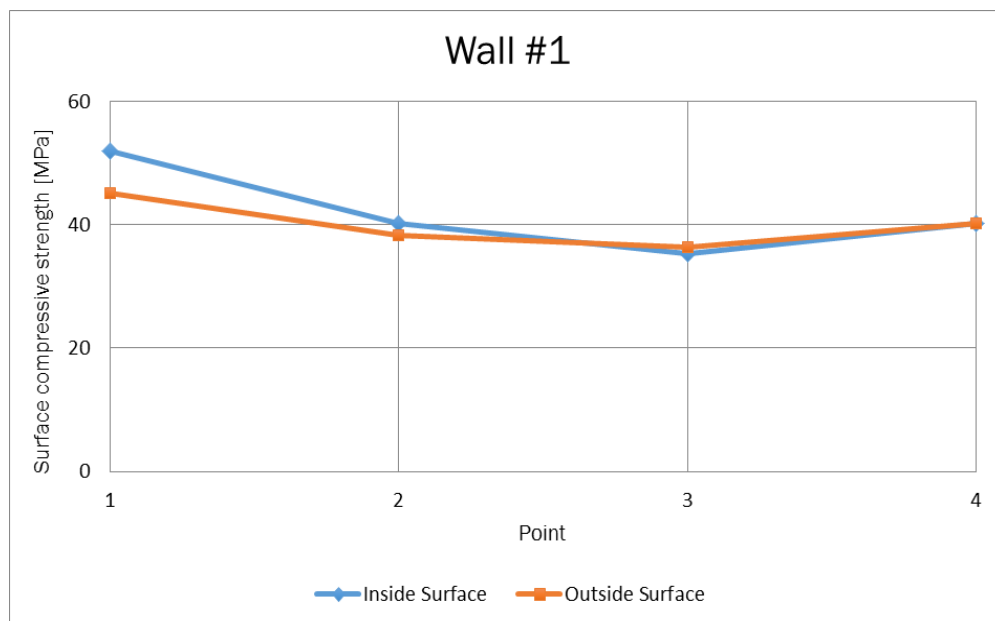
The compressive strengths are again shown in Fig. 5 and Figure for easy visualization. A large difference of 6.86 MPa exists between the outside and inside surfaces at Point 1 on Wall #1. For Wall #2, the largest difference is 11.77 MPa at Point 3.

**Figure 5. Compressive strength variation of Wall #1**

The trend seen on Wall #1 shows that the surfaces on exterior-exterior walls (Points 3 and 4) potentially deteriorate at the same rate. This is not surprising, as both surfaces are exposed to the same climate year round. Larger differences are seen on exterior-interior walls (Points 1 and 2). Interior walls are often kept in an environment that is maintained at 20-25°C whereas exterior walls are exposed to fluctuations in temperature and weather. The result is a wall that stays relatively preserved on one side, and is allowed to age on the other.

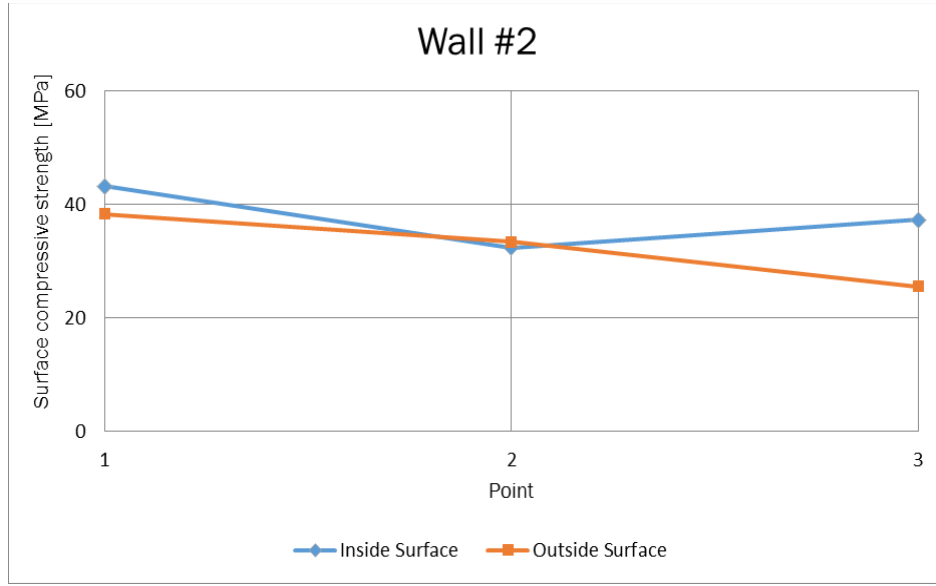
**Figure 6. Compressive strength variation of Wall #2**

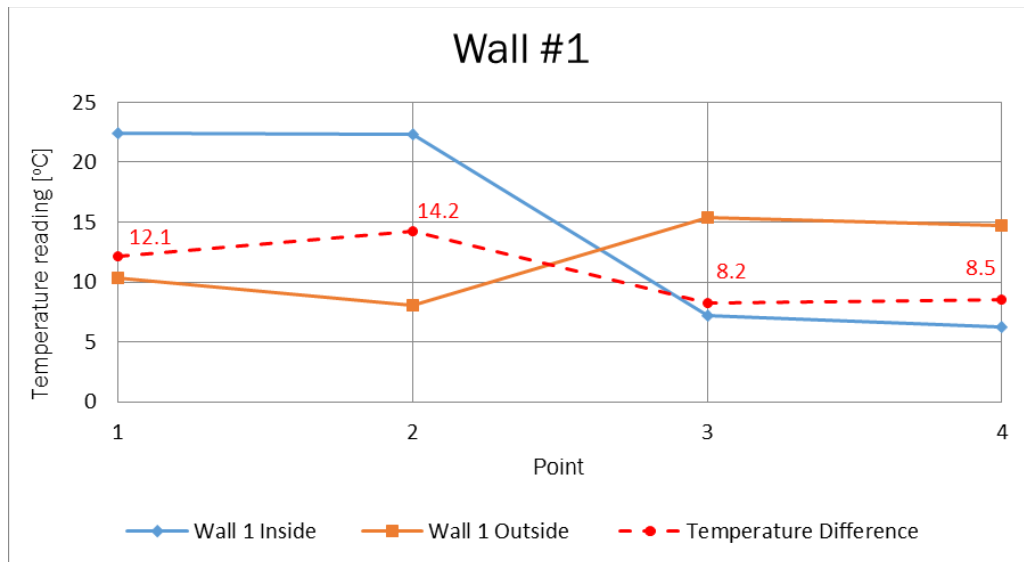
**Surface Temperature Results.** In order to illustrate the effectiveness of SRE as an insulating material, temperature readings were recorded and the conductive heat transfer rate was determined. Temperature was measured at each point on the inside and outside surfaces. A sample thermal image is shown in Figure . The recorded temperatures at each point are visually summarized in Figure and Figure. Point 2 on Wall #1 and Point 3 on Wall #2 exhibited the largest temperature differences, and will therefore experience the largest heat loss.

**Figure 8. Surface temperature results for Wall #1**

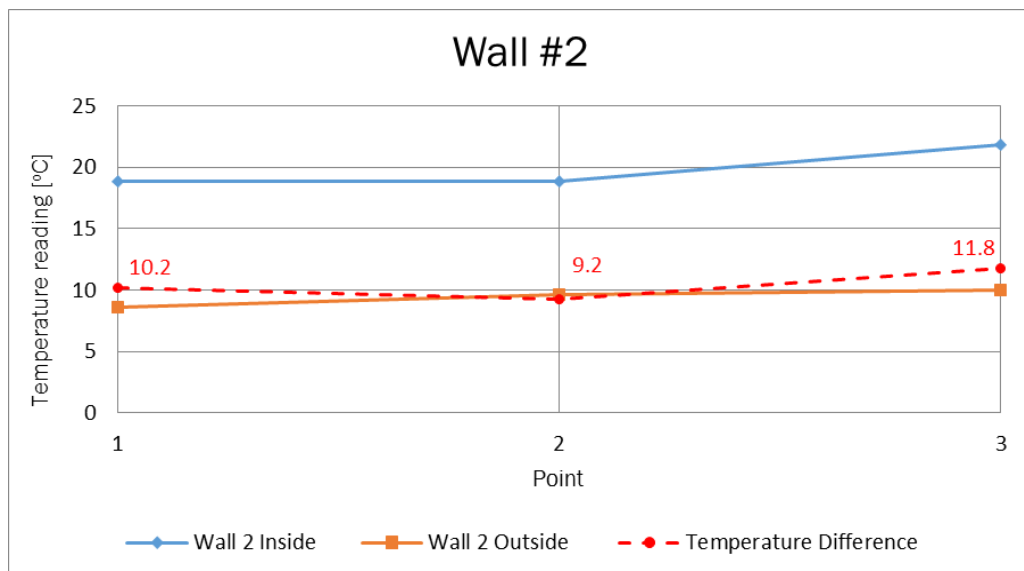
**Figure 9. Surface temperature results for Wall #2**

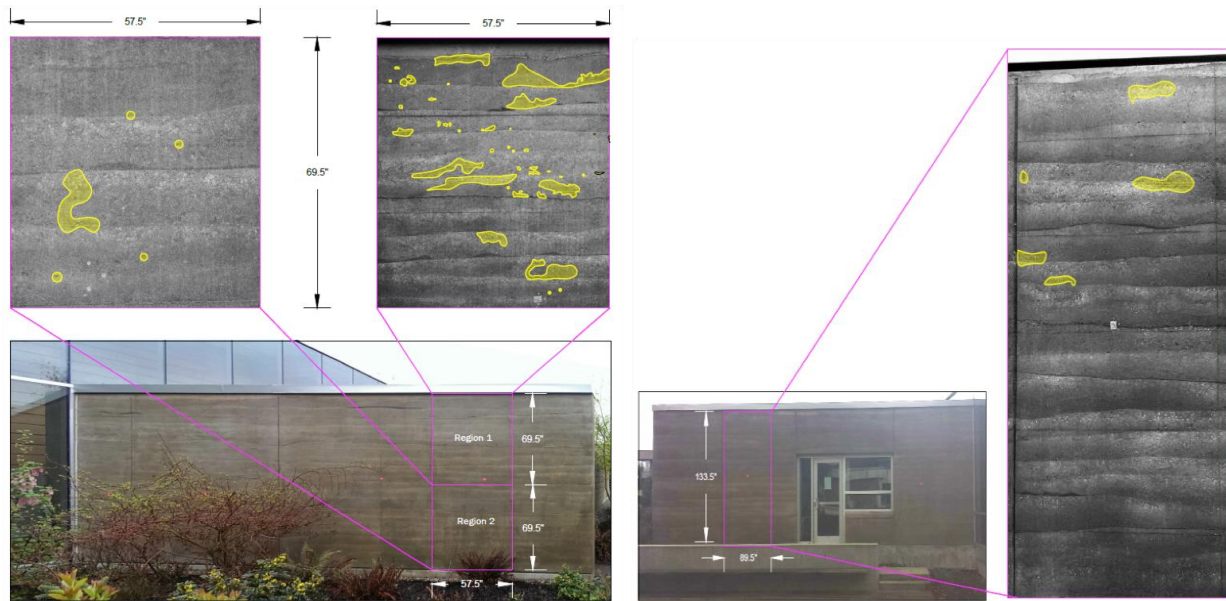
**Figure 10. Wall #1 (left) and Wall #2 (right) surface deterioration analysis**

**Surface Deterioration and Visual Inspection Results.** The wall section analyzed best represented the overall condition of the wall. This was determined by visual inspection, with no relationship between the chosen section and the marked points. The walls were photographed from approximately 4m away, and the results are presented in Table 5. Wall #1 shows an overall surface area deterioration of 3.69%, and Wall #2 as 1.78%.

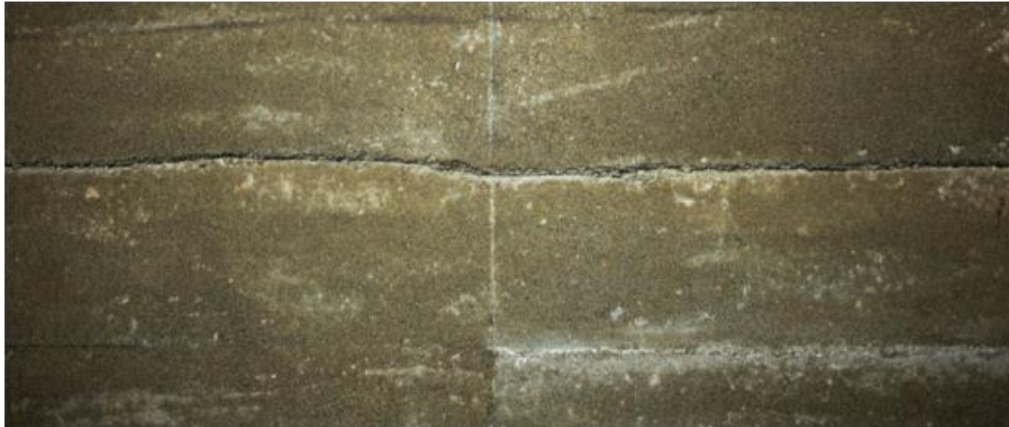
A deterioration analysis was not performed on the inside surfaces because they were well preserved, having never been exposed to the outside environment. However, all interior walls showed significant signs of efflorescence at cracks and other defect sites, as shown in Figure. Efflorescence is a result of moisture migration through a material to bring soluble salts to the surface. The appearance is a white powder, and is often found on poorly sealed concrete. Moisture penetration to RE can occur in a number of ways: wind-driven rainfall, cyclic wetting and drying, poor thermal performance, loss of adhesion between binding aggregates and metal corrosion [12]. Mechanisms that could promote moisture transmission are capillary suction, gravity and hydrostatic pressure. This potentially

explains why efflorescence does not exist on the exterior-exterior wall; no pressure differential would exist to drive the movement of moisture.

**Figure 11. Signs of efflorescence on inside surface of Wall #1**

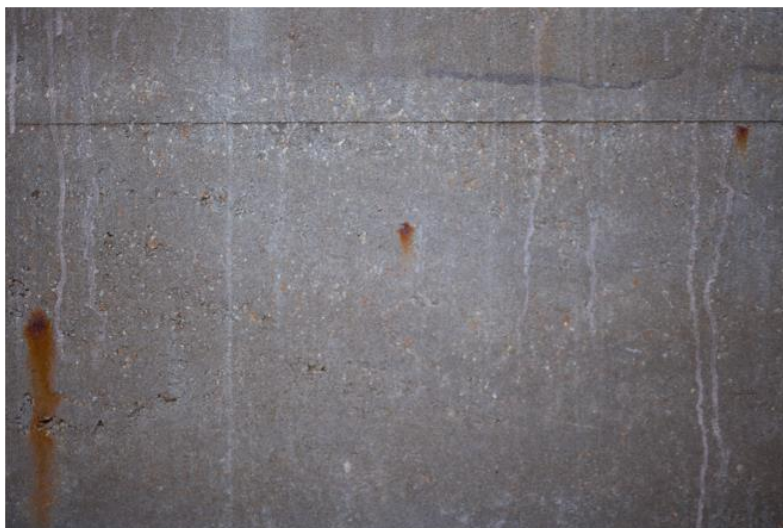
Six rust sites exist on the outside surface of Wall #2. As seen in Figure , a linear relationship exists between the site locations. It is likely that these sites correlate to the placement of interior rebar. If not, formwork during construction could have left small rust deposits on the surface.

**Figure 12. Rust sites on outside surface of Wall #2**

True compressive strength and thermal properties should be determined by destructive testing. Thermocouples can be installed in and near the wall surfaces to obtain accurate temperature data, as wind, shade and other environmental factors can skew temperature readings. Liang found that an ultrasound device is more effective than a rebound hammer at measuring strength [7]. Performing an ultrasonic test should be considered if the FPH is to be further investigated. Additionally, a rebar locator should be used to confirm the rust sites on Wall #2.
