# **Retrofitting Heritage Buildings for Energy and Seismic Upgrades**

A Thesis Submitted in Partial Fulfillment of the Requirements  
for the Degree of  
MASTER OF APPLIED SCIENCE  
in the Department of Civil Engineering

© Mohsen Kobraei, 2020  
University of Victoria

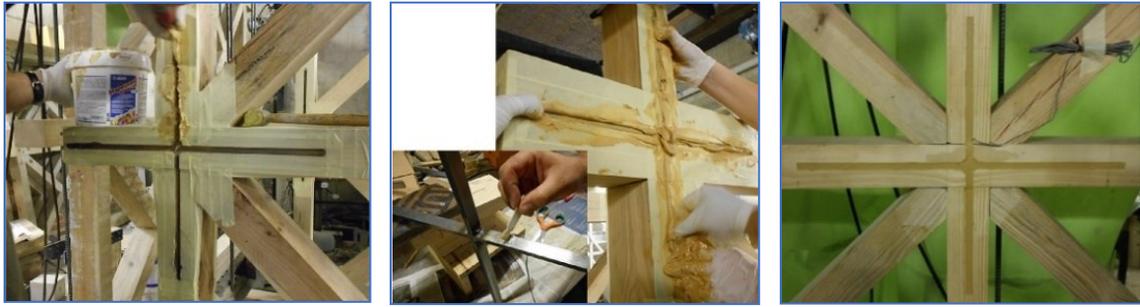
Figure 2.1, Near Surface Mounted (NSM) technique with steel flat bars [24]

Near Surface Mounting (NSM) is an effective technique that applied basically for the strengthening of reinforced concrete (RC) beams and columns. This technique by improving flexural, shear strength and ductility, increases the seismic performance of old-type RC frames [21], [22]. The NSM technique involves drilling shallow grooves along the concrete cover and placing steel or fibre-reinforced polymer rods in those grooves. The grooves are then filled with an epoxy adhesive or cement grout [23], [26].

In wood frame buildings, repair and strengthening of connections are one of the main solutions. NSM has the potential of being reversible and invisible. This method with infill smooth rebars is used to retrofit traditional timber structures, shown in Figure 2.1 [24]. In a study for strengthening connections self-tapping screws, steel plates, GFRP sheets and NSM method were used [25]. Pull-out tests showed that the initial strength of the connections was increased and the NSM technique was capable of solving the need for adequate anchorage length problems [25].

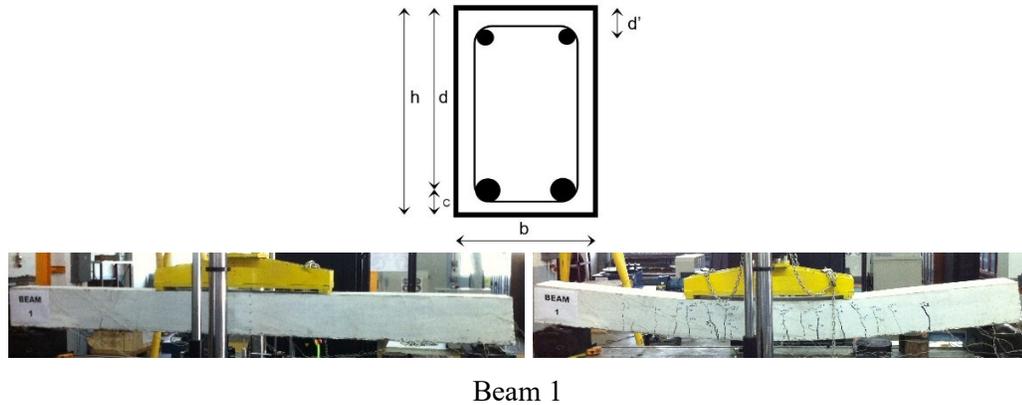
Figure 2.2, Beam 1: Normal designed SCC beam [27]

Beams Number	Ultimate Moment (UM) (kN.m)	Design Moment (DM) (kN.m)	UM/DM	Load of First Crack (kN)	F <sub>c</sub> (Mpa)
Beam 1 (Normal design)	32.14	24.45	1.43	20	95.57
Beam 3 (NSM concept)	32.82	24.45	1.46	19.2	95.57

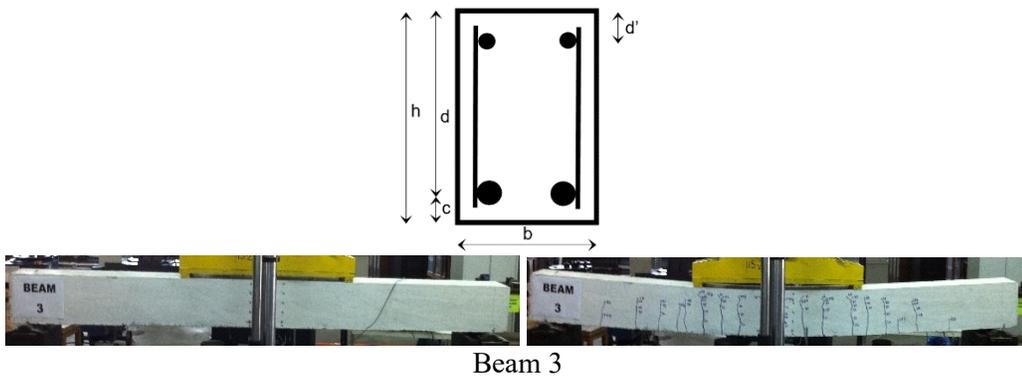
Figure 2.3, Beam 3: NSM concept shear reinforcement bars [27]

Although this study addressed the application of shear reinforcement rebars in RC beams, it also concluded that it is possible to strengthen shear cracks and avoid brittle ruptures of existing members without stirrups by adding steel rebars as shear reinforcements and NSM concept.

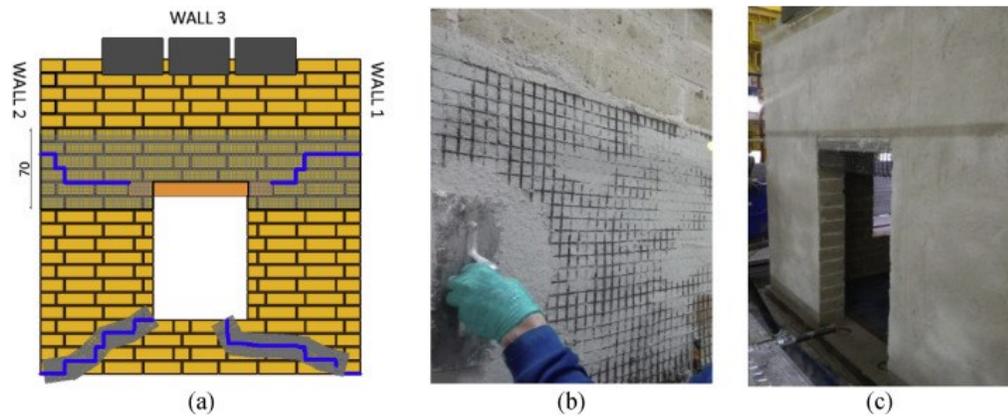
Figure 2.4, Strengthening phase: (a) FRCM layout for out of plane strengthening; (b) and (c) FRCM application for in-plane strengthening [28].

One of the main difficulties in seismic retrofitting is using appropriate materials for historical and URM buildings. It is recommended to use FRCM and fibre-reinforced plaster for strengthening of external walls in historical buildings [28]. FRCM is made of dry fibres

embedded in an inorganic matrix, which is considered as a shear strengthening method for RC and URM structures [29]. For URM buildings, adding reinforced concrete footings under the walls and using horizontal steel beams to link the walls with a reinforced concrete slab is recommended [30]. Results have shown that (i) deformation of slabs was changed from non-rigid to rigid with diaphragm effects; (ii) the failure mechanism transformed from a local to a global formation under earthquake conditions; and (iii) more displacement capacity was recorded [30].

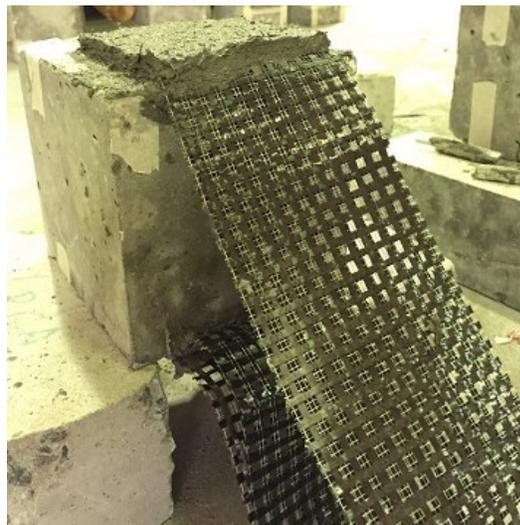
Figure 2.5, Test specimen with an FRCM double-shear connection [29]

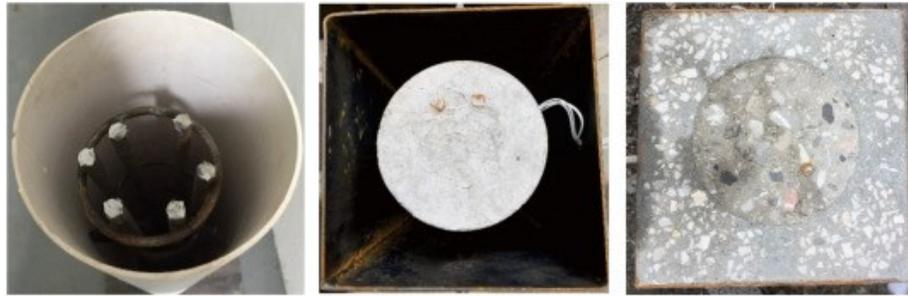
Figure 2.6, Sandwich columns preparation process [34]

Based on the experimental and theoretical results, the sandwich columns themselves increase to the seismic capacity of the buildings [33], [34]. In this method, basically, the column is strengthened by reinforced concrete with two techniques: either by using the hollow structural sections (HSS) as the outermost layer or by enclosing the column with reinforcement bars or both [34].

In a masonry school building built in 1970, sandwich columns were used in brick walls [35]. The sandwich columns were applied to either side of the walls with normal strength concrete (27.5 MPa) and transverse reinforcement rebars. This option improved the seismic capacity of the building by 65% [35].

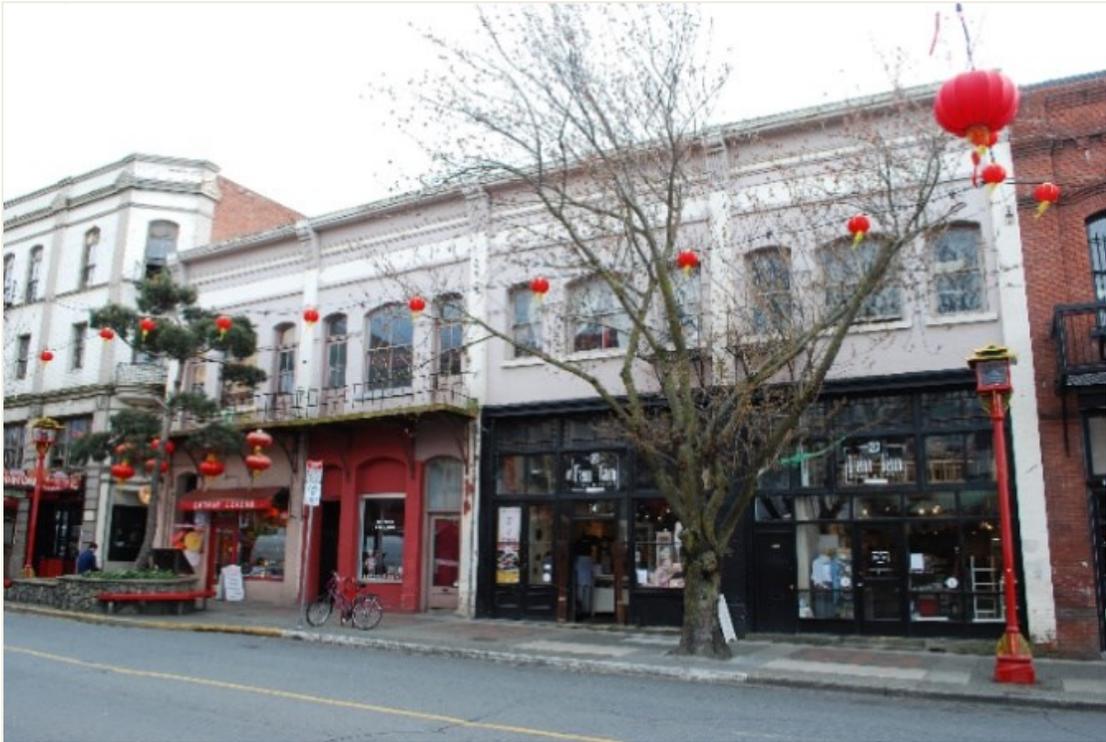
Figure 3.1, North façade of the building at Fisgard Street

The case study is a two-story heritage building located in Victoria, BC, Canada, has a footprint of about 7,500 square feet. The first floor is used for commercial purposes and the second floor consists of residential units. All portions of the building are constructed of load-bearing URM walls, with some load-bearing wood framing at interior walls and mezzanines. Roofs and floors are constructed of wood decking on wood joists. The exterior walls are constructed of old clay bricks. On the interior side, there is no insulation on the wall assemblies except a layer of plaster on the bricks. This building does not have a foundation system and its flooring is slab on grade. Figure 3.2 indicates the layout of the

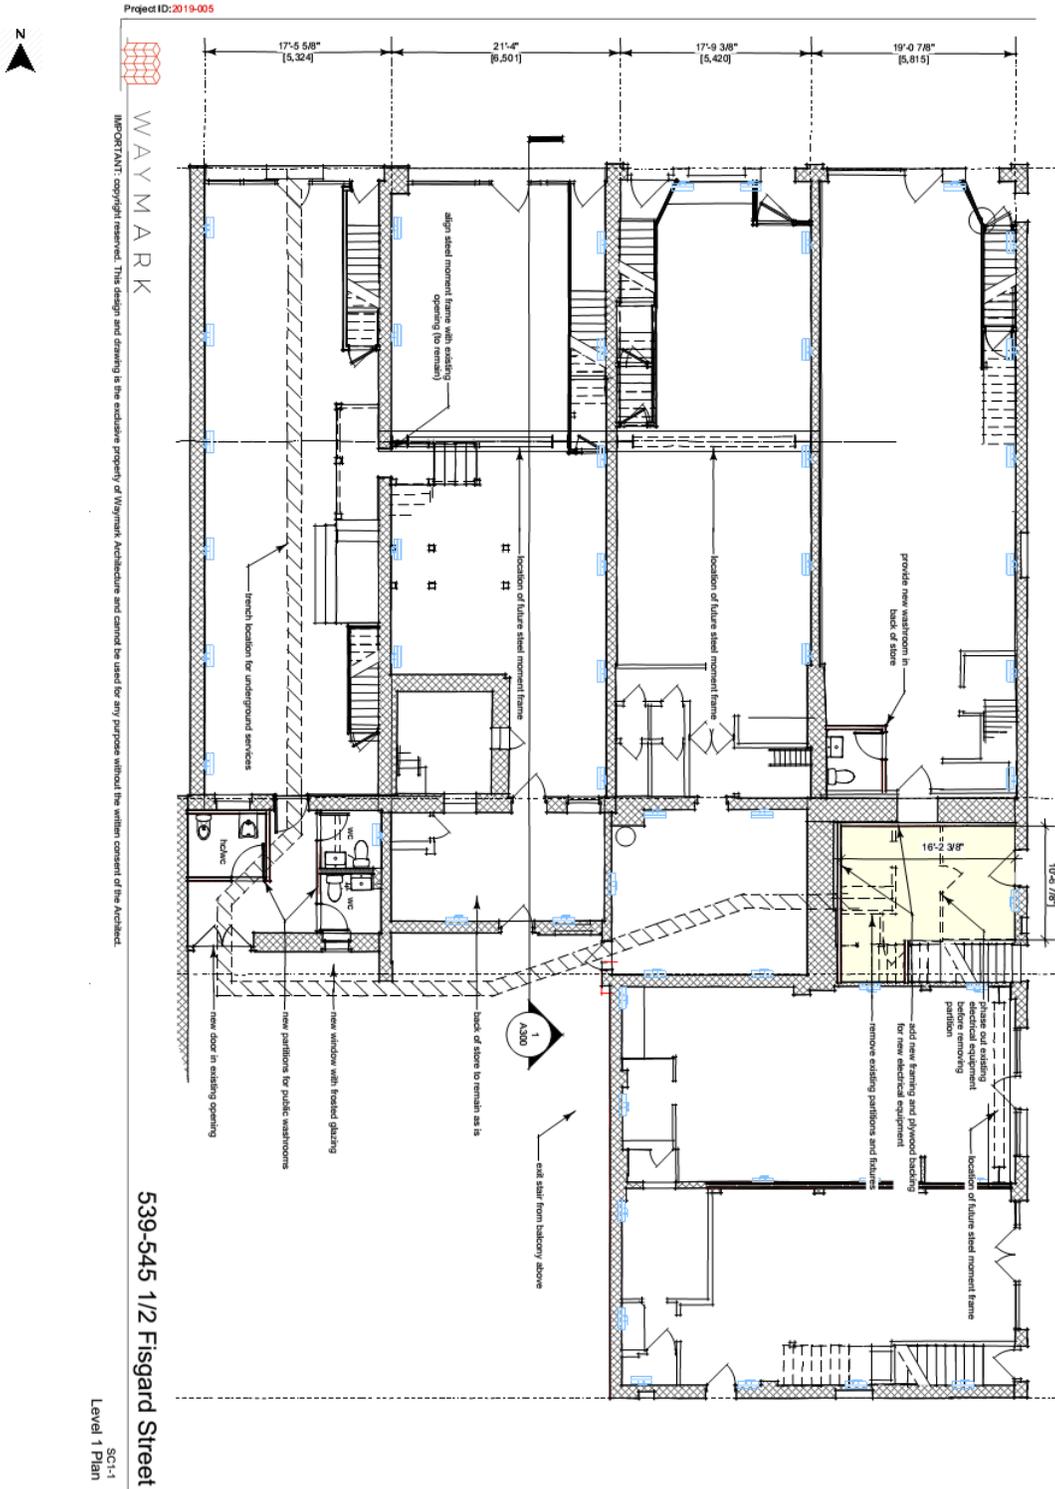
Figure 3.2, Layout of 1<sup>st</sup> floor of the building

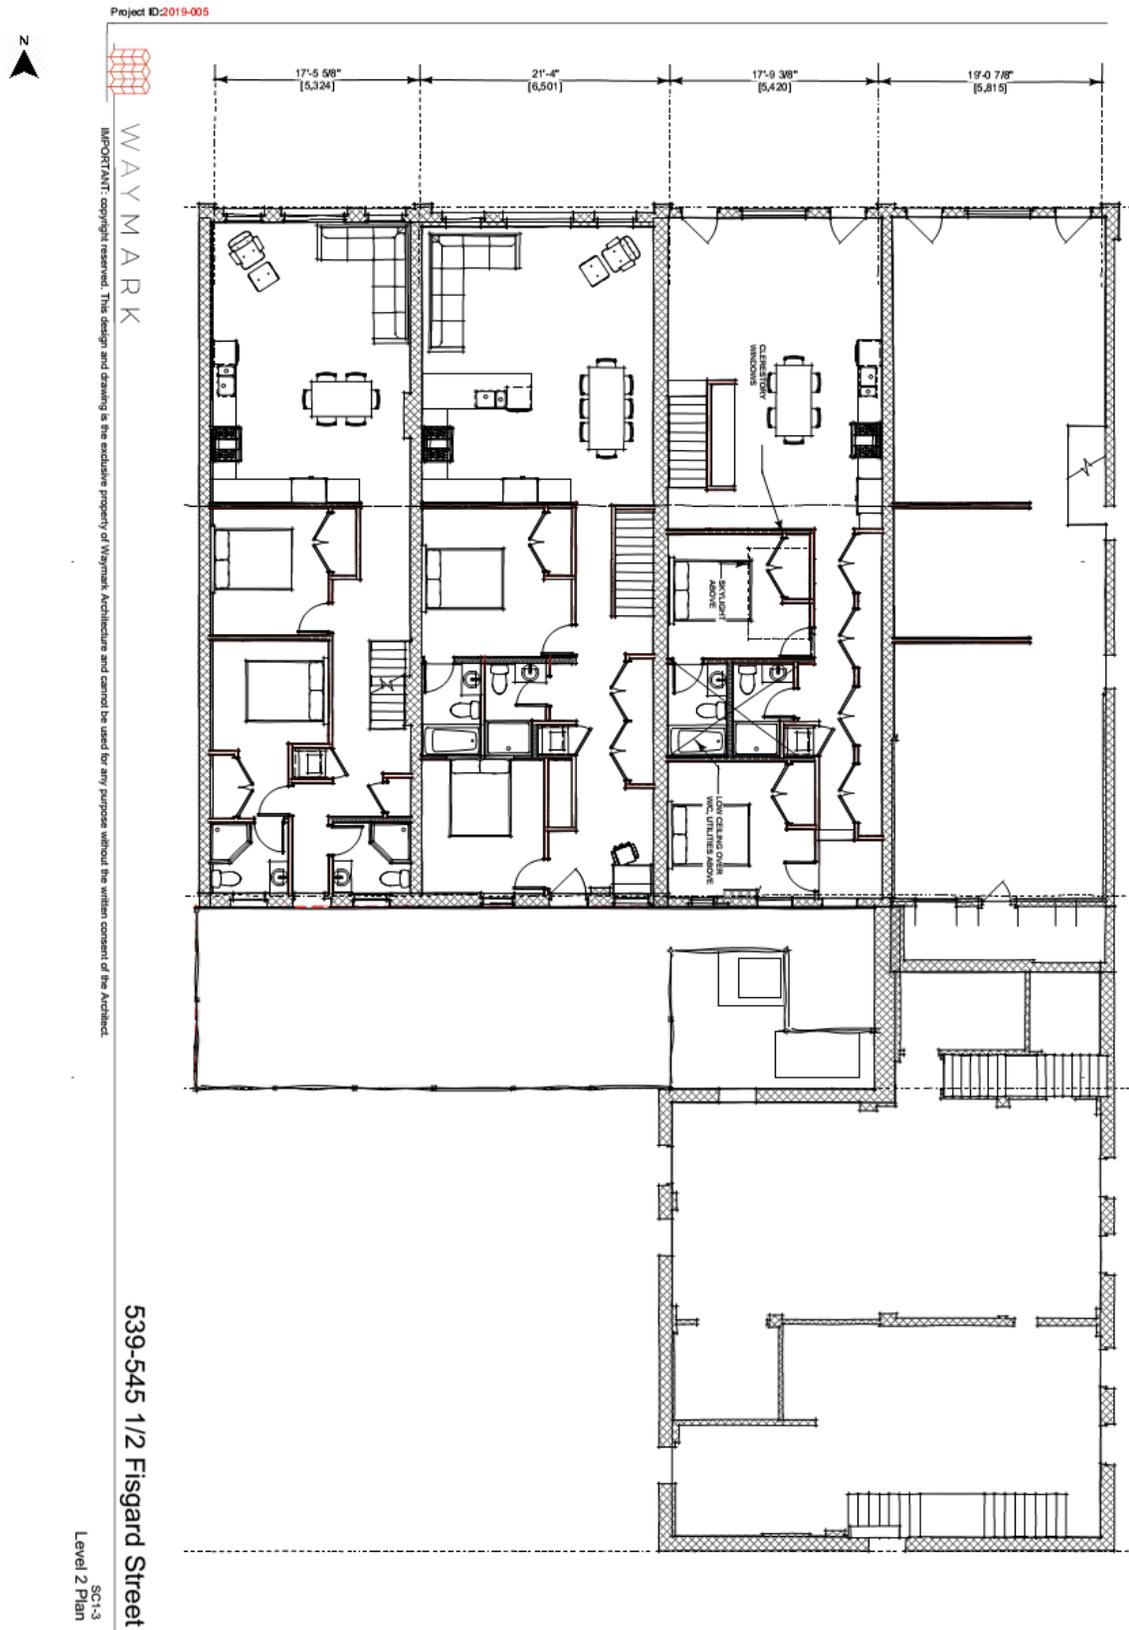
Figure 3.3, Layout of 2<sup>nd</sup> floor of the building

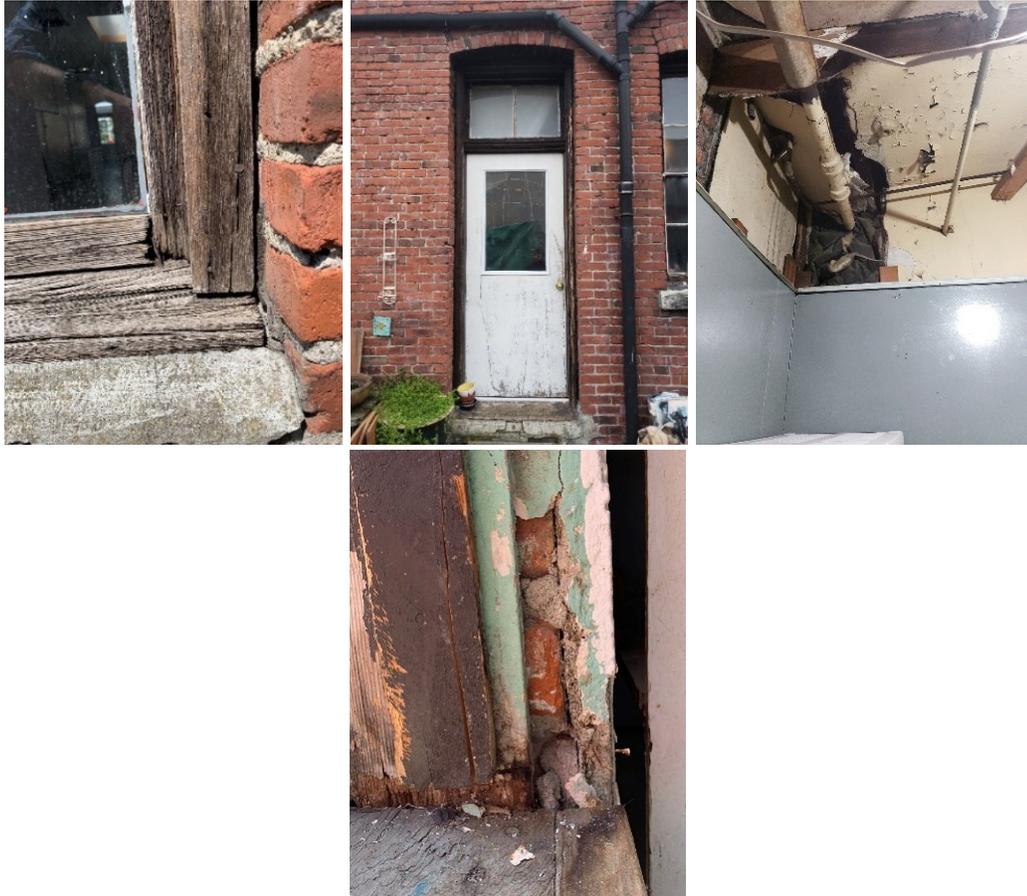
Figure 3.4, Rotted frames, gap between walls and missed seals

Besides, as Figures 3.4, 3.5 and 3.6 demonstrate, the lack of insulation in the building envelope is another main reason for losing high amounts of energy from the building. The reason that it is not possible to get an airtightness rate close to a passive house rate (0.6 ACH @ 50pa) anywhere of the many holes throughout the walls. Therefore, it is important

to bring the brick back to a point where doing a proper retooling of the masonry joints and putting the new woodwork back inside is possible.

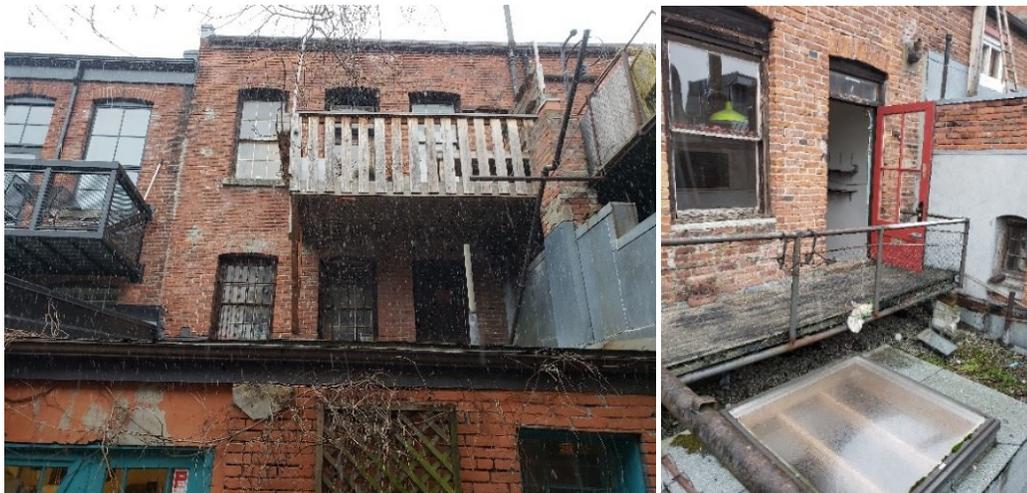
Figure 3.5, South façade of the building; degraded doors and windows

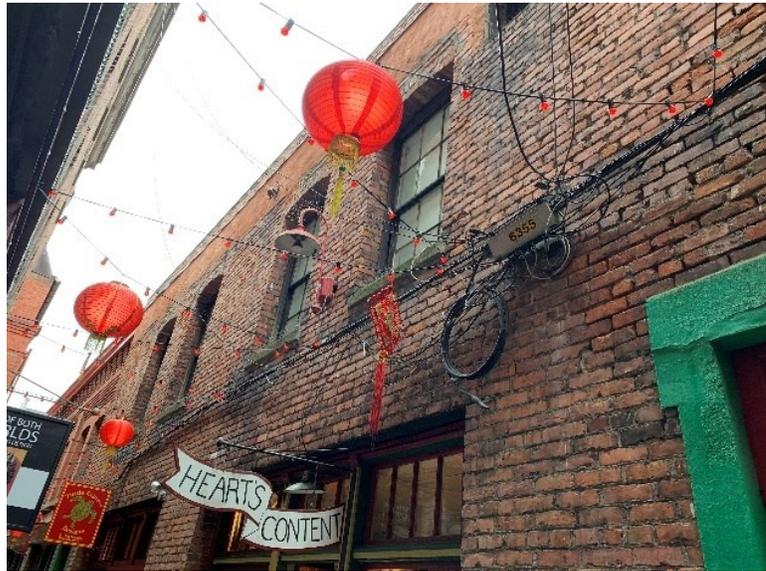
Figure 3.6, East façade of the building at Fantan Alley

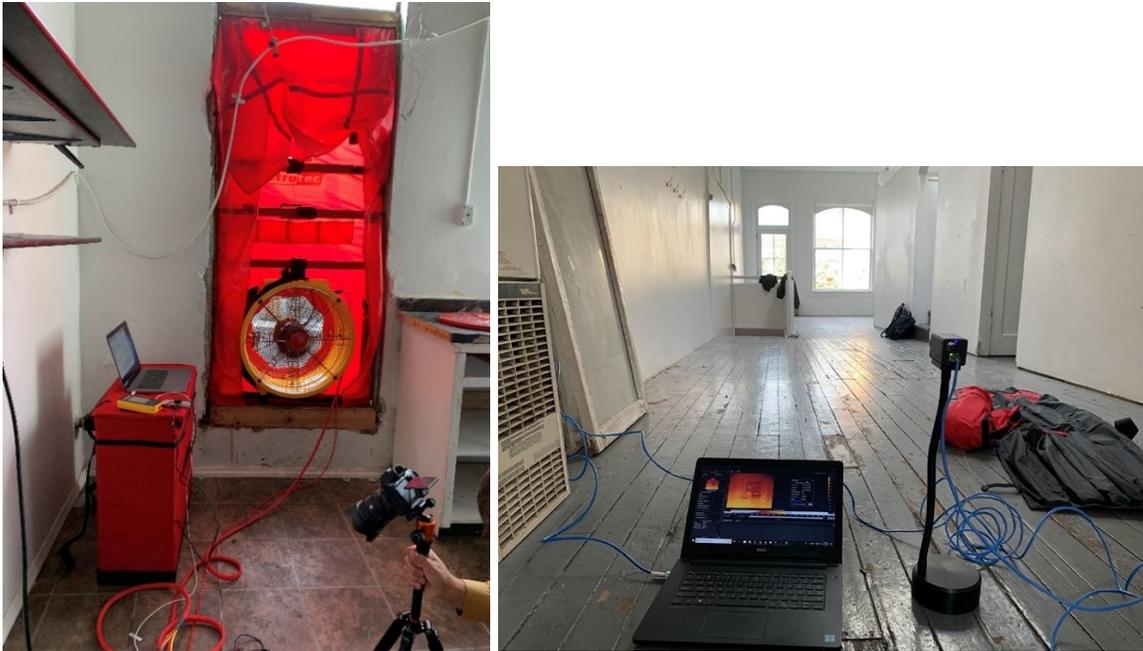
Figure 3.8; Blower door and thermography tests

*Energy Considerations:* As the first step, the details of installed insulation for the exterior building assemblies, thermal imaging from the building at the current condition,

and results of the air blower tests would be required for the passive house planning package (PHPP) to evaluate the current condition. Then, the selected energy retrofit options will be simulated using PHPP and compared based on the amount of saved energy, annual heating demand and estimated cost.

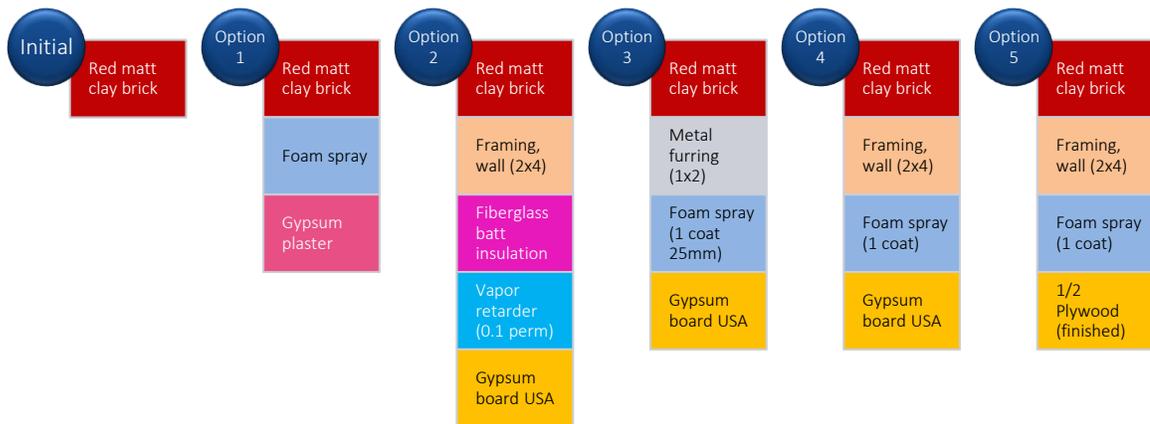
Figure 3.9; Energy retrofit options for external walls

Five options are proposed for the exterior walls and these are detailed in Figure 3.9. Since in this research the seismic and energy retrofitting of the building were supposed to be done simultaneously, the flooring system of the second level and roof was designed by different specific considerations. Therefore, only one option was provided for the second floor and roof. The details of which are shown in Tables 3.2 and 3.3. Also, on the first floor, only the flooring system of one store, which has wooden finished flooring on the slab, could be upgraded (Table 3.1). Other stores have a slab on grade flooring systems.

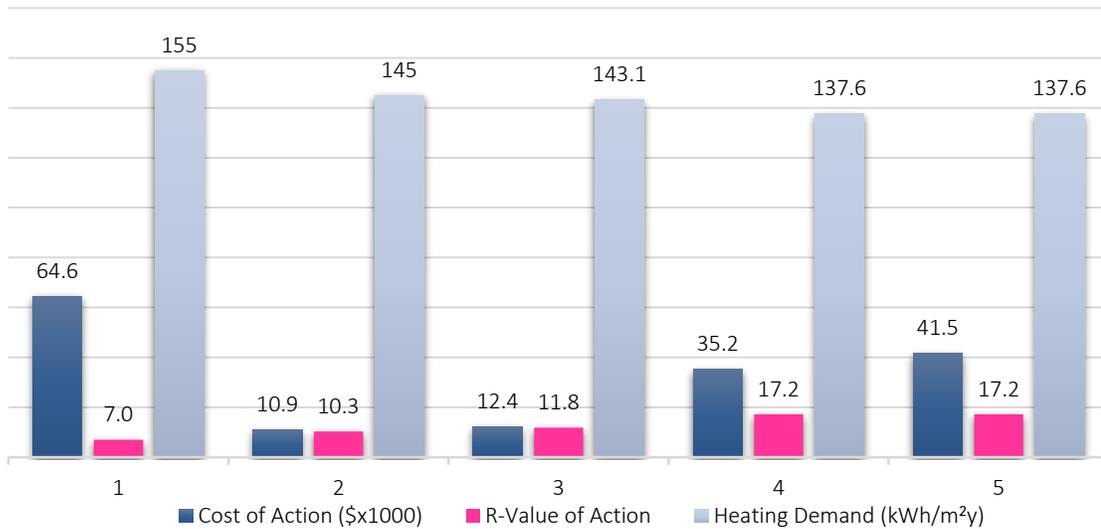
Figure 3.10, Cost estimation, R-value of each option and Heating demand of each option at the 5 ACH@50 pa

Solution Number	R-Value	Cost Estimation
Initial condition	-	-
1	7.0	\$64,588
2	10.3	\$10,935
3	11.8	\$12,365
4	17.2	\$35,157
5	17.2	\$41,533

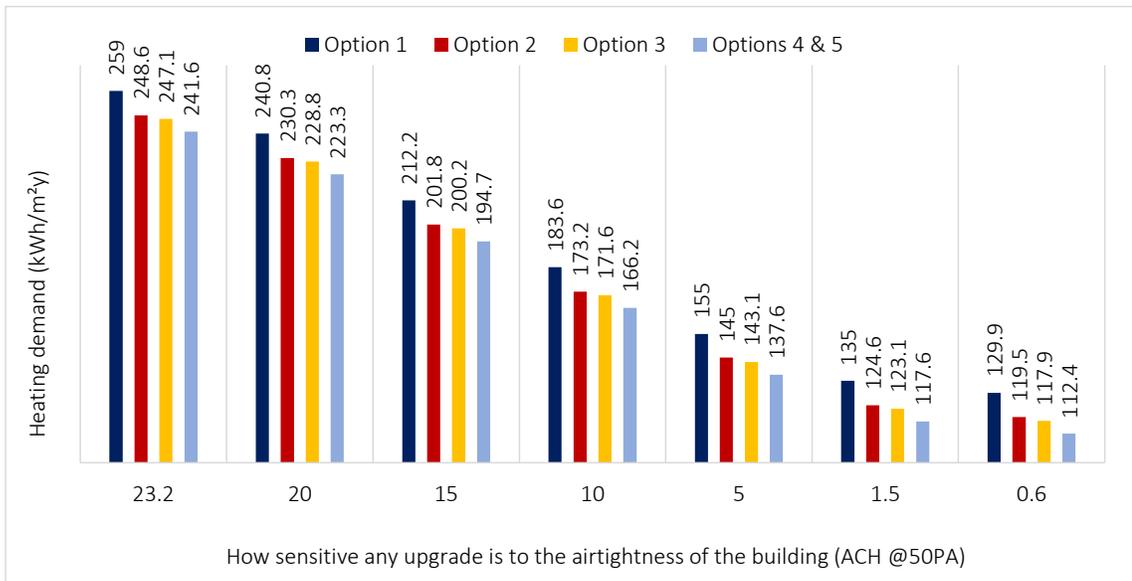
Figure 3.11, comparison between different airtightness rates and related heating demands

Solution	23.2 ACH	20 ACH	15 ACH	10 ACH	5 ACH	1.5 ACH	0.6 ACH
1	259	240.8	212.2	183.6	155	135	129.9
2	248.6	230.3	201.8	173.2	145	124.6	119.5
3	247.1	228.8	200.2	171.6	143.1	123.1	117.9
4	241.6	223.3	194.7	166.2	137.6	117.6	112.4
5	241.6	223.3	194.7	166.2	137.6	117.6	112.4

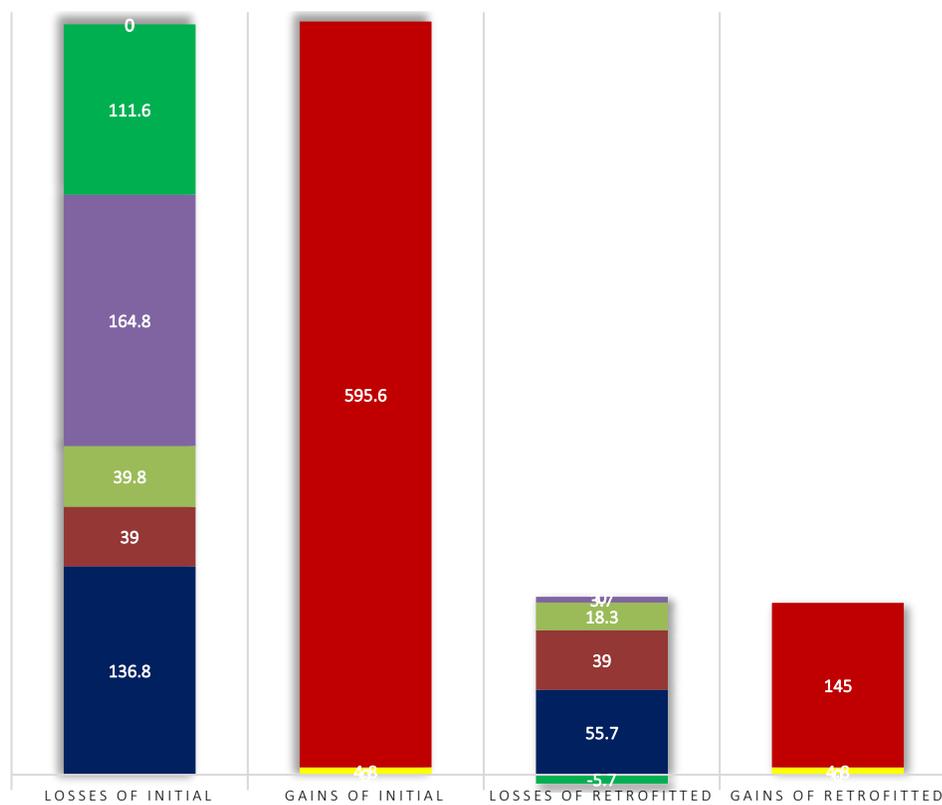
■ Ventalation ■ Windows ■ Floor/ Slab Basement ■ Roof / Ceiling ■ External Walls ■ Solar Heat Gains ■ Heating Demand

Figure 3.12, Details of comparing heating losses and gains between initial and retrofitted

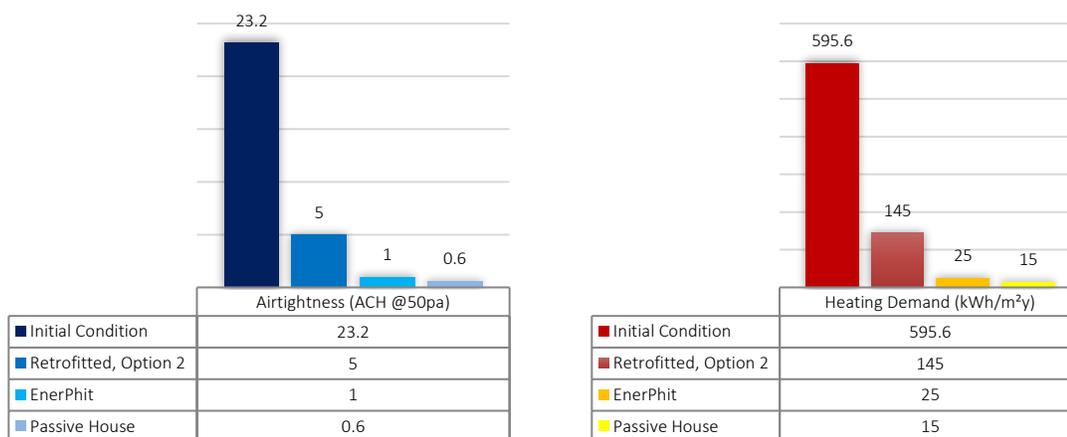
Figure 3.13, Comparing Airtightness rates and Heating demands between initial, retrofitted, EnerPhit and Passive House standard

Figure 3.13 illustrates a comparison between Passive House and EnerPhit standards with retrofitted and initial conditions for both airtightness rate and heating demand. The average air exchange rate represents infiltration in the building. The maximum acceptable value for residences based on the Passive House Standard is 0.6 ACH @50pa. This value

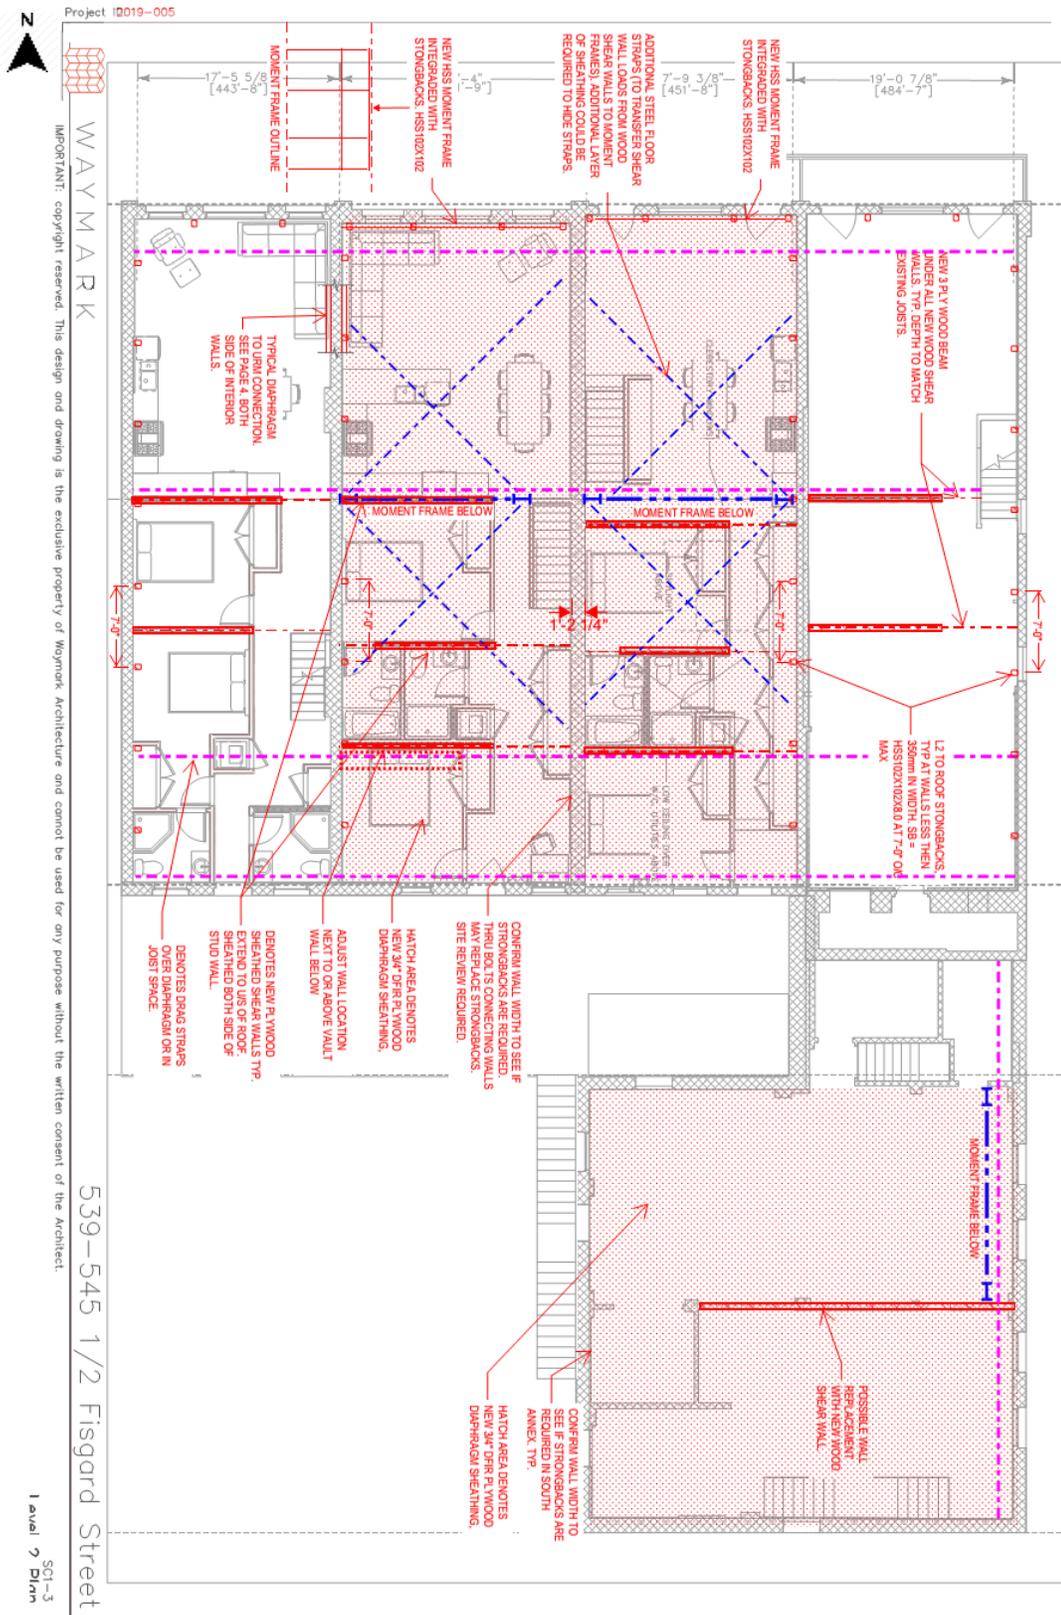
1. Adding a layer of plywood sheathing in the floor and additional steel floor straps to transfer shear wall loads from wood shear walls to moment frames in the units #541 1/2, #543 1/2.
2. Adding two HSS moment frames around the windows in the front façade, integrated with HSS 102mm×102mm×8mm strongbacks.
3. Adding plywood shear walls in all units as indicated in Figure 10.
4. Adding 44 HSS 102mm×102mm×8mm strongbacks from level two to roof at 2 meters spacing.

Figure 3.15, Structural seismic upgrade drawings – second floor

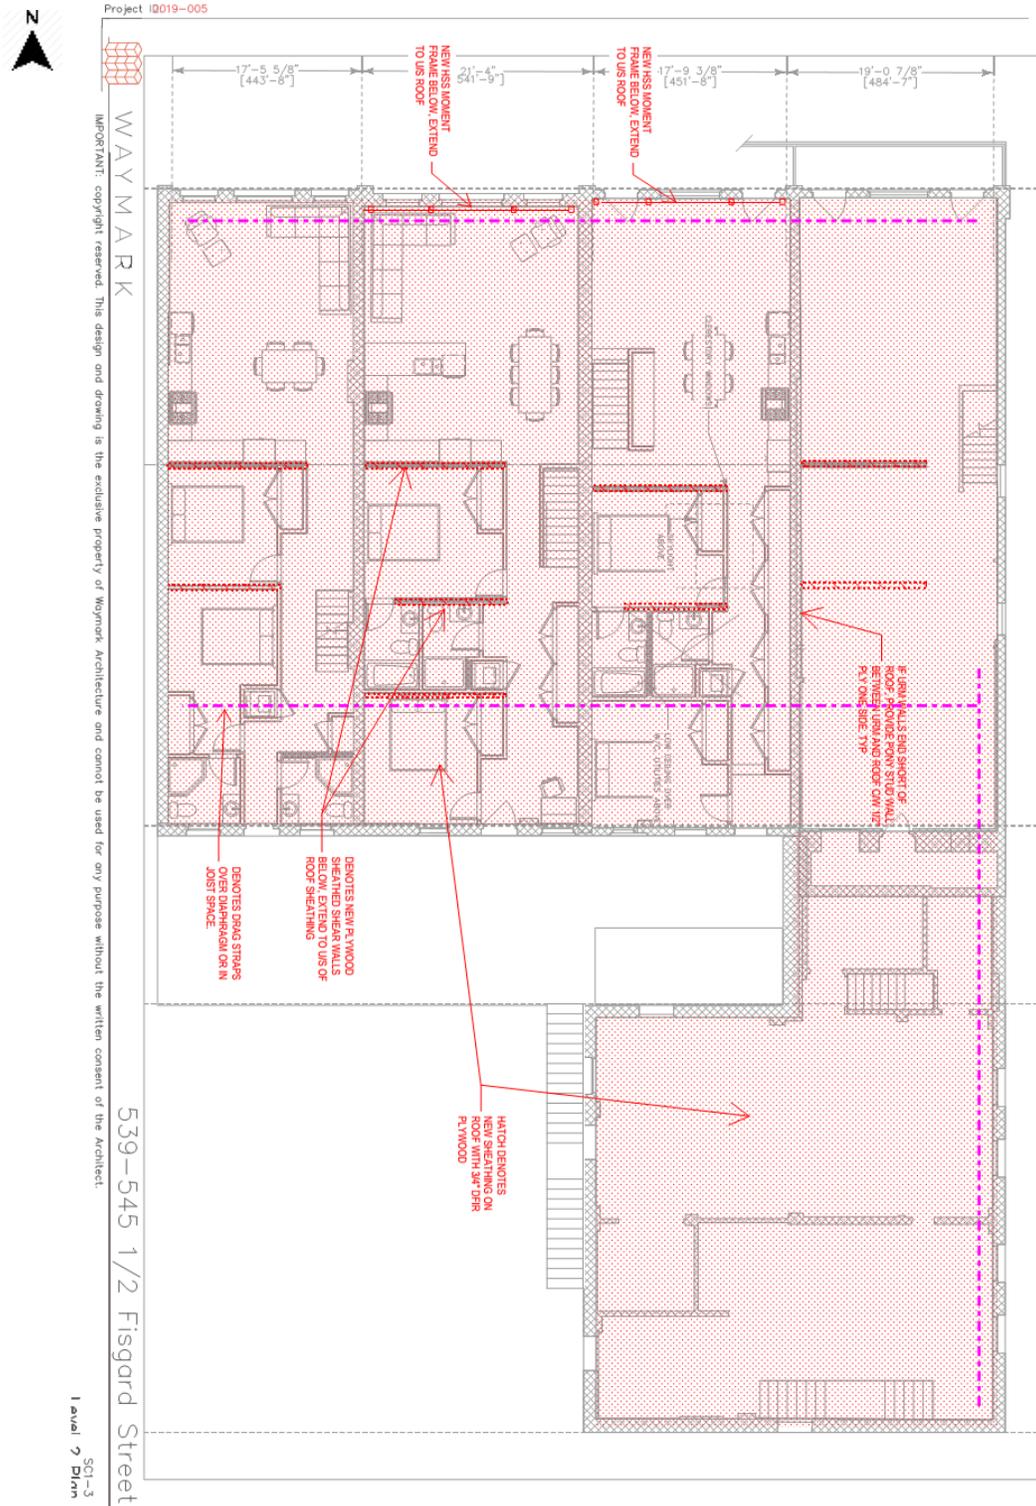
5. Adding plywood sheathing on the roof.

Figure 3.16, Structural seismic upgrade drawings – roof

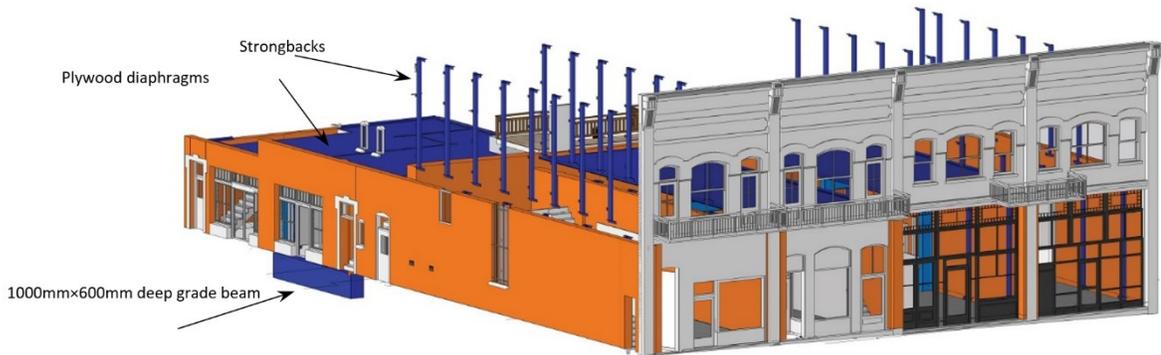
Figure 3.17, Structural seismic upgrade solution by adding HSS strongbacks, moment frames and plywood sheathings, north-east view

In general, 65 HSS strongbacks on both floors are needed to make the building seismic-resistant. Each of these strongbacks will be connected to the wall with four steel brackets and linked to the other one with three more L angle brackets. It is estimated that more than 500 meters of L Angle Steel Bracket 4"×4"×1/4" will be required for this purpose. The construction costs for the listed seismic upgrades would be around \$53.6 per square meter. Table 3.12 describes the cost estimation of the seismic retrofitting solution in detail. To mention, the cost of plywood sheathing was considered in the energy part as it has impacts on seismic and energy retrofitting [6], [9]–[15].

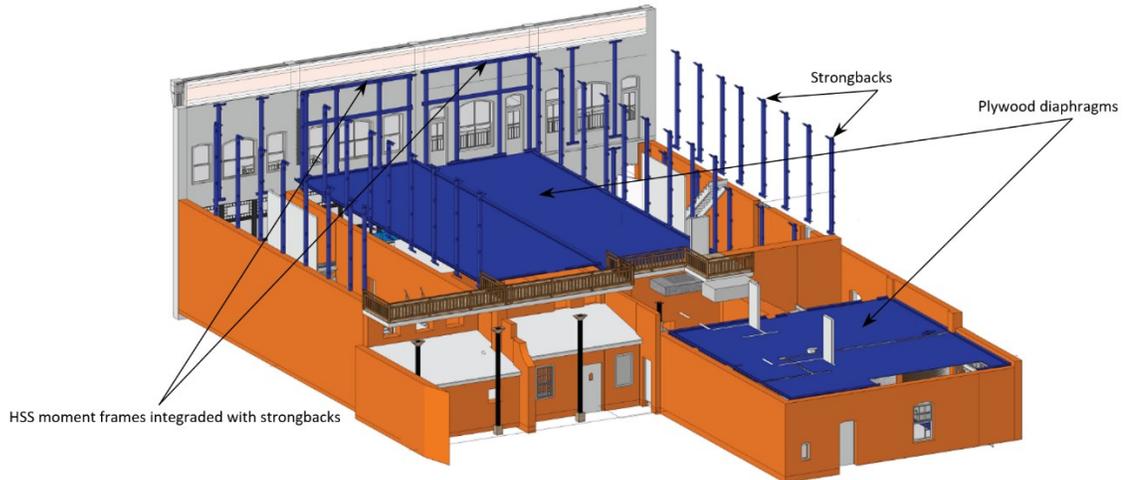
Figure 3.18, Structural seismic upgrade solution by adding HSS strongbacks, moment frames and plywood sheathings, south-west view

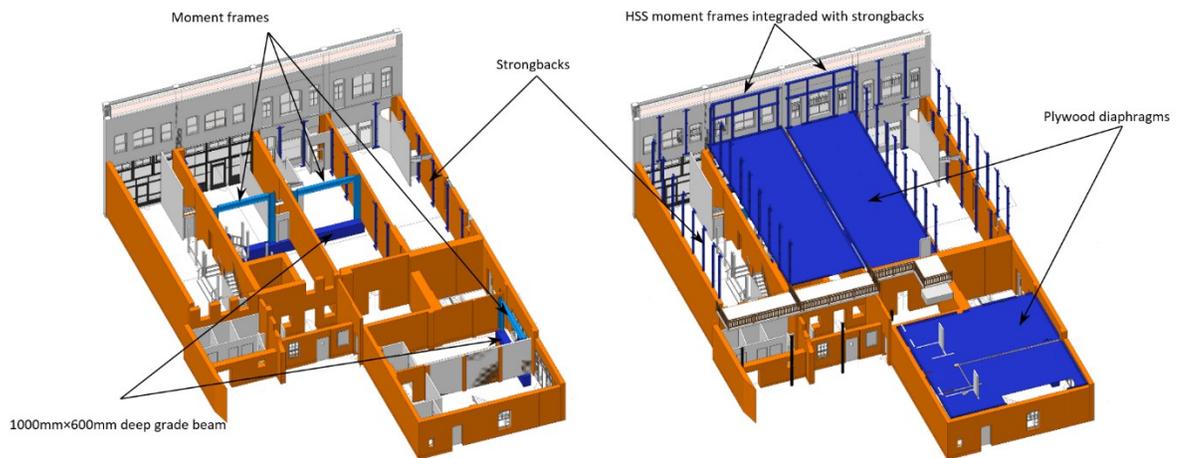
Figure 3.19, a) Layout of HSS strongbacks and moment frames at level 1; b) Layout of HSS strongbacks, moment frames and plywood sheathings at level 2

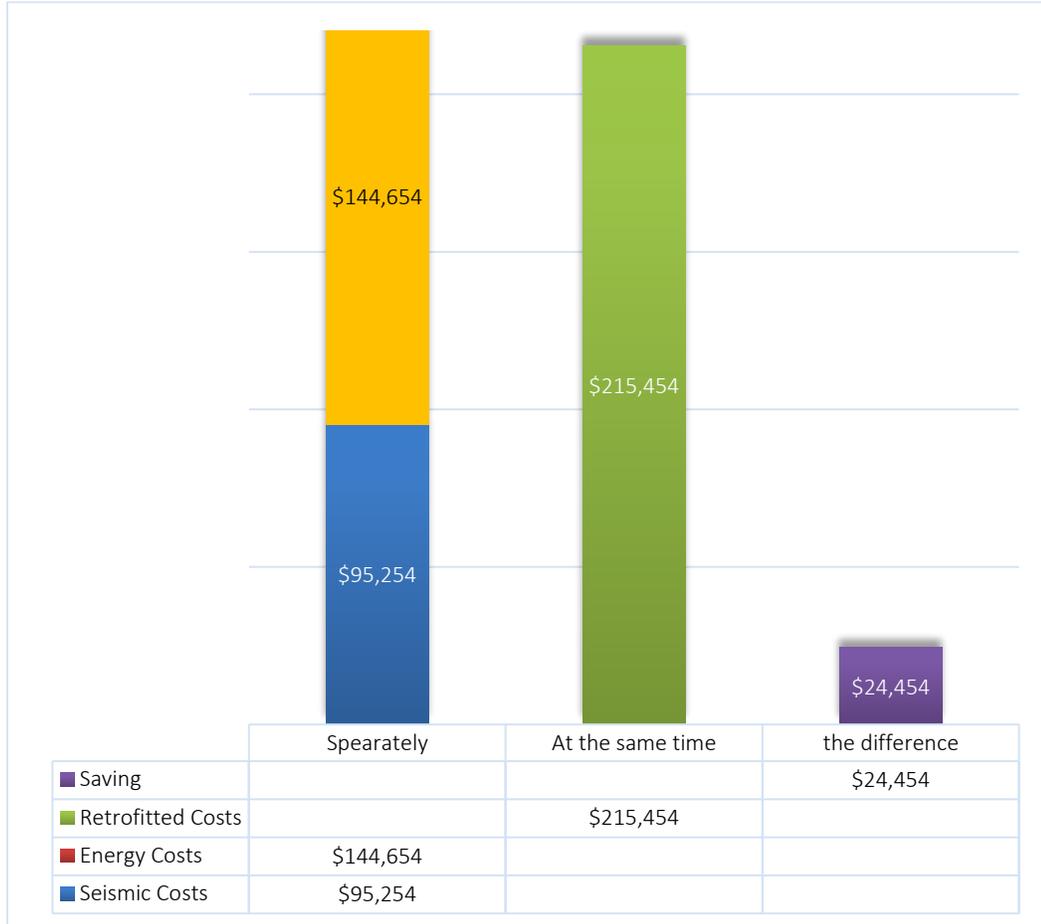
Figure 3.20, Comparison between costs of separate and simultaneous seismic and energy retrofit

Therefore, integrating energy and seismic retrofits delivers payback with safety. As immediate benefits, energy upgrades reduce the energy consumption and carbon emissions of the building. Besides, as long-term benefits, seismic upgrades improve the structural resistance of the building; consequently, occupants' safety is increased as well. Meanwhile, separate seismic and energy retrofit adds \$24,454 more to the project's costs. This

additional cost is related to plywood sheathing which is an important component for both energy and seismic retrofitting. Figure 3.20 shows the cost differences in doing separate and simultaneous seismic and energy retrofitting.
