**Structural Health Monitoring of the Marine Structure Using Guided Wave and UAV-based testing**

**Thesis Submitted in Partial Fulfillment  
of the Requirements for the Degree of**

**MASTER OF ENGINEERING**

**in the Department of Mechanical Engineering**

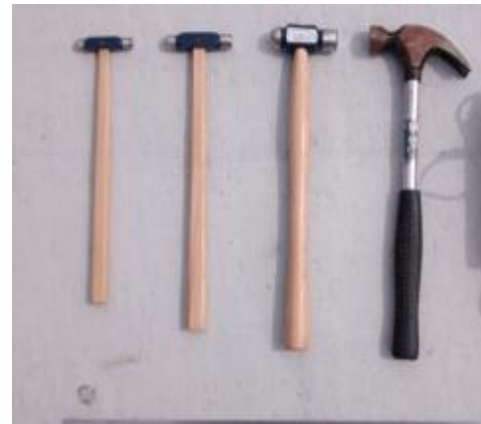
**Figure 3:  
Hammer**

**percussion test equipment**

In hammer percussion testing, a microphone is used to record the acoustic response, while steel specimens are struck with a hammer to cause an acoustic disturbance. The specimens are placed on a sponge pad to simulate resonance frequency when struck by a hammer. A 56.7-g (2-ounce) steel ball hammer is used, and the resulting acoustic response was recorded using a set of microphones and an audio recorder, as shown in fig(3). The Zoom H1 digital voice recorder was used to record the audio. With a maximum sampling rate of 96 kHz at 24-bit depth, this recorder is capable of recording vibration frequencies up to 48 kHz. Additionally, Zoom H1 has a 24-bit depth analogue-to-digital conversion capability, ensuring great precision during post-production. A Polsen OLM-20 Dual Omnidirectional Lavalier Microphone was utilised. The distance between the microphone and the specimen is kept between 5 to 25 mm to reduce environmental noises [109]; in addition, as the microphone has two channels, the closest channel to the surface of the specimen was utilised for post-processing. The acoustic data were trimmed using Audacity® audio software to get rid of the ambient noises that were recorded before and after the hammer hit. MATLAB© was used to perform Fast Fourier transformation on the WAV file, and the peaks are identified as the resonant frequency. Any particular specimen has various resonant frequency modes. The total number of specimen used in this experiment are 8 steel ring. Out of 8 rings, four steel rings have a bigger outer diameter(OD), and four steel rings have smaller outer diameters (OD) with different thicknesses, which can be used to simulate various marine structures such as underwater pipe, offshore structures and ship hull. The dimension of all the specimens used is given in the following table 3.

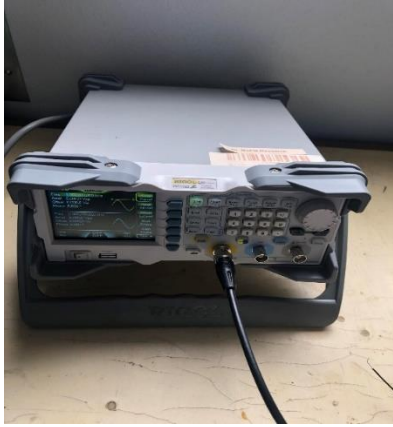
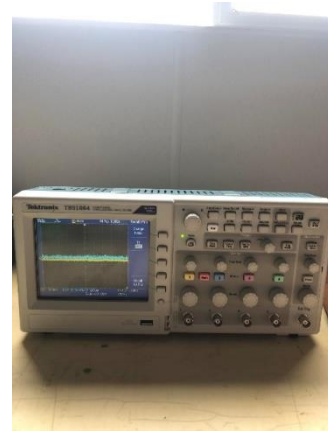
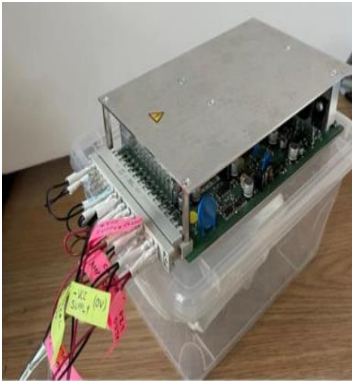
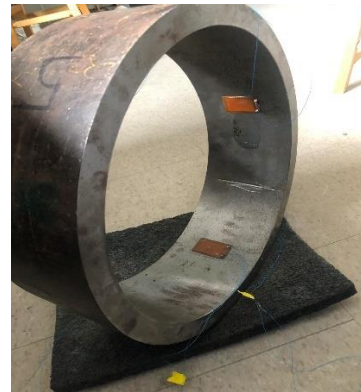
**Figure 5: Piezo patches based experimental set up**

In this experiment, a Harmonic signal is generated using the RIGOL DG1022 function/arbitrary waveform generator. The signal from the waveform generator is amplified by using the PI piezo power amplifier (Model E-413.D2) before triggering the piezo patch P1. The harmonic response signal of the P2 piezoelectric sensor is recorded by using the Tektronix digital oscilloscope (Model TBS 1064). The Tektronix oscilloscope is also used to record the signal from the P1 actuator to calculate the time delay for the harmonic signal to reach the P2 sensor. The piezopatches is glued to the steel plate for proper contact with the steel plate and steel ring. The below figure (5) shows the complete setup as well as complete details.

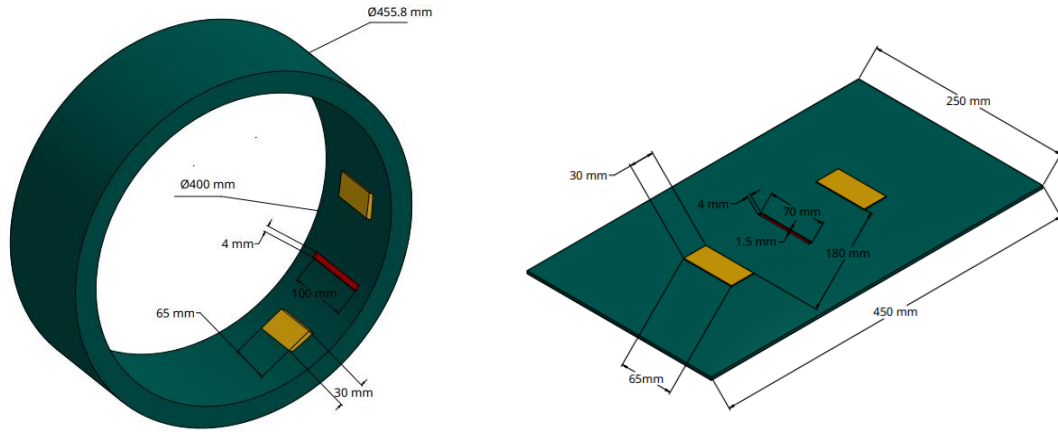
**Figure 6: Specimens for Experiment**

One of the key components of the Wave propagation technique is the actuation frequency. The frequency response was observed between 50 KHz and 62 KHz. The two specimens are tested 1) Flat steel plate and 2) Thick steel ring. The specimen dimension can be seen in the figure (6).

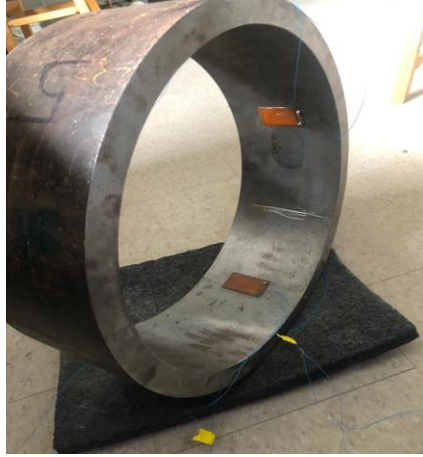
Figure A.1.1: Steel ring with Piezo Patches

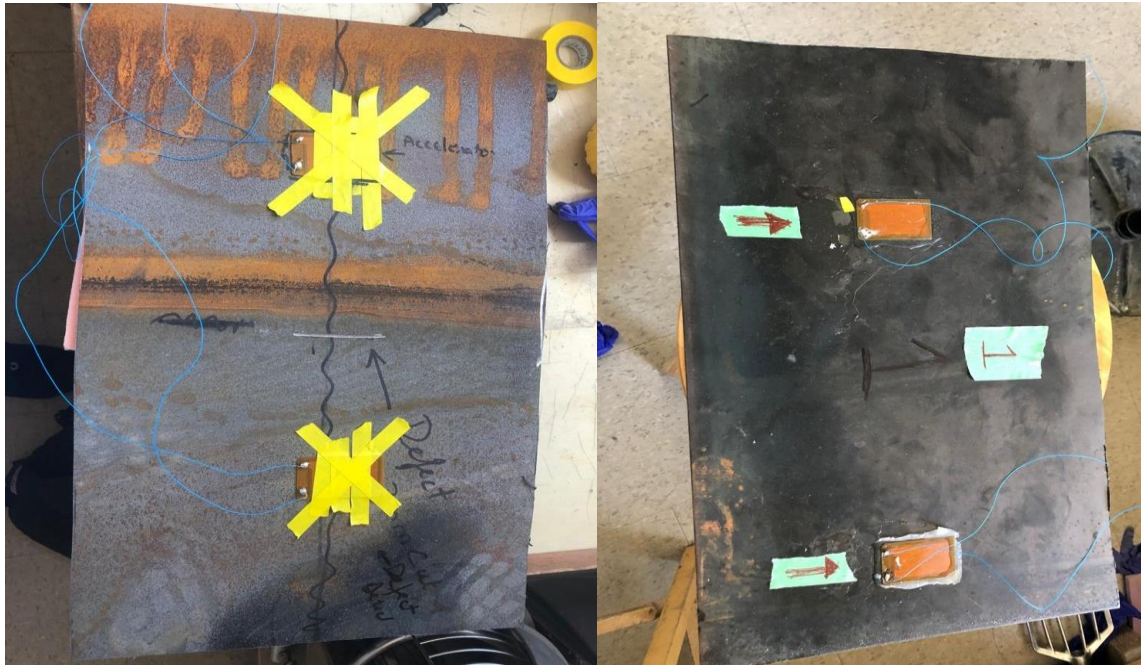
Figure A.2.1: Steel plate as a Specimen
