**The Characterization and Dating of Landslides  
in the Tsitika River and Schmidt Creek Watersheds,  
Northern Vancouver Island,  
British Columbia**

A Thesis Submitted in Partial Fulfillment of the  
Requirements for the Degree of

Master of Science

in the School of Earth and Ocean Sciences

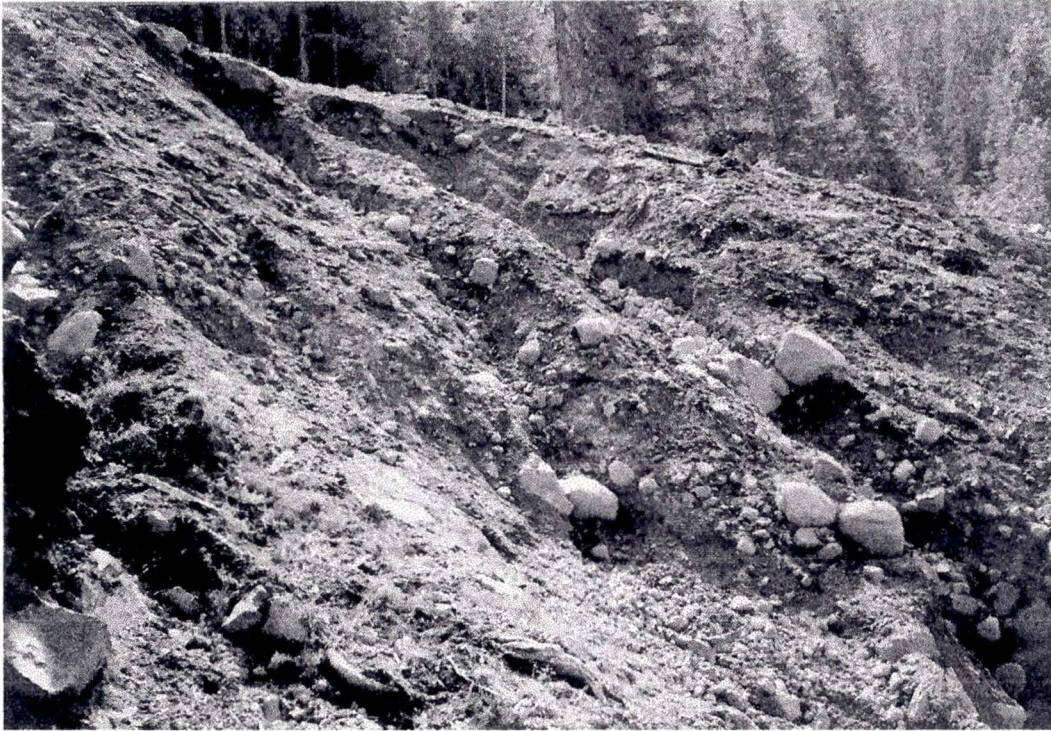
Figure 2.7: Morainal deposits in the Tsitika study, are generally considered to be a medium to coarse basal till. They are composed of poorly sorted sand, and cobbles, and range in thickness from a thin veneer, to several metres.

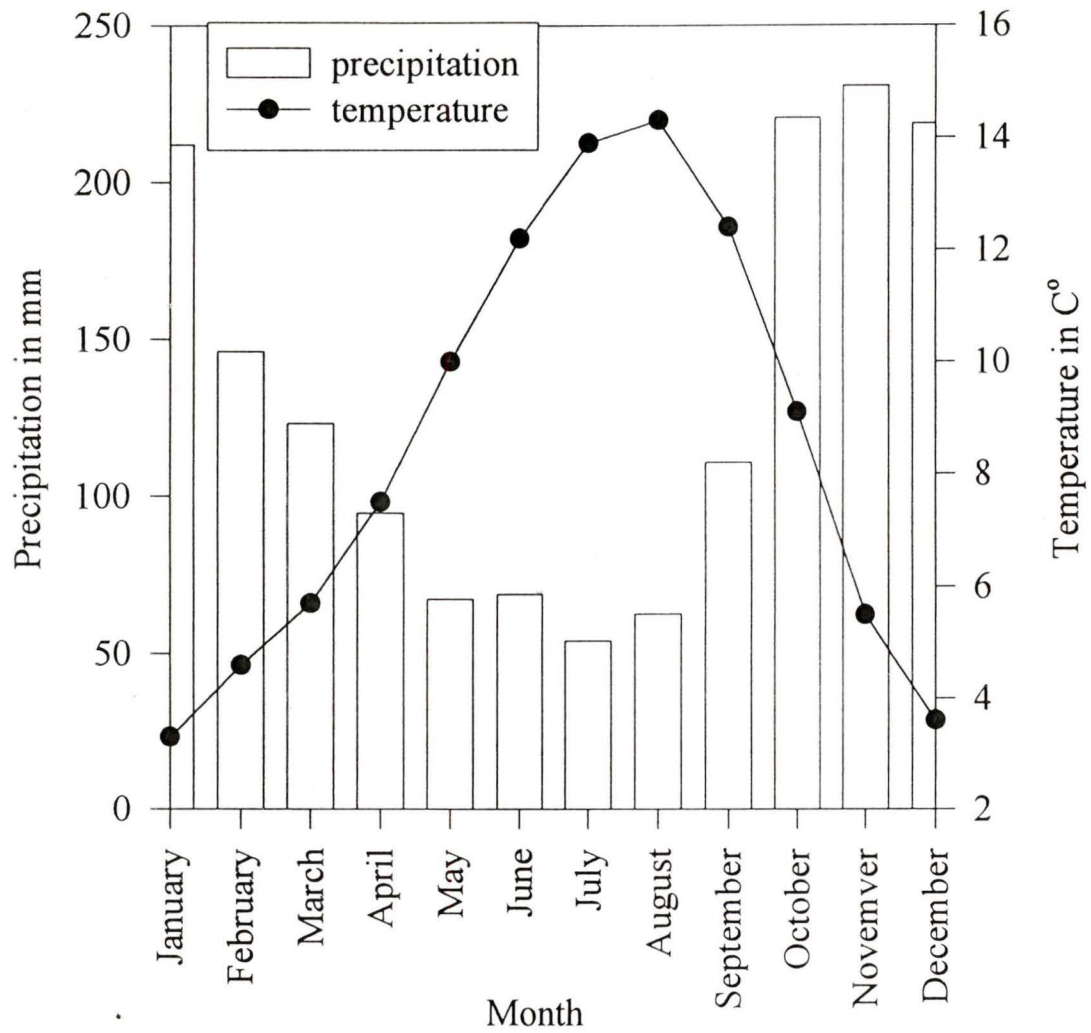
Figure 2.8: Mean monthly precipitation and temperature at Alert Bay, 1913-1990 (Environment Canada, 1993).

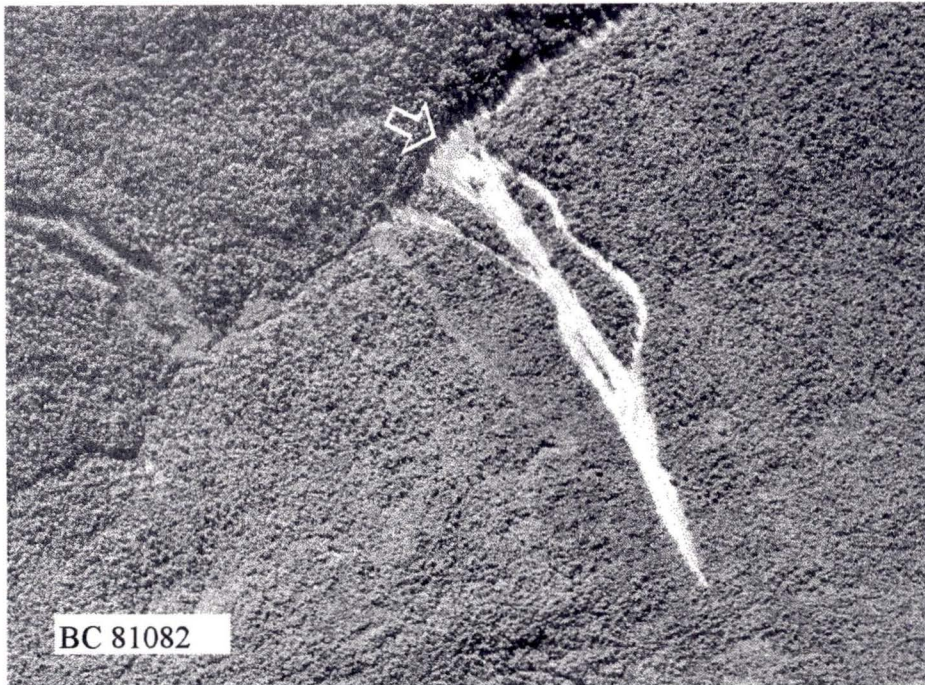
Figure 3.1: A landslide in Schmidt Creek as seen from air photograph. Note: New vegetation is beginning to grow at the base of the slide (at arrow). Original scale was 1:20,000, year was 1981.

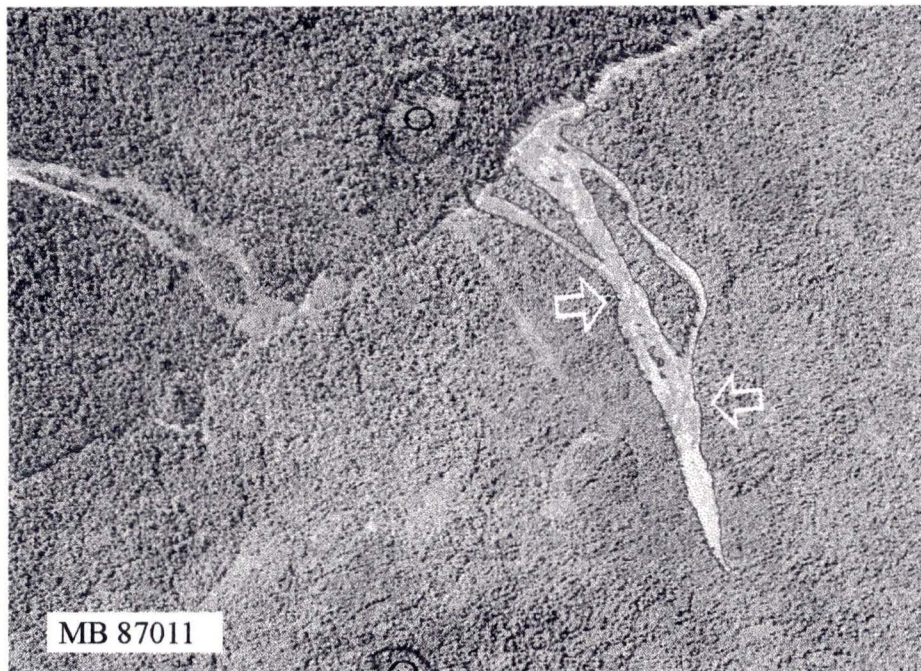
Figure 3.2: The same landslide seen on an air photograph six years later. Note: Vegetation has now grown much further up the landslide (arrows). The oldest trees are at the base, where they were first established on the site (see Figure 3.1 above). Original scale was 1:15,000, year was 1987.

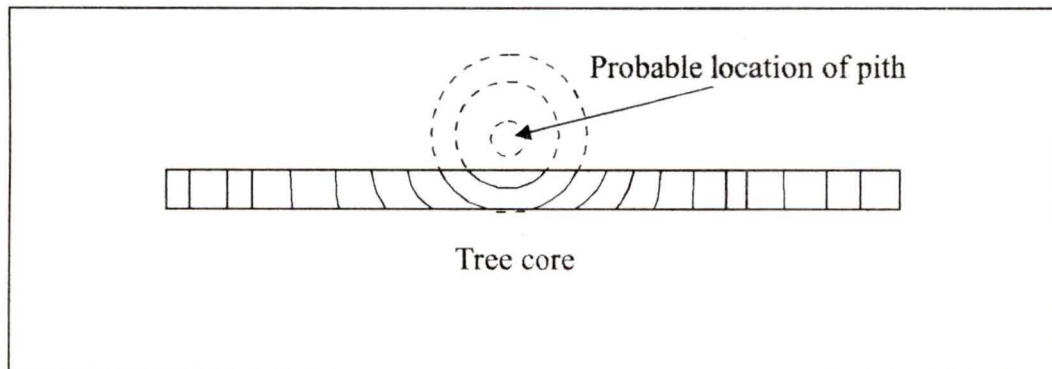
Figure 3.4: Diagram showing how the pith is extrapolated based on tree ring curvature.

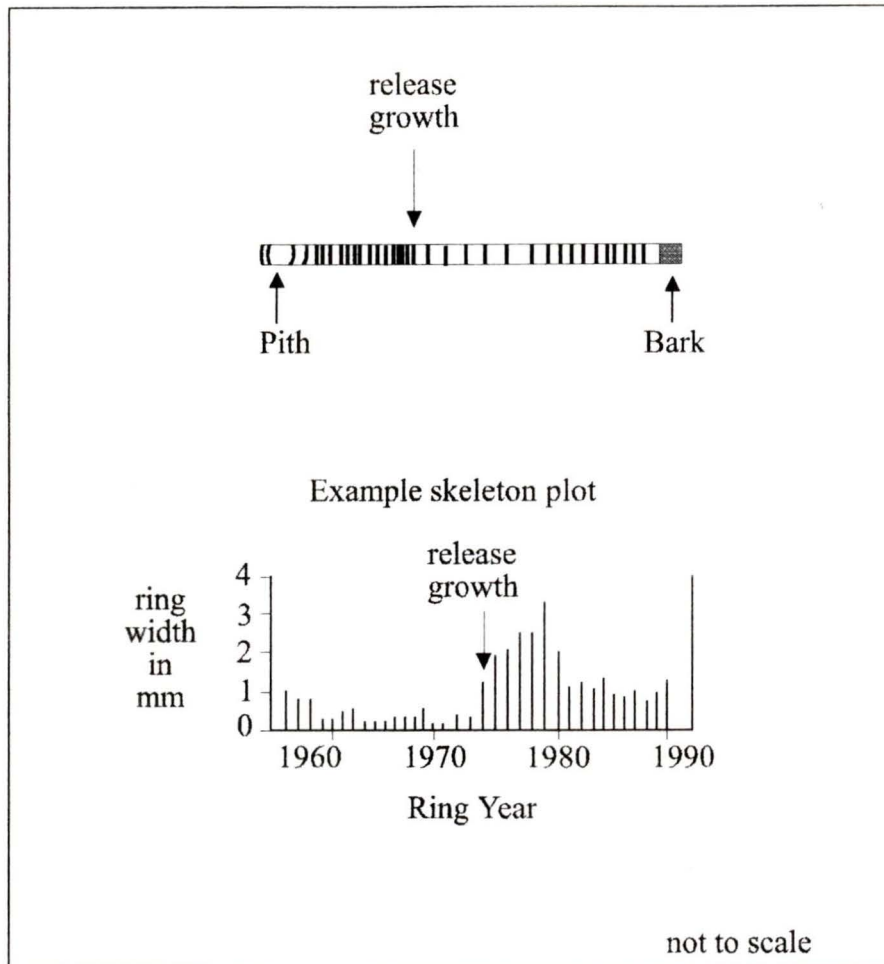
Figure 3.7: Release growth in trees may occur following landslide activity. Release growth is identified by wider annual rings. A skeleton plot is typically made by measuring the rings. This allows the viewer to better see the growth patterns.

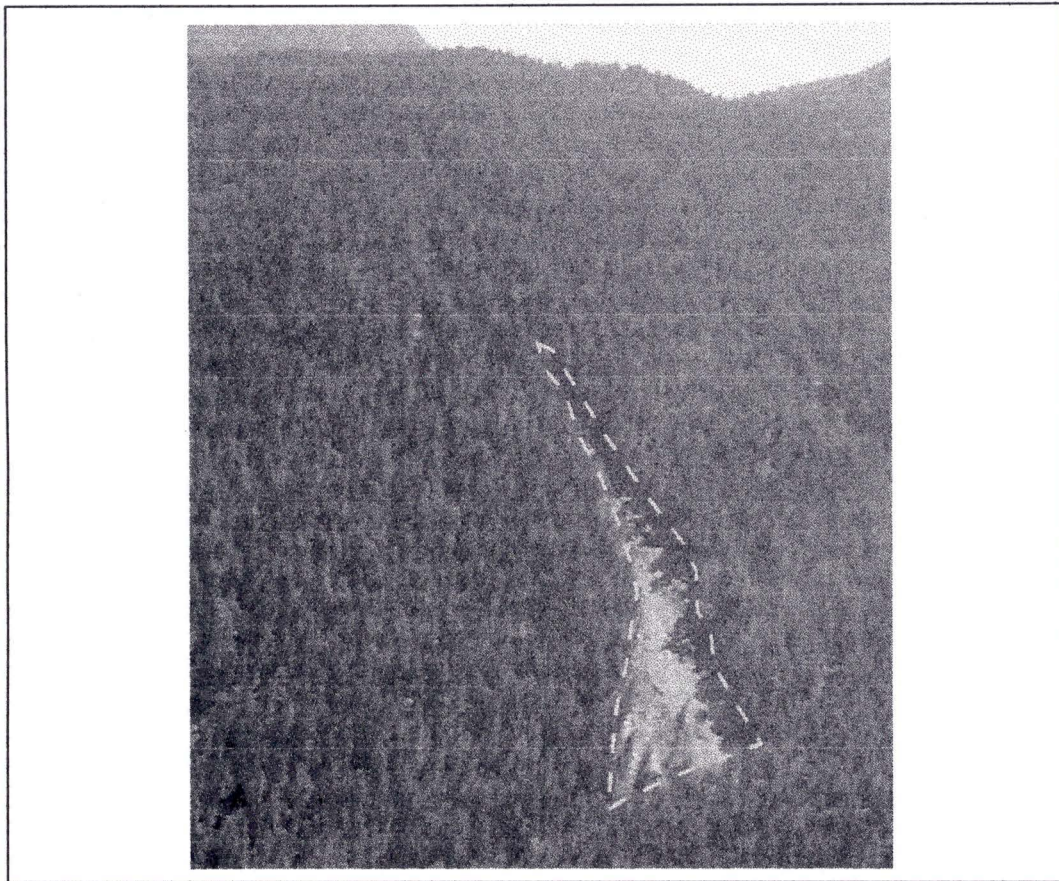
Figure 4.3: The wedge shaped track of a landslide in the study area.

Debris slides are easily identified by a linear, wedge shaped track, expanding toward the base of the slope (Figure 4.3). Older debris slides are identified by similar tracks, usually covered by vegetation of different species or maturity (height) than the

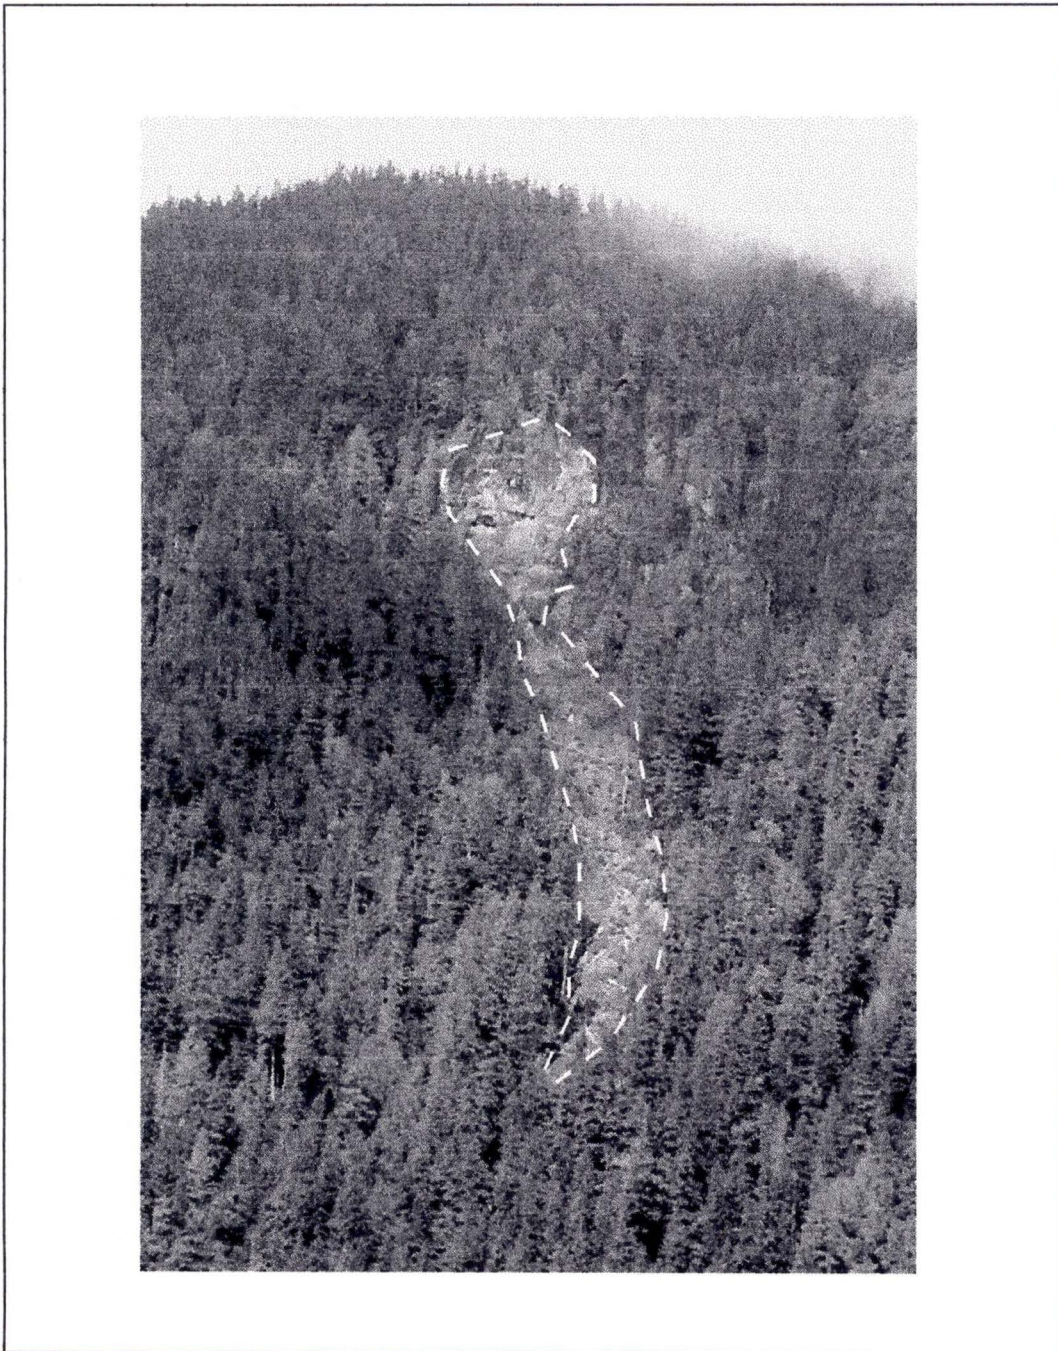
Figure 4.5: A typical rockfall, showing the detachment face and deposition path.

Rockfalls are identified in the study by the presence of a detachment face on a steep cliff, and a track where the rock has fallen, broken up and is deposited (Figure 4.5). Active rockfalls may be identified by the presence of talus cones at the base of cliffs.

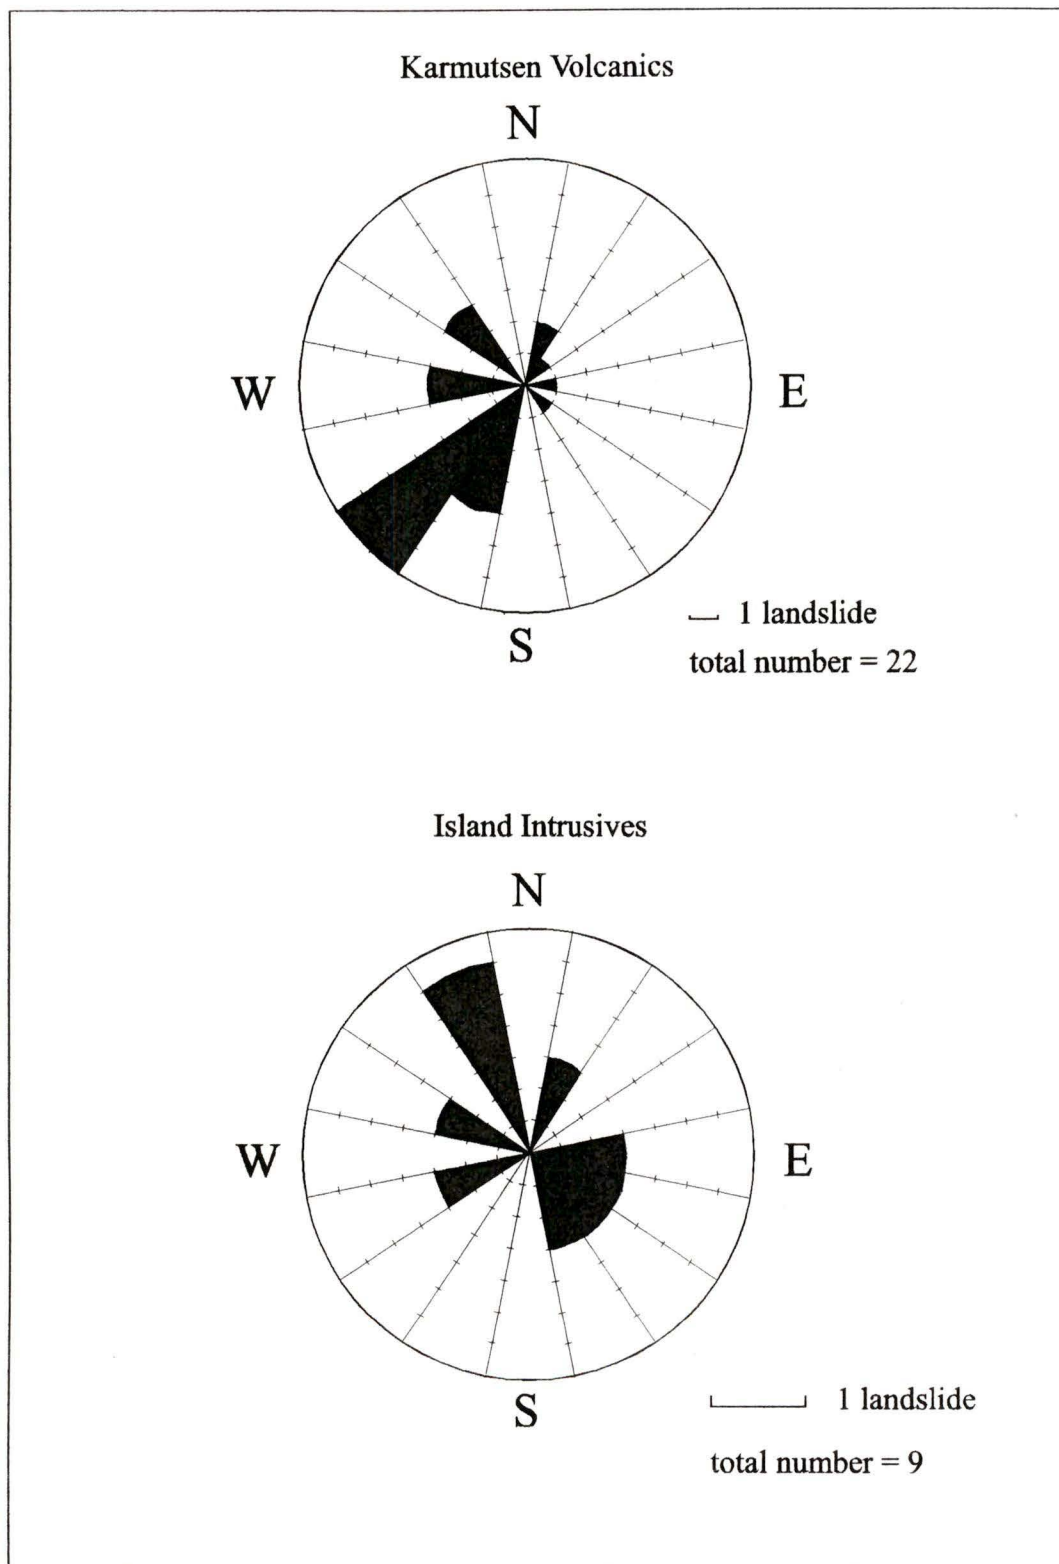
Figure 5.5: Azimuth direction of landslides in the study area compared to geology.

Azimuth directions of landslides in the Tsitika study area are shown in Figure 5.3. A summary rose diagram of azimuth direction is given in Figure 5.5 comparing landslides over the two different bedrock units. Landslides in the Karmutsen Volcanics show a strong southwesterly orientation and therefore a southwesterly aspect on slopes in the study area. In contrast, landslides over the the Island Intrusives, are distributed

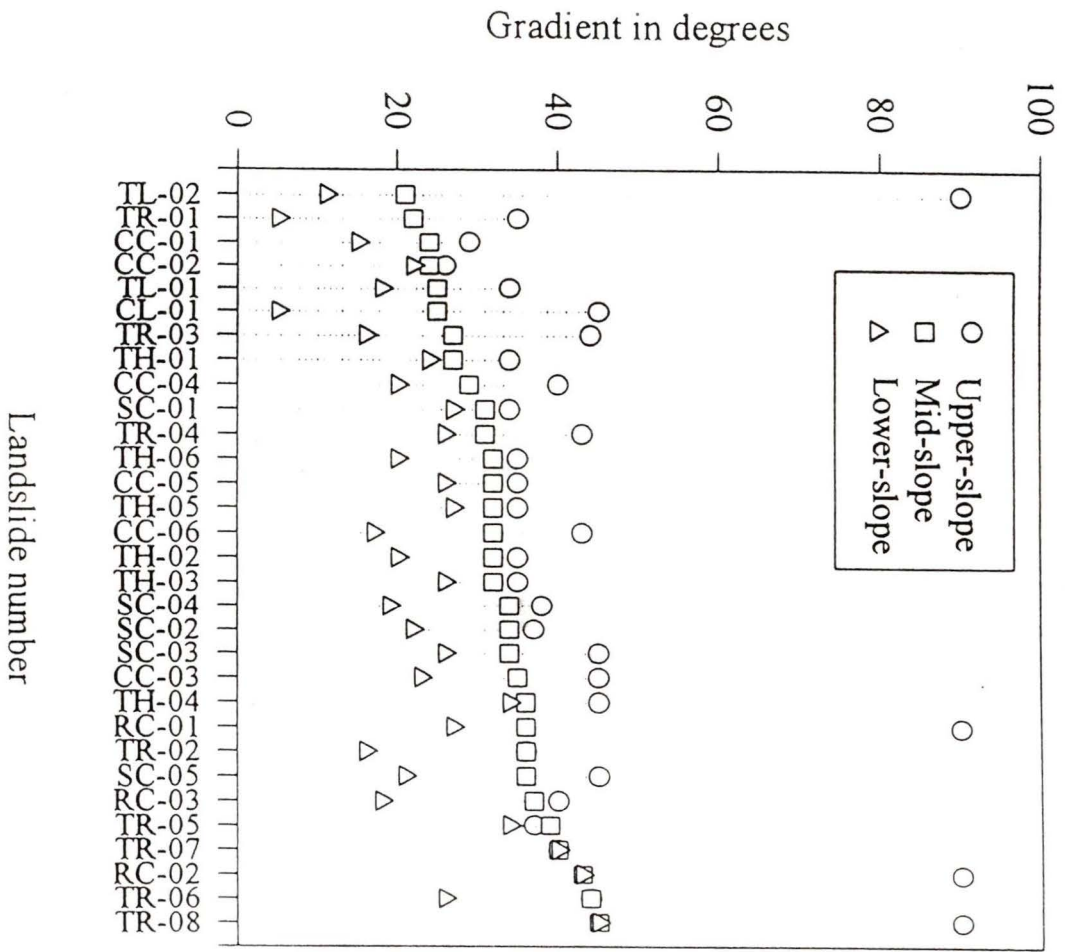
Figure 5.7: Gradients of landslides

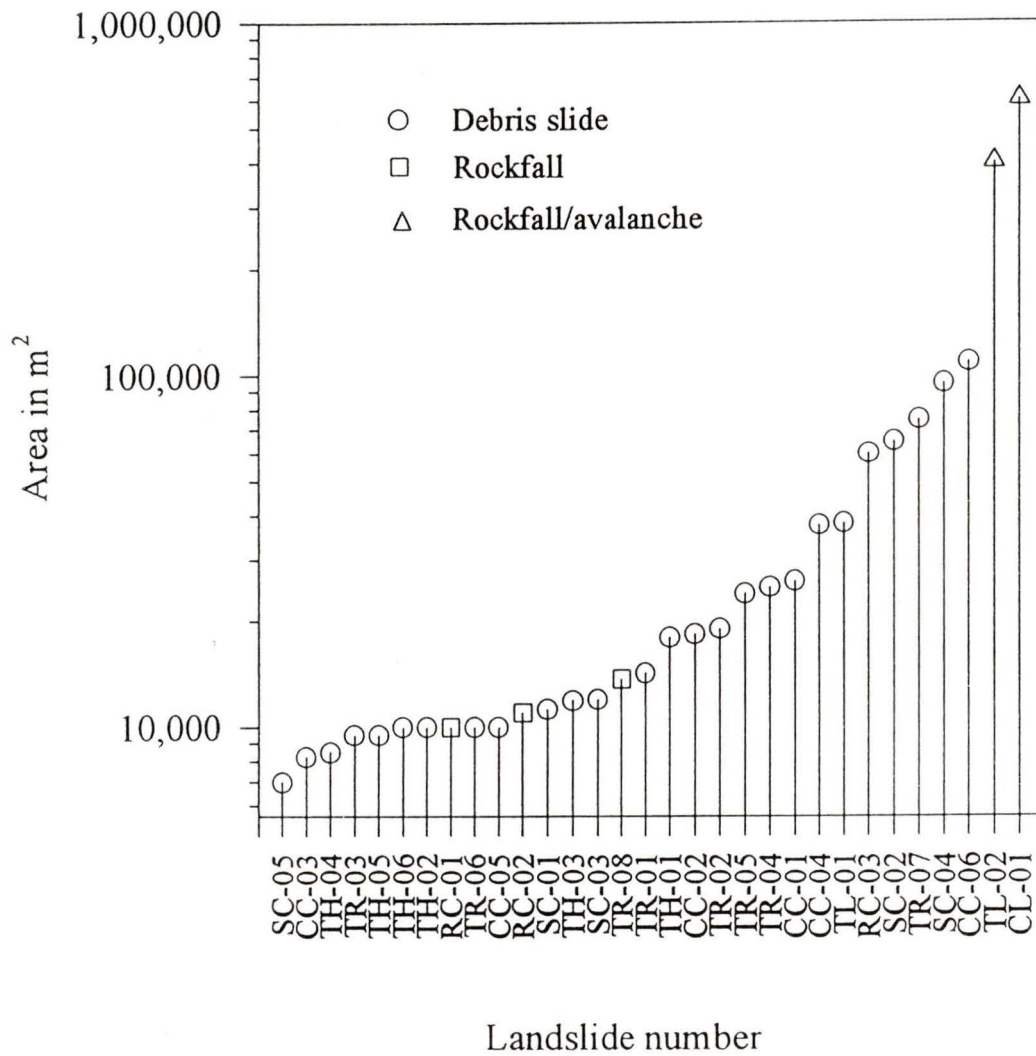
Figure 5.8: Landslide areas.

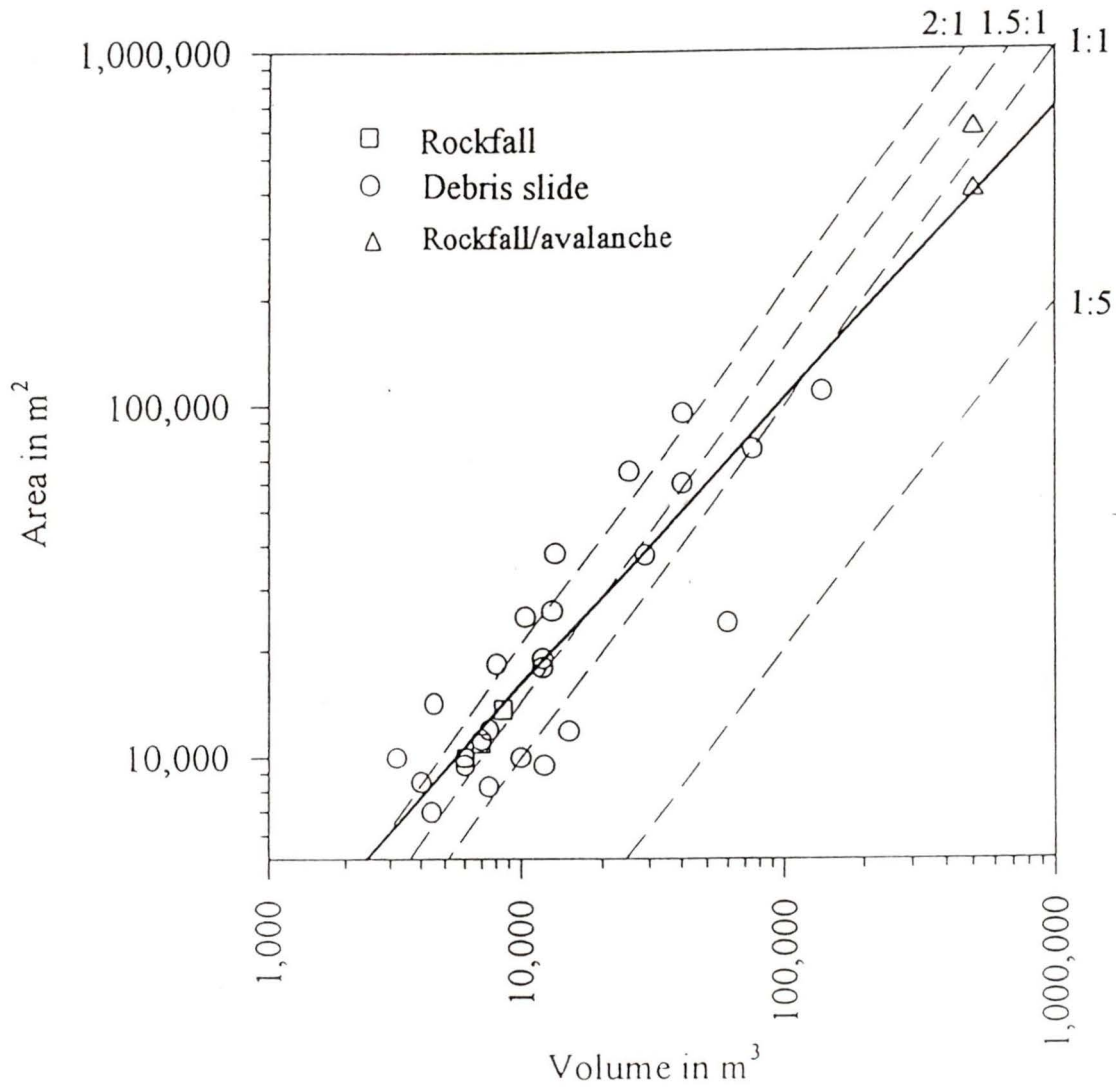
Figure 5.13: Comparison between landslide areas and volumes.

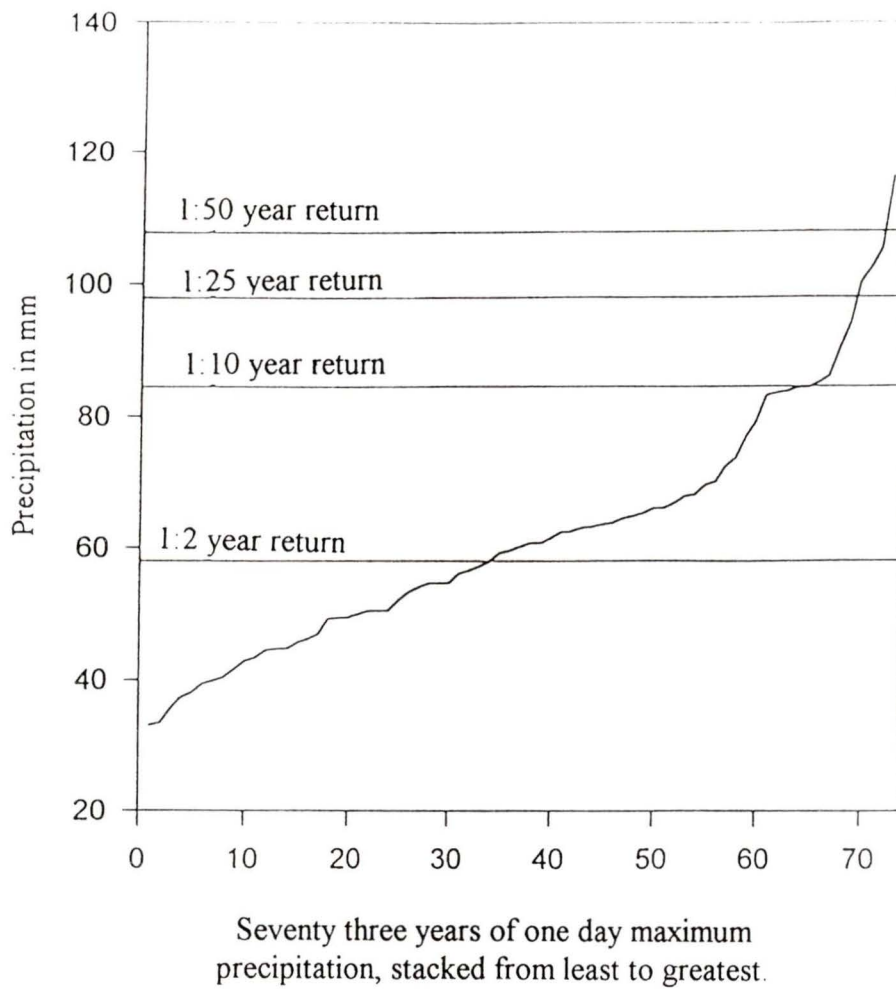
Figure 5.16: One day maximum annual precipitation for 73 years of record at Alert Bay, and return periods (from unpublished data, Environment Canada, 1994, and M. Miles and Associates, 1996).
