Surface and Subsurface Damage Quantification using Multi-Device Robotics-based
Sensor System and other Non-Destructive Testing Techniques

DOCTOR OF PHILOSOPHY

in the Department of Civil Engineering

© Harsh Rathod 2019
University of Victoria

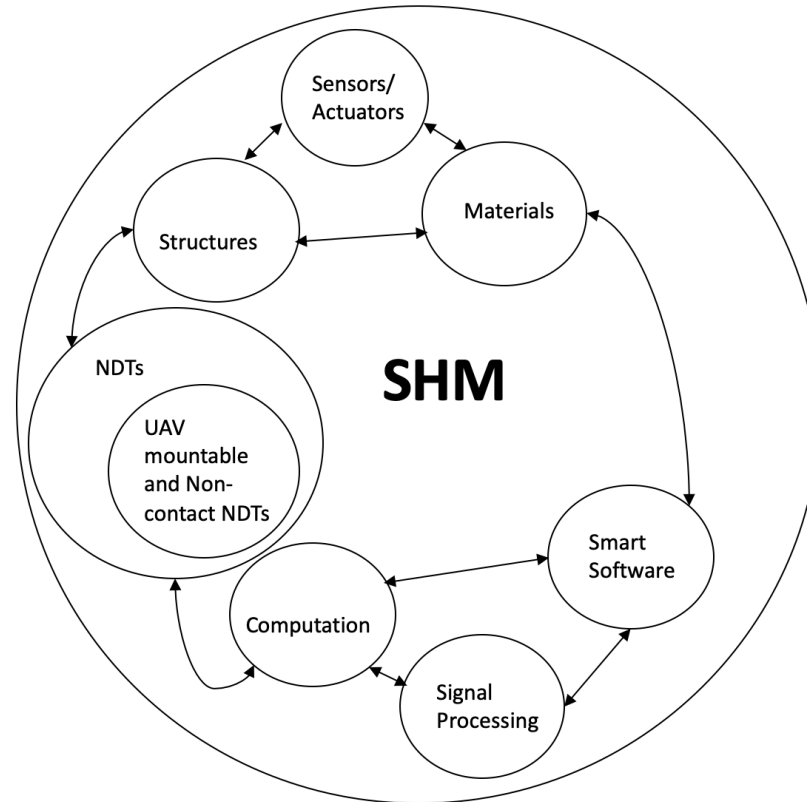
Figure 1: The Basic Components of SHM (Modified from (Balageas et al., 2010))

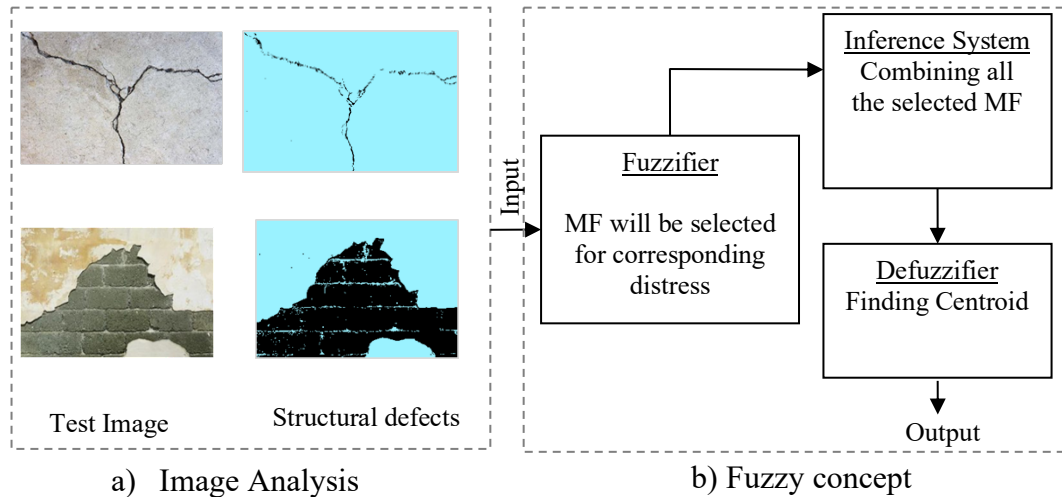
Figure 2: Integration of image processing tool with the fuzzy logic framework for decision making: a) image analysis; b) fuzzy concept

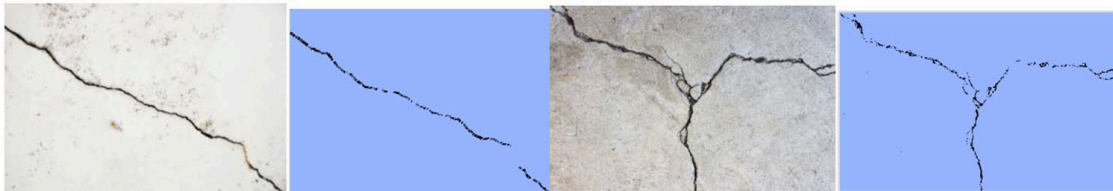
Figure 4: HSV thresholding crack output

Extensive experiments are conducted to derive thresholding limit, and it has been found that cracks are characterized by lower saturation and value in HSV space. The algorithm is tested for various test images, and the results shown in Figure 4 confirm the detection of cracks.

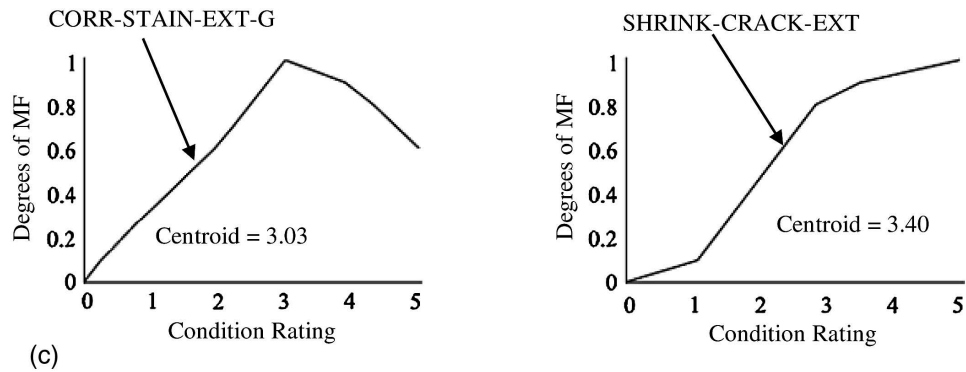
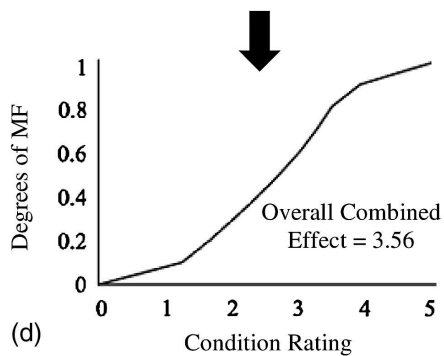
Figure 10: South side wall of storage building: (a) unprocessed images; (b) corresponding distress-identified images; (c) effect for each deterioration;

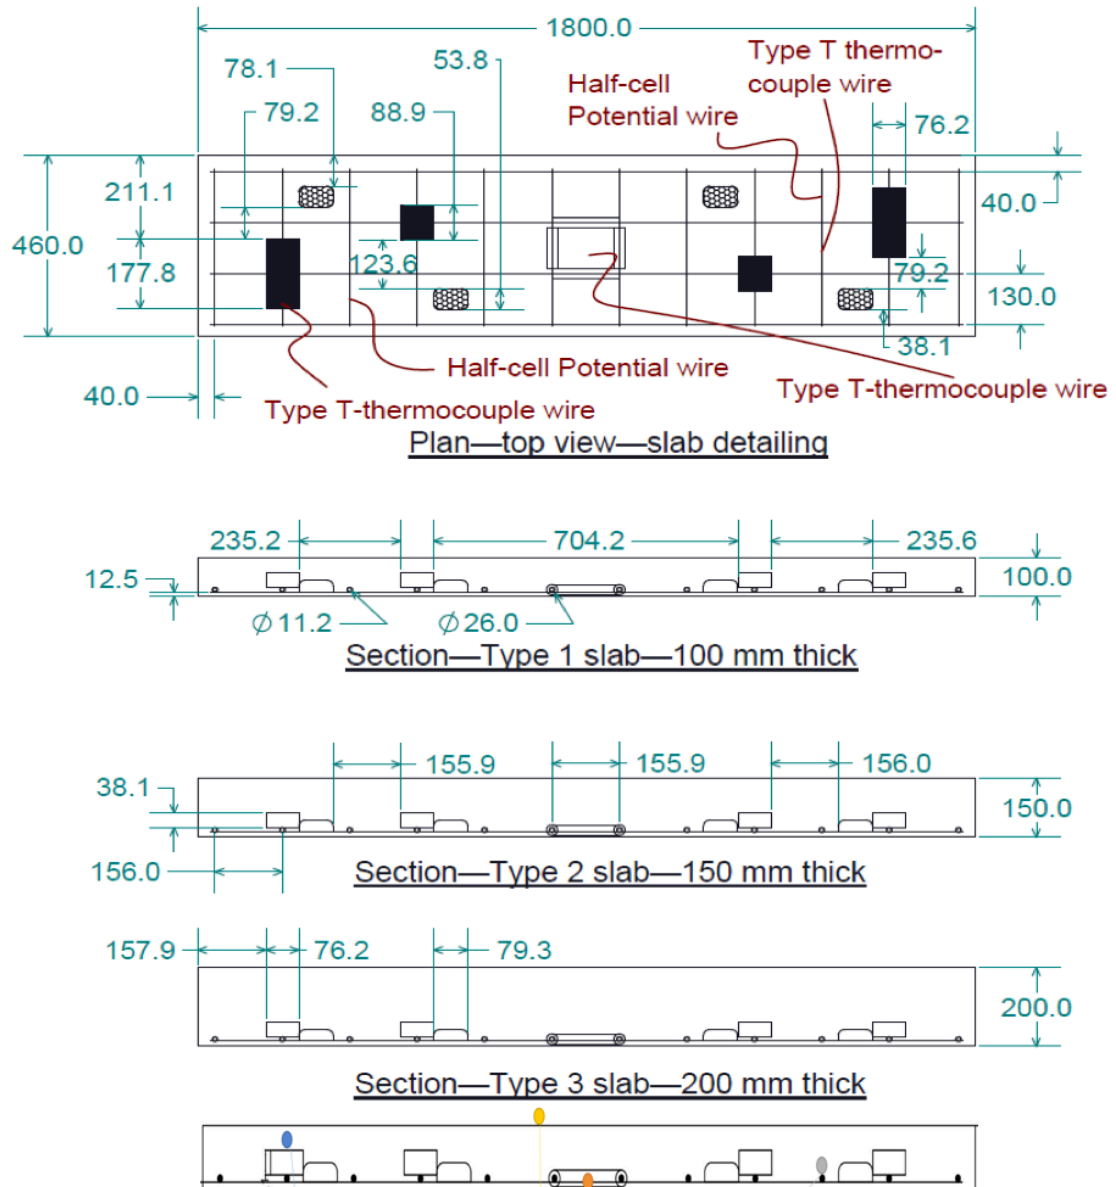
Cross section showing location of the type T thermocouples (Yellow- On the surface of the slab, Blue- Above the void, Orange- At the bottom of the slab, Gray- At the rebar level)

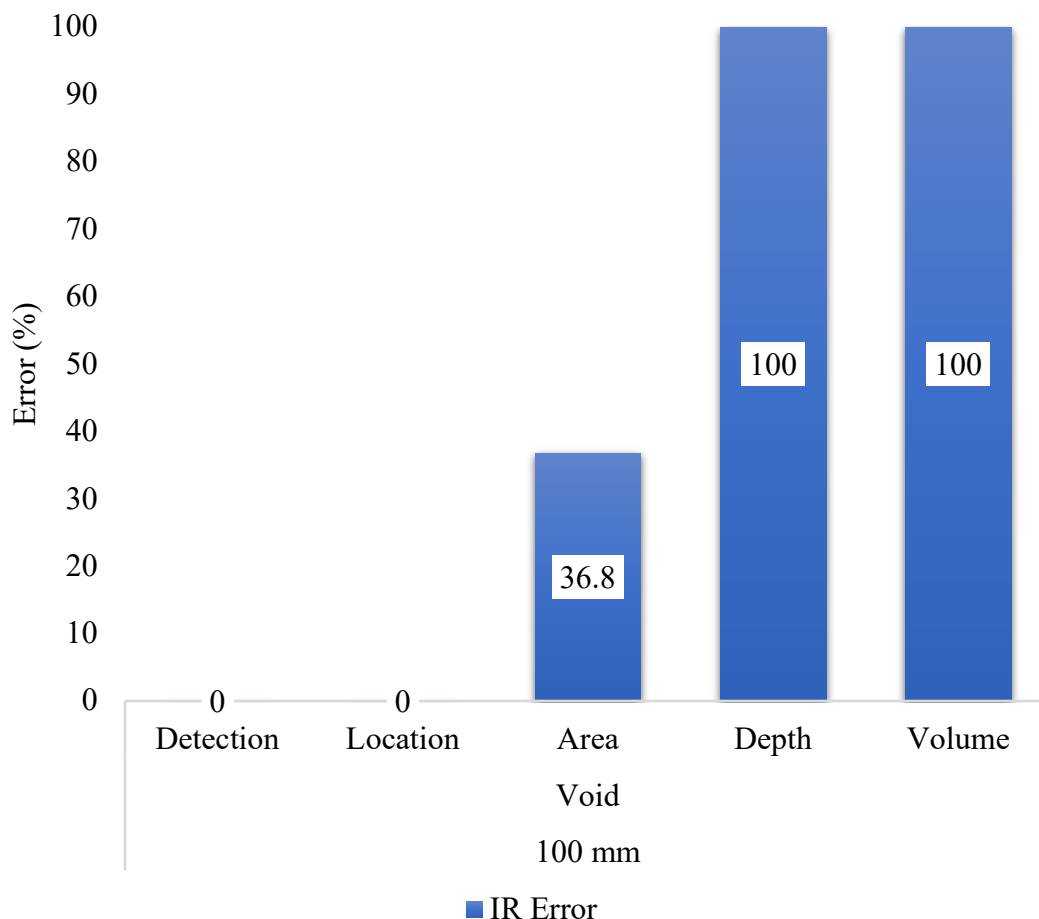
Figure 16: Error of IRT in identifying the subsurface damage in reinforced concrete

Figure 16 shows the errors for IRT in identifying defects in only 100 mm slab. It should be noted that the error value for 150 and 200 mm slabs is 100.

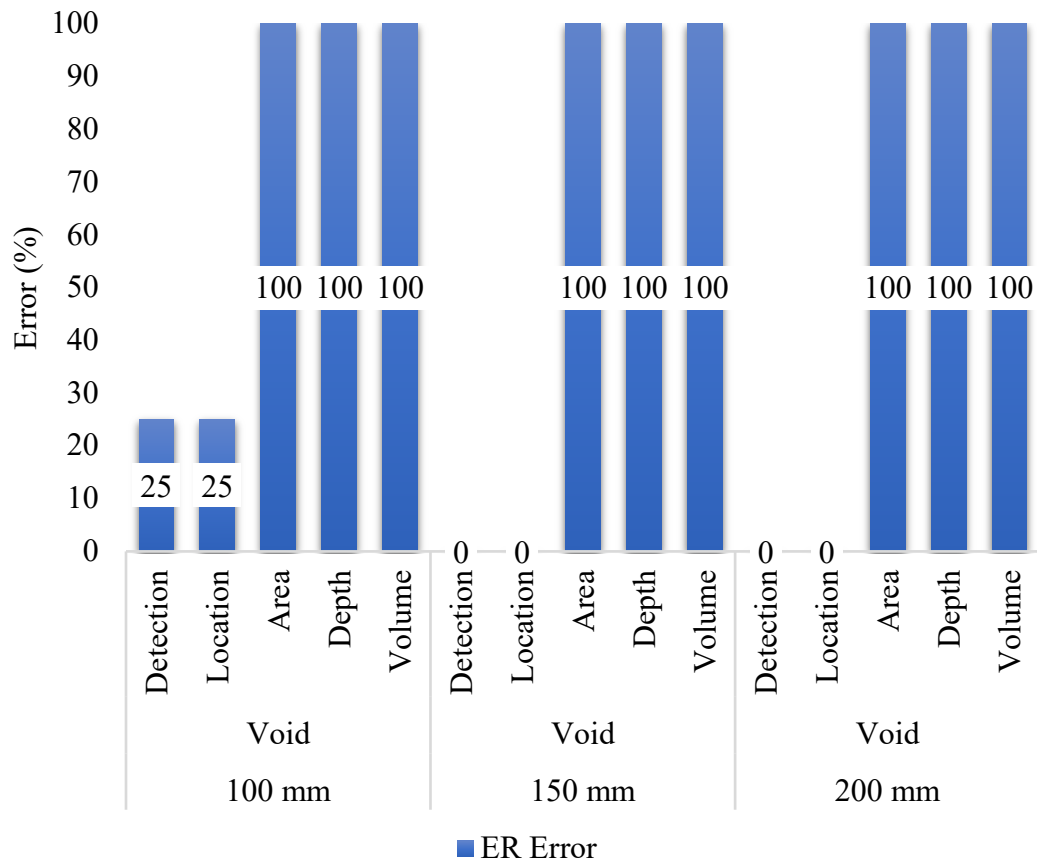
Figure 17: Error of ER in identifying the subsurface damage in reinforced concrete

The errors were calculated based on the number of defects detected. Error value of 0 was assigned if all the defects (e.g., voids) are detected. When not even a single defect was detected, error value of 100 was assigned. This can be seen in Figure 17. It was observed that the error for 100 mm slab was found to be higher than for 150 and 200 mm slabs. The authors hypothesize that other than the implicit errors associated with the ER technique, the lack of void detection could be due to the uneven concrete surface and lack of probe contact (Azarsa et al., 2017).

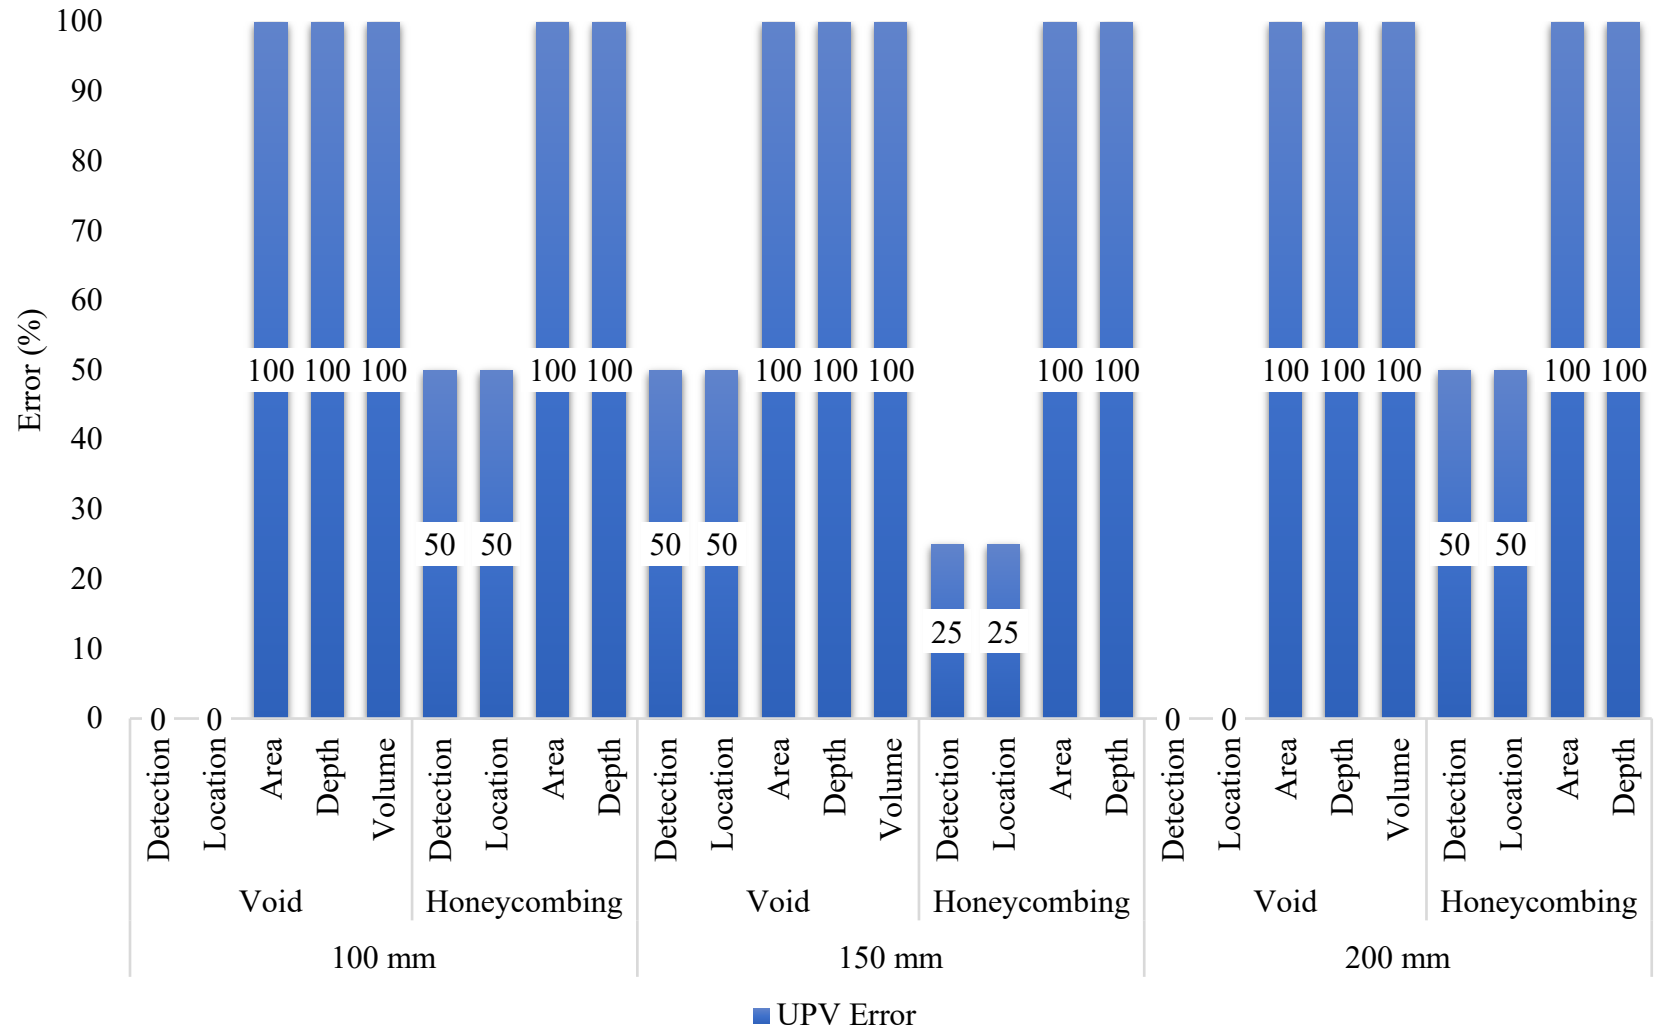
Figure 18: Error of UPV in identifying the subsurface damage in reinforced concrete

From the error plot (Figure 18) it can be observed that UPV was able to locate and detect void and honeycombing with minimum errors. However, UPV was unable to determine the affected area, volume and the depth at which the defect is present. It should be noted that the debonding was not detected by any of the techniques.

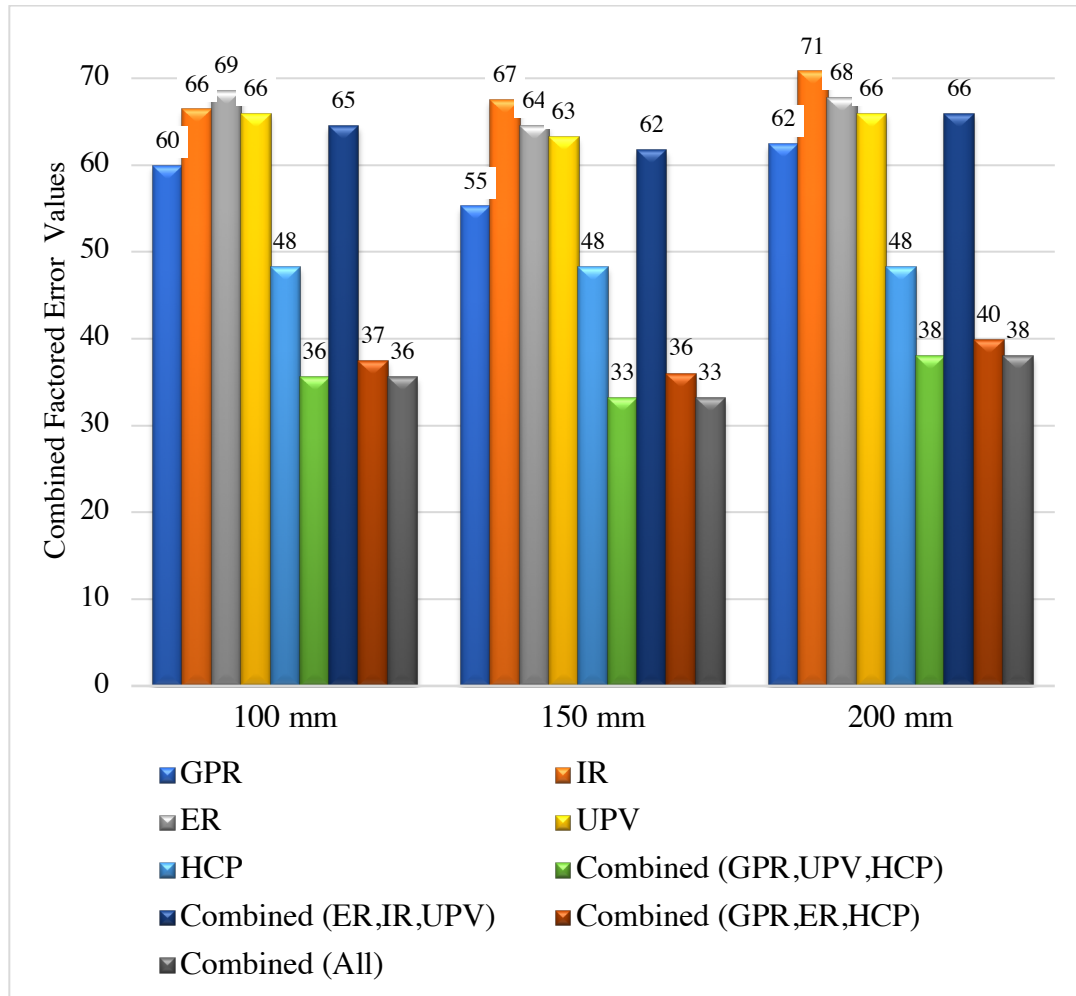
Figure 20: Combined Factored error values of NDT techniques in identifying the subsurface damage in reinforced concrete

Honeycombing was detected using only UPV. Voids were detected by all four NDT techniques. HCP demonstrated excellent use for determining corrosion potential as can be noticed from the plots. From the plot, it can be observed that GPR proved to be excellent for detecting voids. Taking the advantage of each of these NDT techniques in detecting a particular type of defect, a set of NDT techniques can be proposed when identifying the subsurface damage in RC. Combination of multiple NDT techniques in identifying subsurface damage increases the accuracy significantly (reduces error) compared to a standalone technique. However, it should be noted that if the NDT techniques are not combined strategically, the reduction in the error values could be insignificant. It can be seen from Figure 20 (calculated using equation 3.8) that the combination of ER, IR, UPV and GPR, ER, HCP have significantly higher factored error values compared to the combination of GPR, UPV, HCP. The error values of the combination of all five NDT techniques were found to be the same as the combination of three NDT techniques- GPR, UPV, and HCP. This is due to the fact that GPR has the lowest error values in detecting voids, UPV has the lowest error values in detecting honeycombing, and HCP has the lowest error values in detecting sea salt.

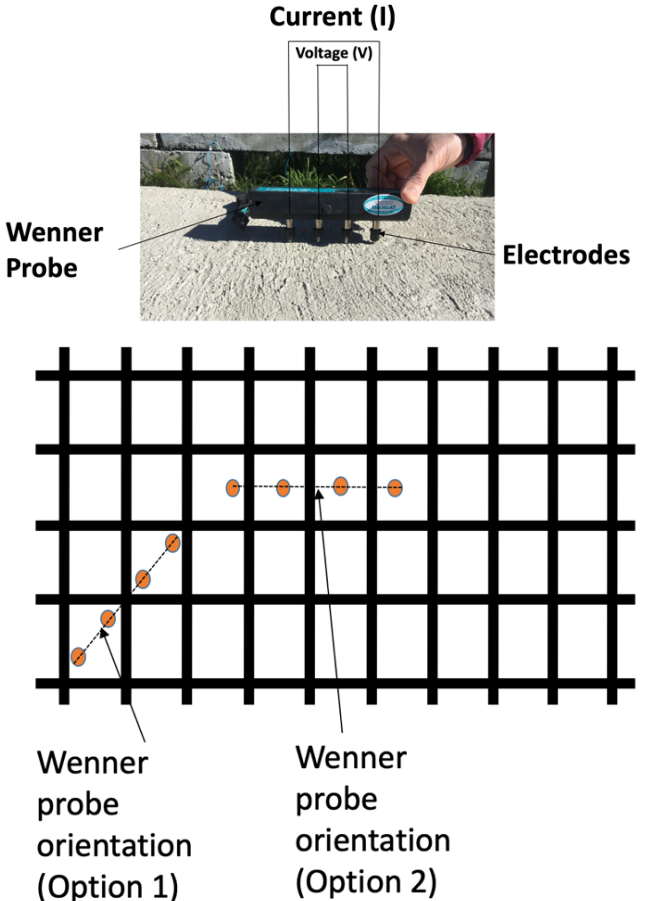
<p>The diagram illustrates the experimental setup for the Wenner probe technique. It includes a photograph of a hand holding a Wenner probe on a concrete surface. The probe has four electrodes, with two labeled 'Wenner Probe' and two labeled 'Electrodes'. A 'Voltage (V)' meter is connected to the probe, and 'Current (I)' is also indicated. Below the photograph is a grid diagram showing two probe orientations: 'Wenner probe orientation (Option 1)' and 'Wenner probe orientation (Option 2)'. Option 1 shows the probe electrodes at the corners of a square, while Option 2 shows them in a line.</p>

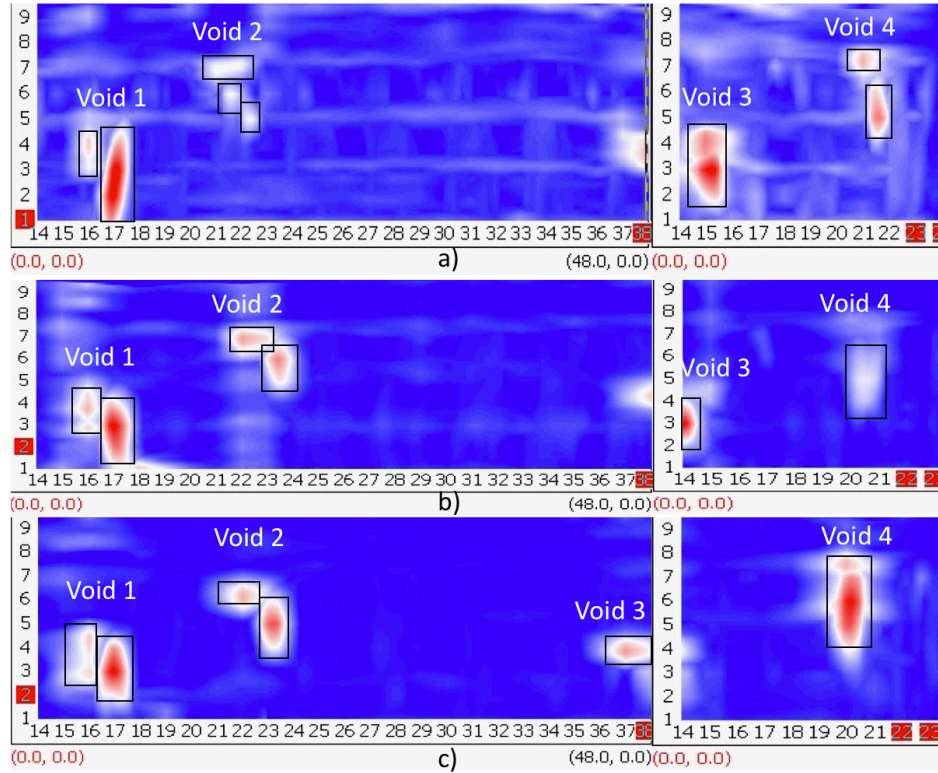
Figure 24: GPR- Area, Depth and Volume Accuracy Computation: a) 100 mm, b) 150 mm, and c) 200 mm

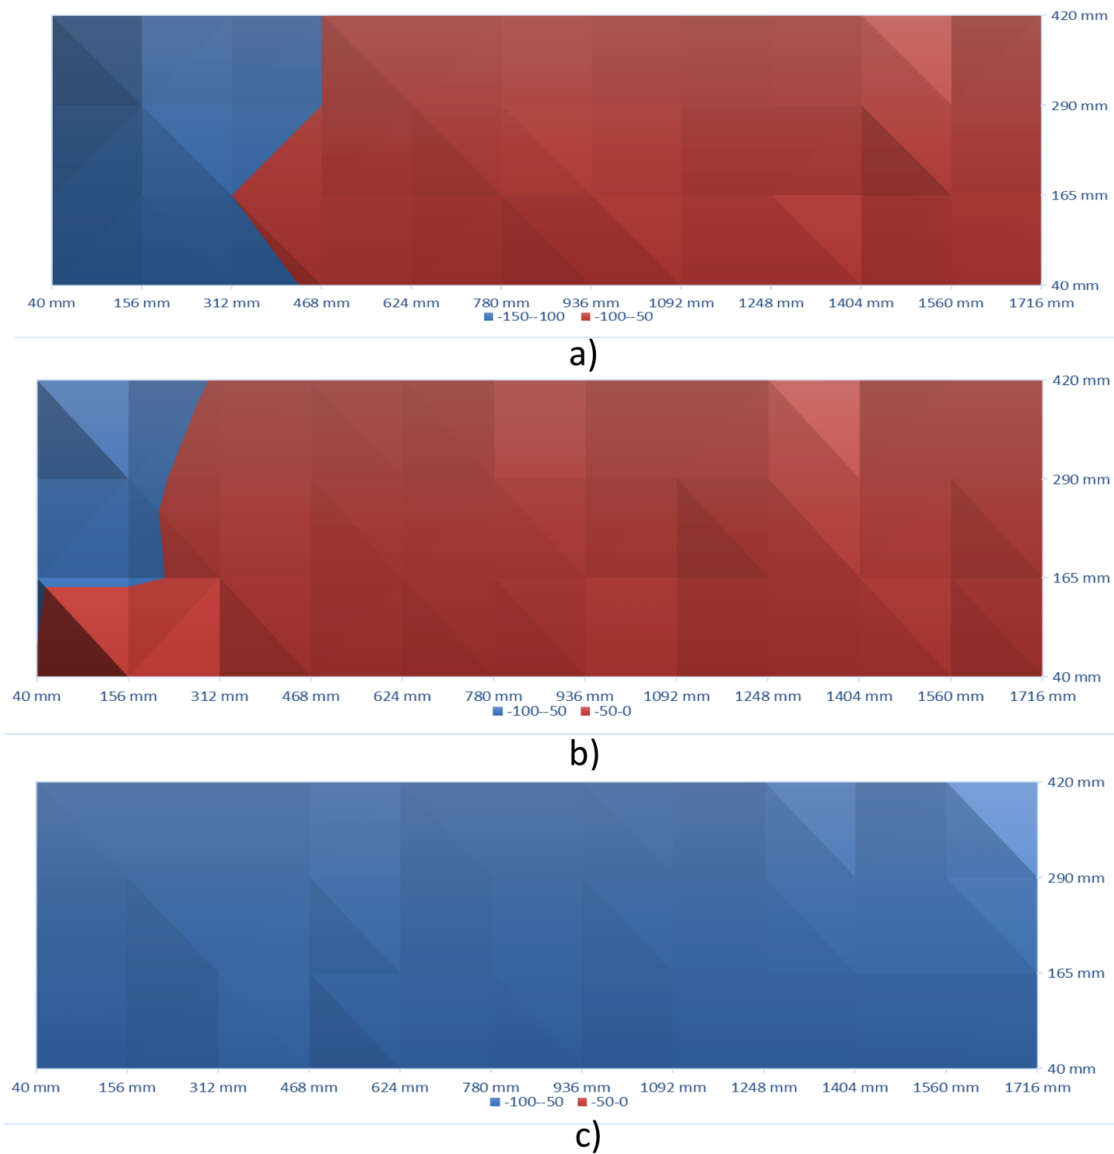
Figure 31: Half-Cell Potential - control slabs - a) 100 mm, b) 150 mm, and c) 200 mm

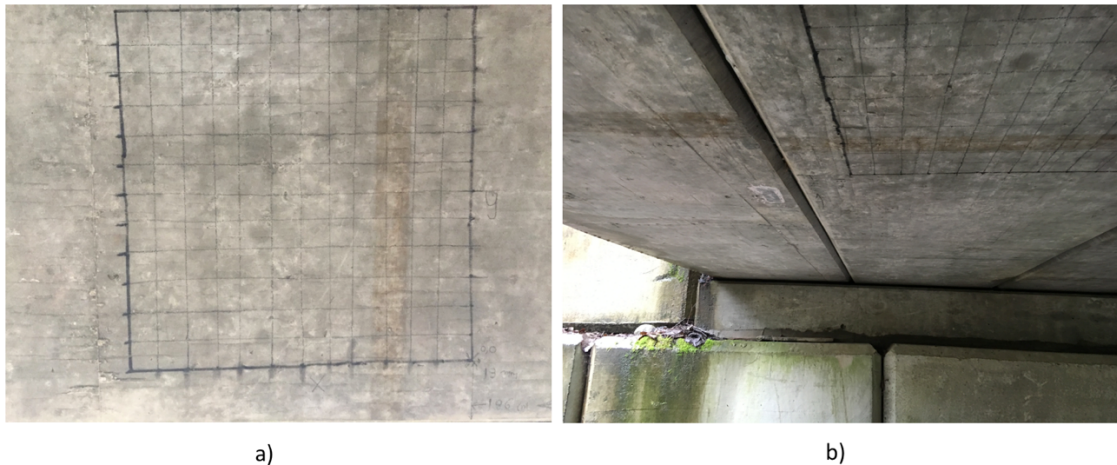
Figure 34: GPR and Profoscope tests on the bottom of the bridge deck slab; a) Test grid, b) Test Site SI-3006A

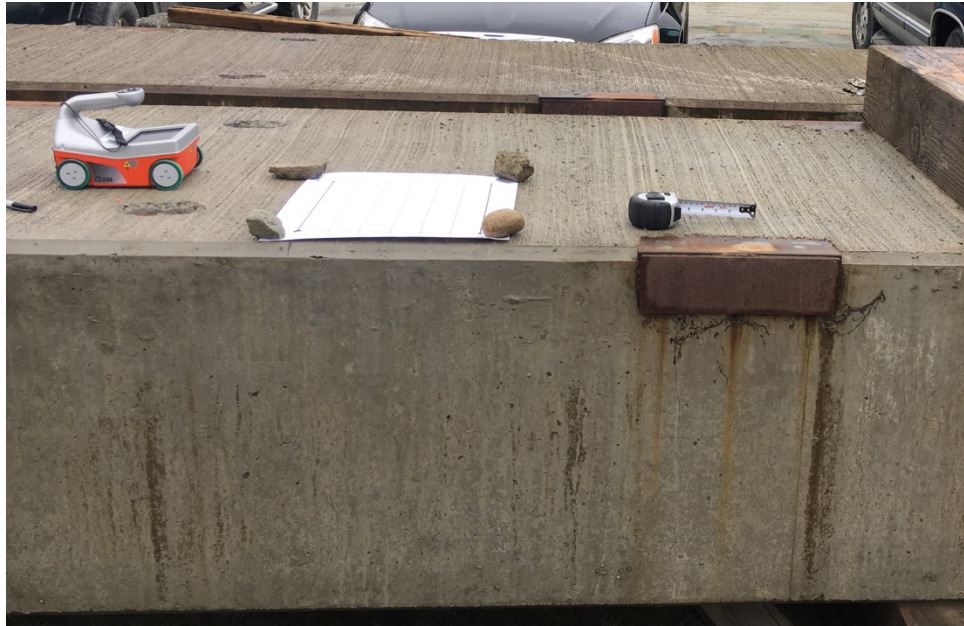
Figure 35: GPR and Profoscope tests on the top the precast girder at Surespan Structures

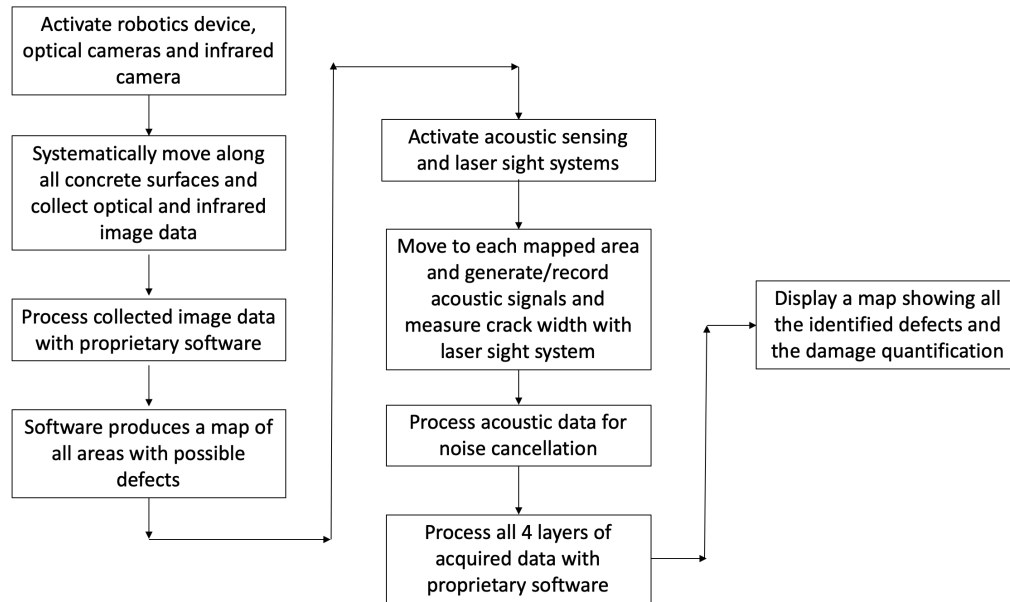
Figure 52: Flowchart outlining the process of applying the integrated robotics and sensor data acquisition system and software quantification for mapping and assessing structural defects

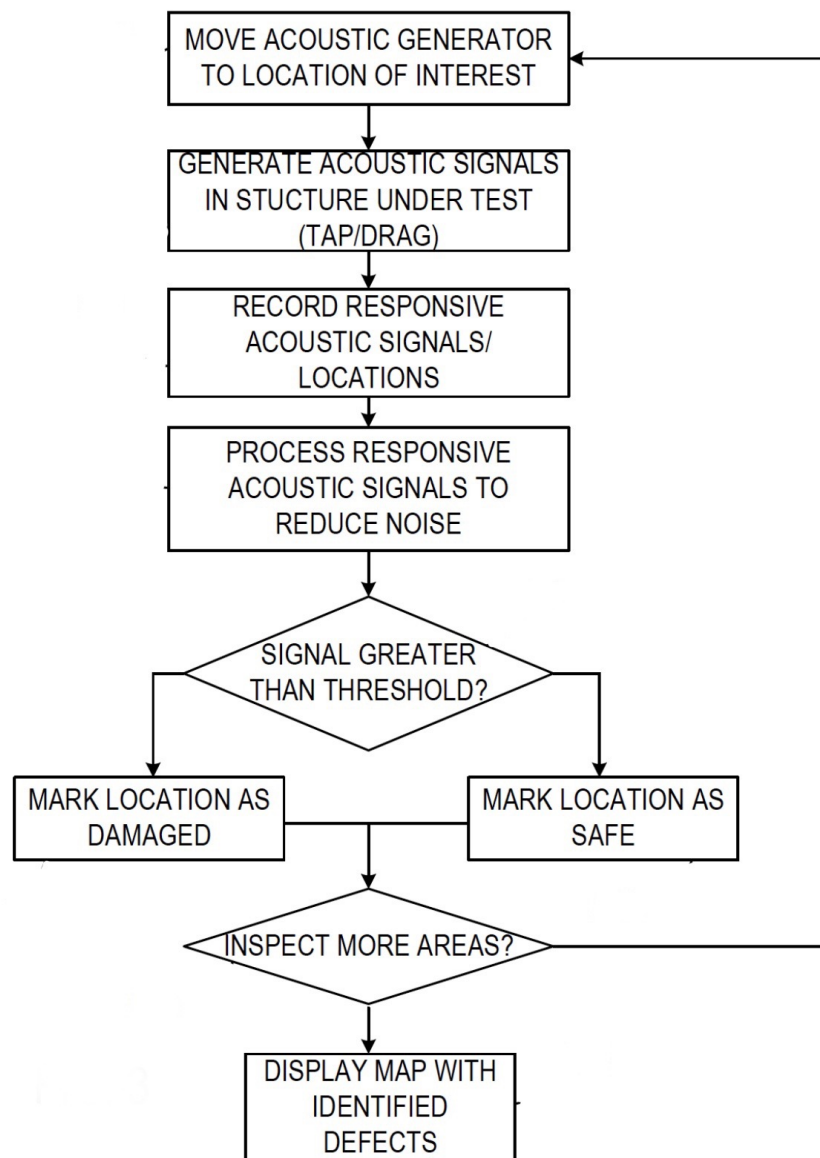
Figure 57: Flowchart showing a method of mapping defects in a bridge or other structure

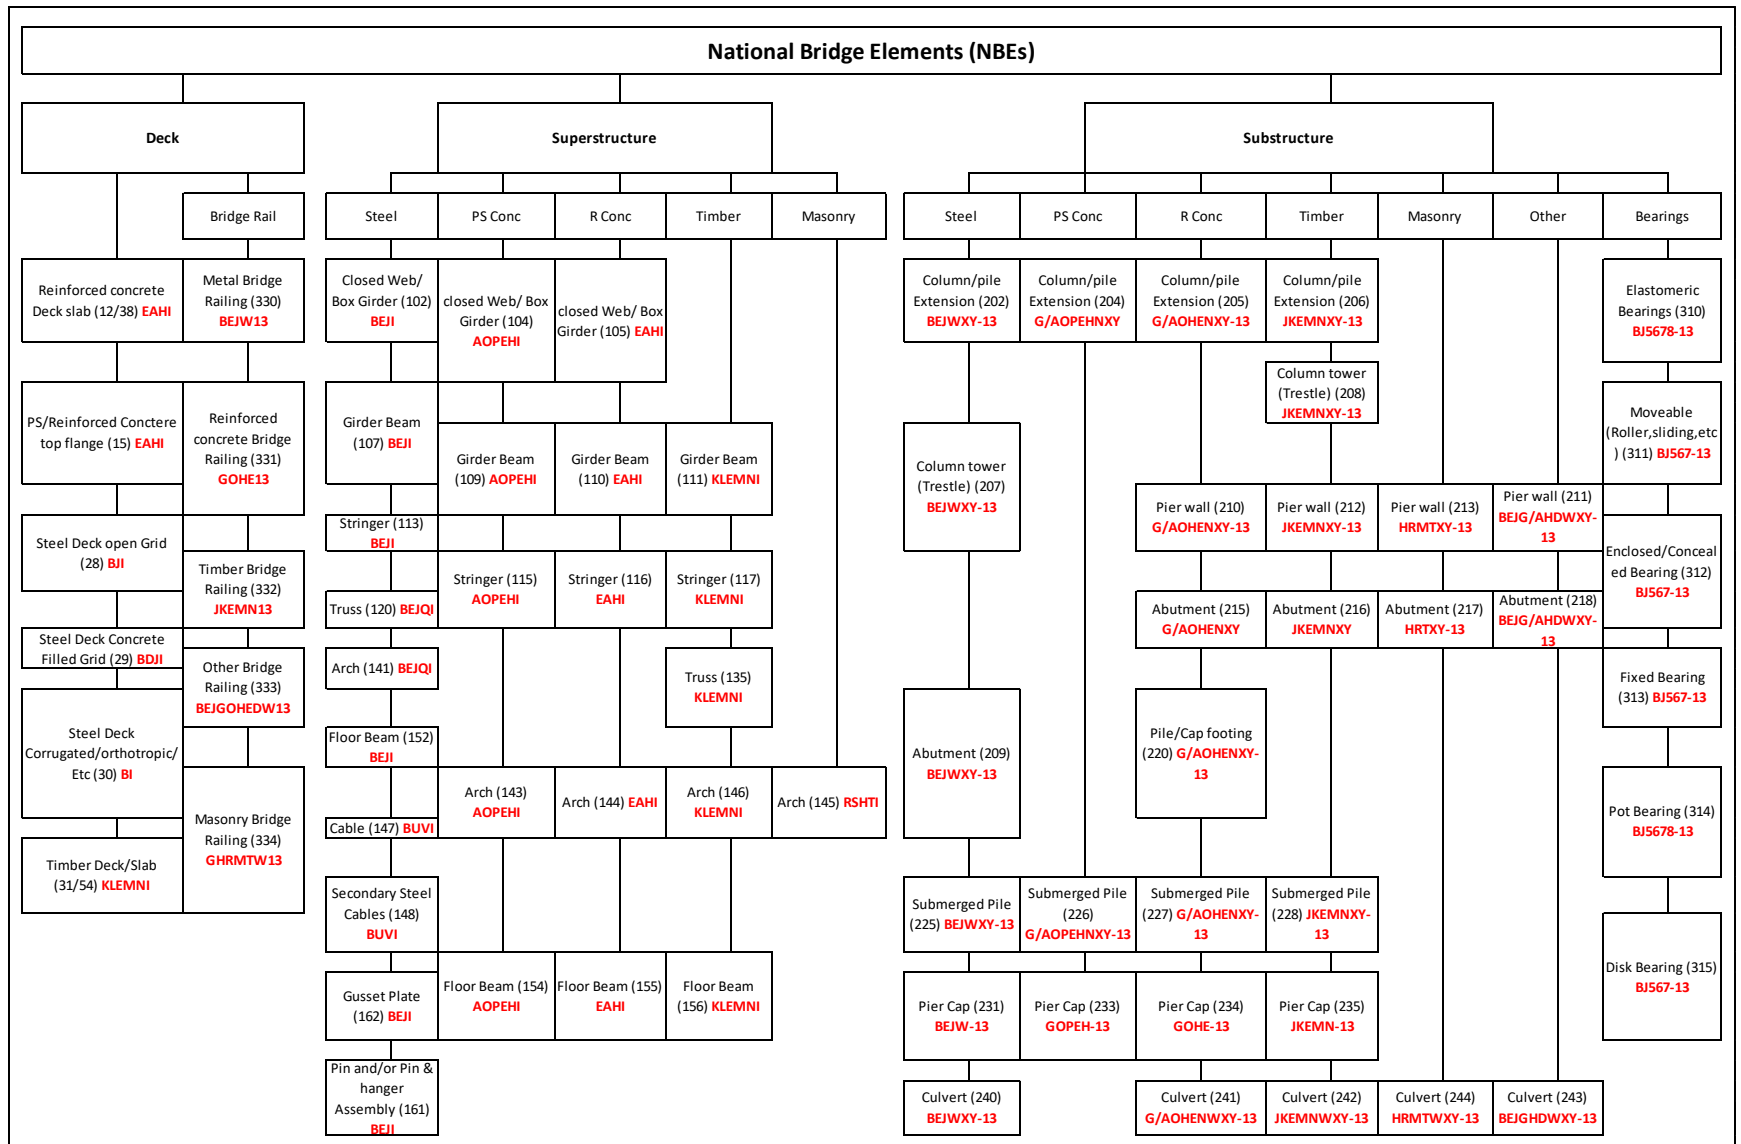
Figure 62: National Bridge Elements with the type of defects (shown in red bold letters), (AASHTO, 2011)

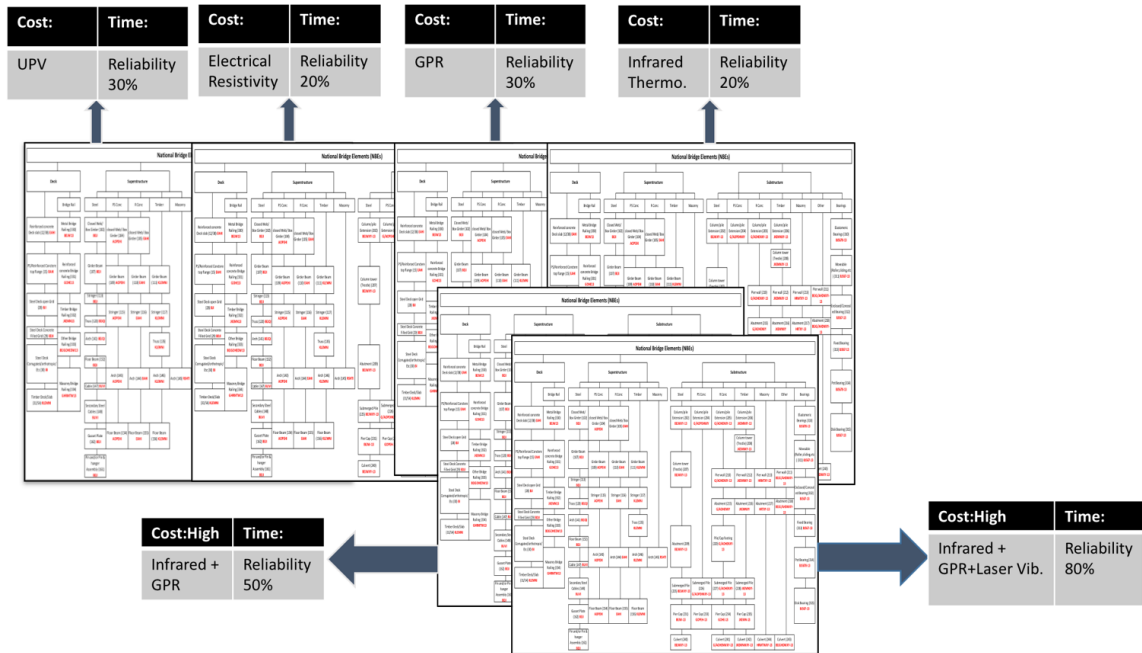
Figure 64: Conceptual layered NDT data refinement model
