***Evaluation of Criteria and Investigation of Fatigue Failure
Characteristics of Precast Unreinforced Concrete Arch Panel Decks***

A Thesis Submitted in Partial Fulfillment of the Requirements for the Degree of

MASTER OF APPLIED SCIENCE

in the Department of Mechanical Engineering

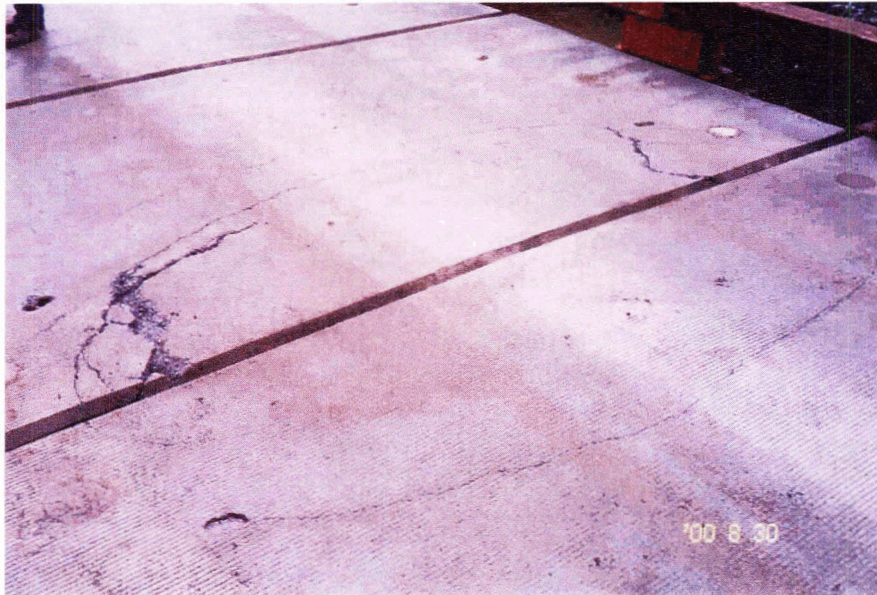
Figure 2.3 - Slab Failure at Unconfined Edge

Slabs with unconfined edges have no provision for additional in-plane flexural reinforcement or support at the free edge. Ultimate resistance to point loading at unconfined edges is typically drastically reduced. Locations where unconfined edges may occur in practice include the ends of slabs on bridges and the free edges of adjoining precast slab panels. Figure 2.3 shows a failed reinforced concrete deck due to lack of edge confinement.

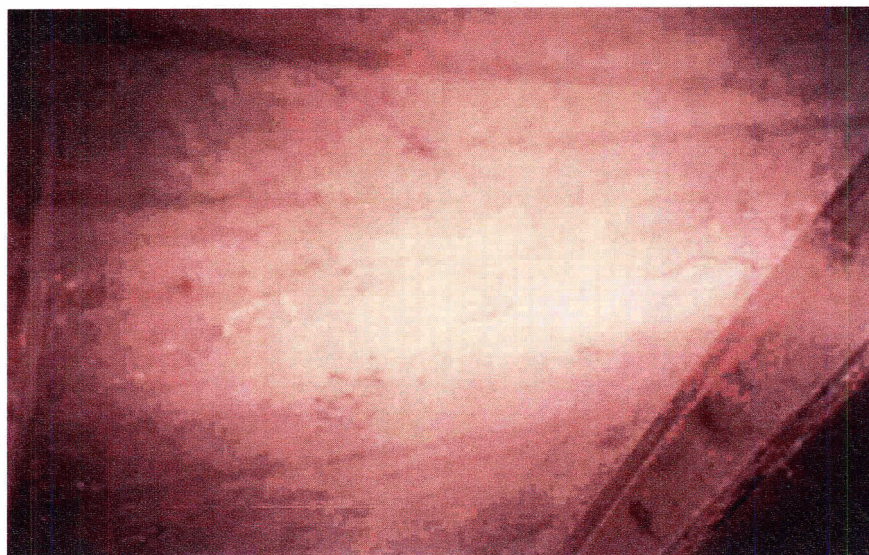
Figure 4.10 - Cracking Pattern on Bottom Surface of Panel 1

Figure 4.10 shows the progression of cracks on the bottom of panel 1 as of February 26, 1999, while Figures 4.11 and 4.12 show the progression of cracks on March 19, and May 23, 1999 on the top of Panels 1 and 2, respectively. Figure 4.13 gives the complete pattern of cracking which developed on the two slabs during testing under pulsating loads. The numbers beside each of the cracks indicate the cumulative number of cycles to reach a given location on the particular crack. The top cracks formed directly above the bottom cracks but are shown slightly offset for clarity.

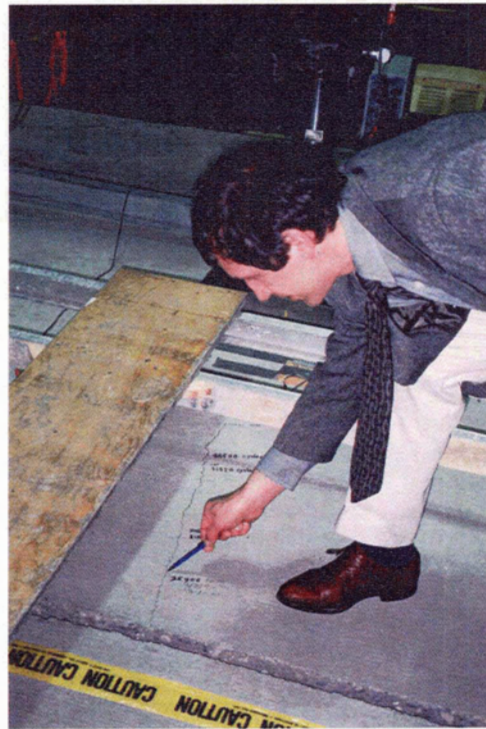
**Figure 4.11 - Progression of Cracking
on Top Surface of Panel 1**

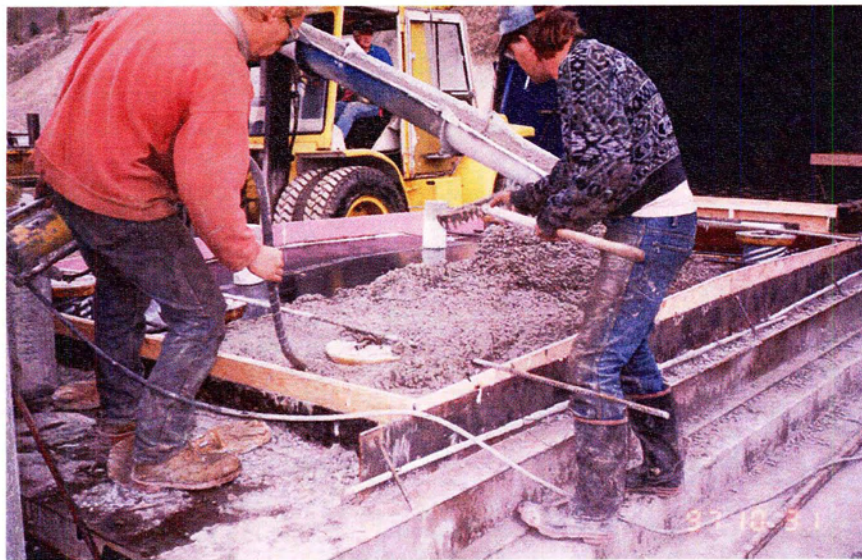
Figure 4.19 - Precast Arch Panel Fabrication

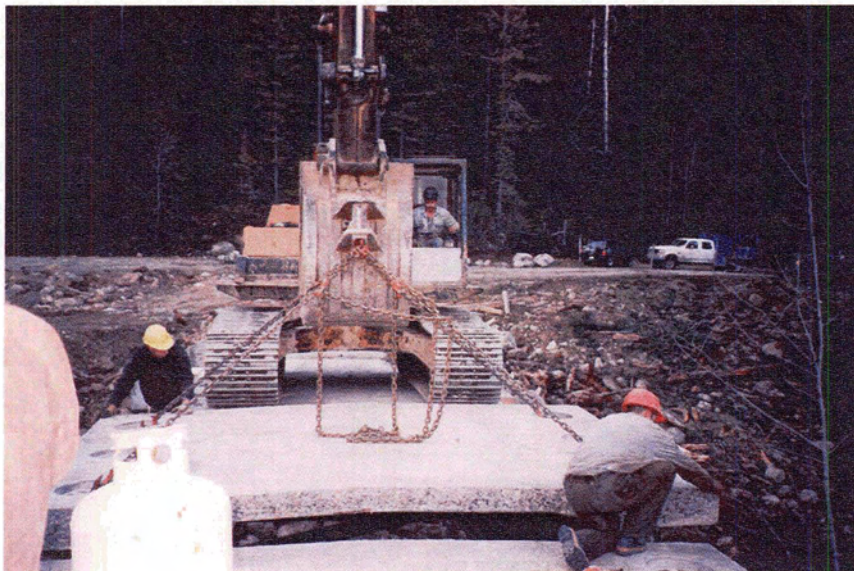
Figure 4.20 - Precast Panel Erection

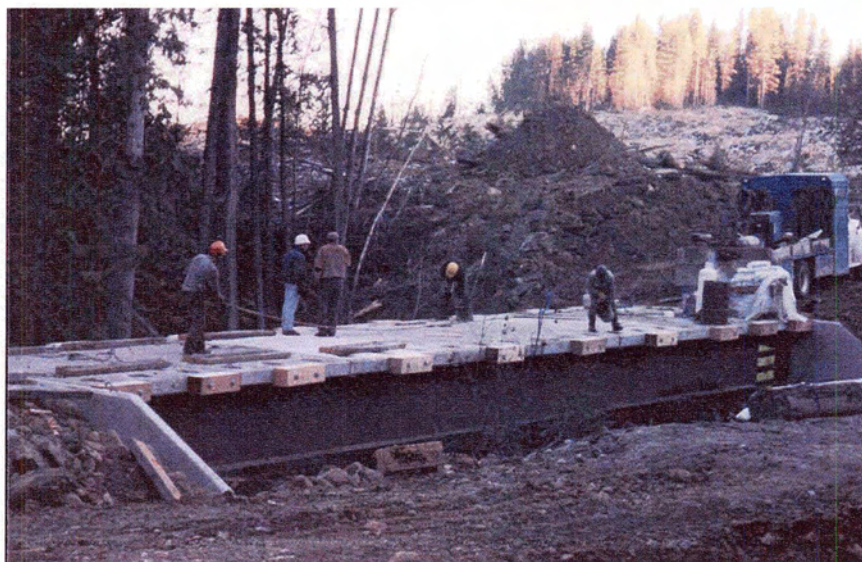
Figure 4.21 - Grout Placement in Grout Pockets and in Joints between Panels

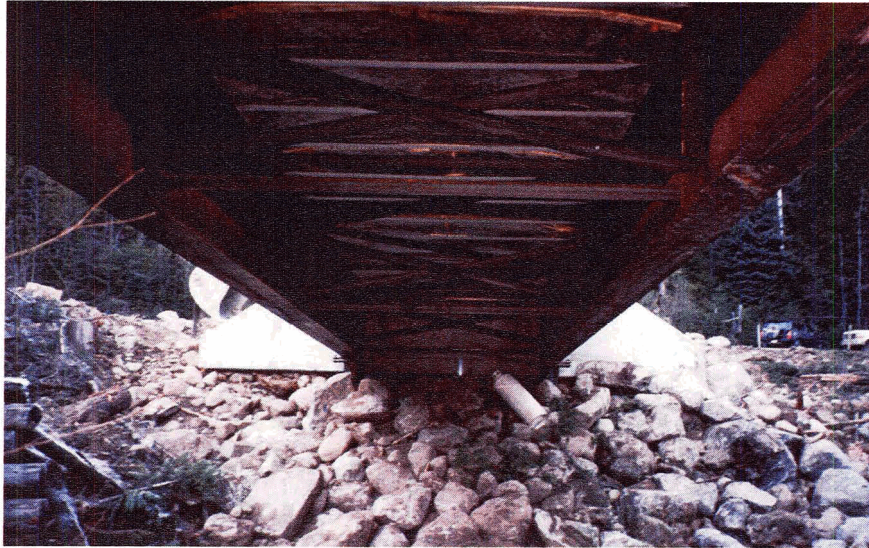
Figure 4.22 - Underside of Deck showing Steel Straps

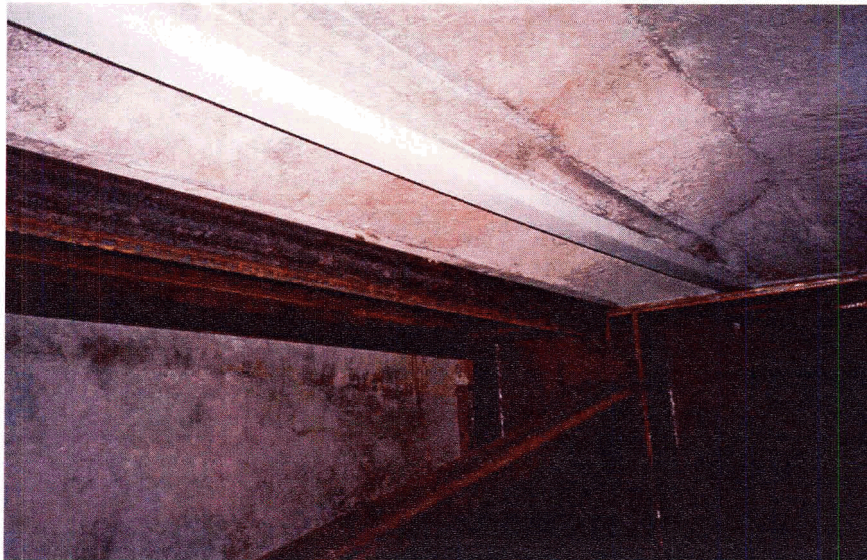
Figure 4.23 - Underside of Deck showing Steel Channel for Transverse Edge Stiffening

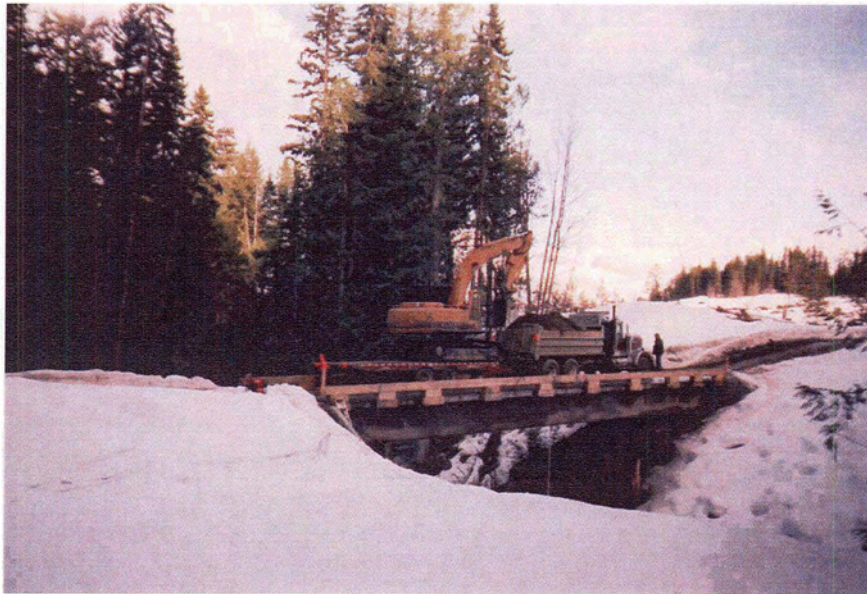
Figure 4.28 - Fully Loaded Test Vehicle on Bridge

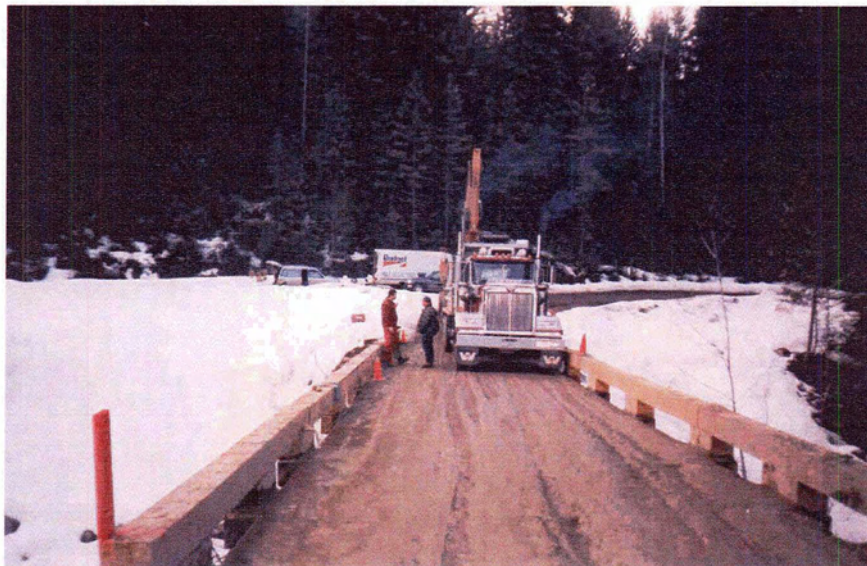
**Figure 4.29 - Test Vehicle in Left Position
(Monitoring Station in Background)**

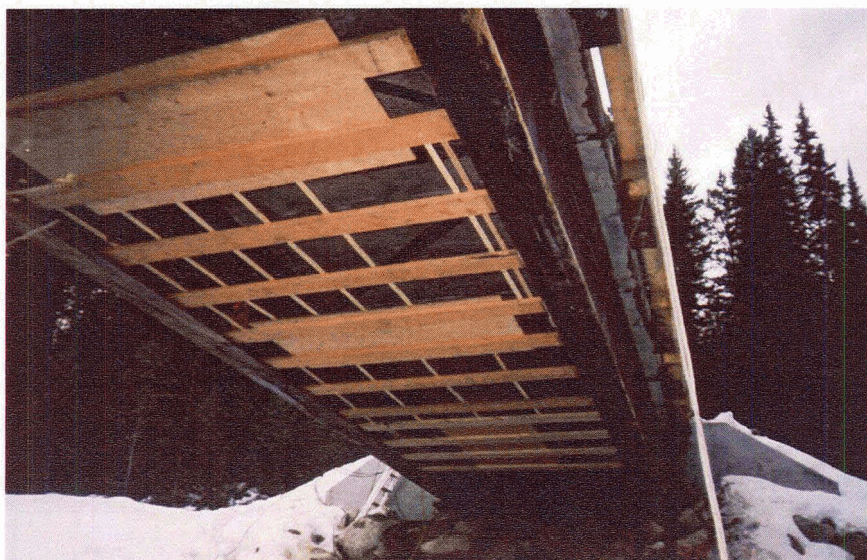
Figure 4.30 - Access Platform beneath Deck

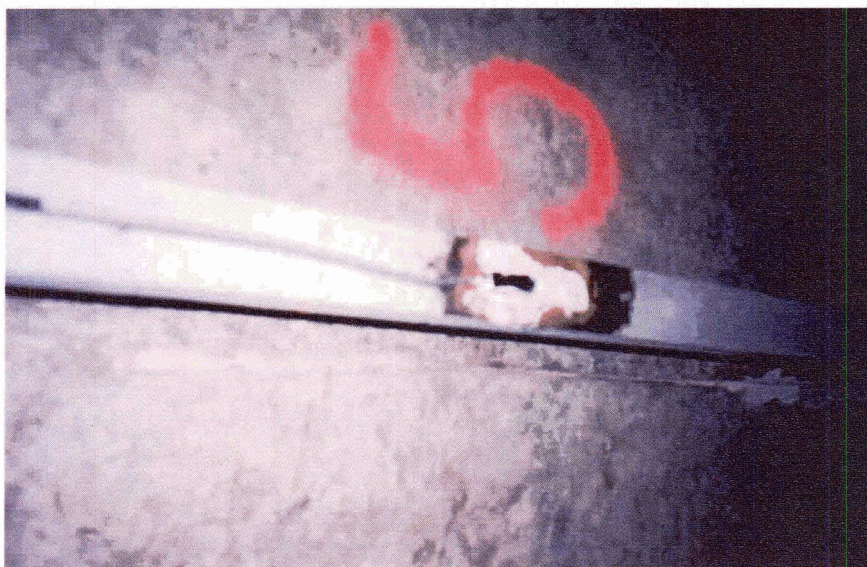
Figure 4.31 - Strain Gauge on Strap 5

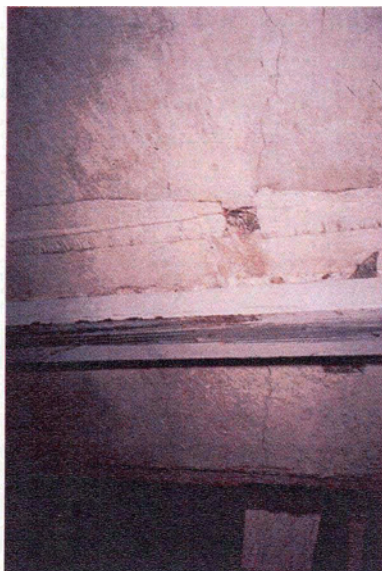
Longitudinal Crack at Underside of Deck
Slab near Transverse Edge Stiffener

less accessible and therefore crack observation was more difficult at this location. Figure 4.32 shows a typical crack on the bottom of the slab and the cleaned deck.

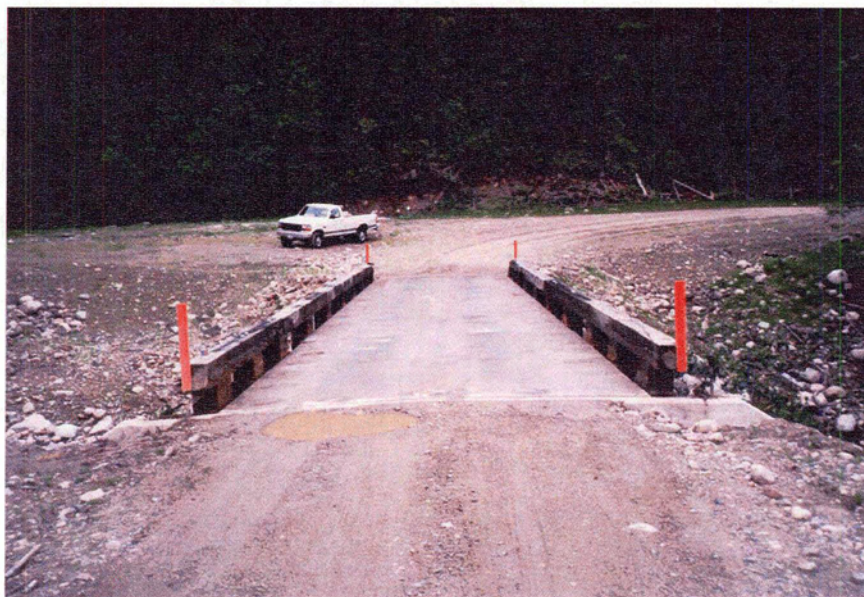
Deck Cleaned for Review of Crack Development

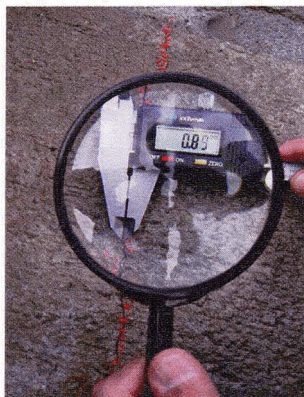
Figure 4.34 - Method of Measurement for Crack Widths, October 2003

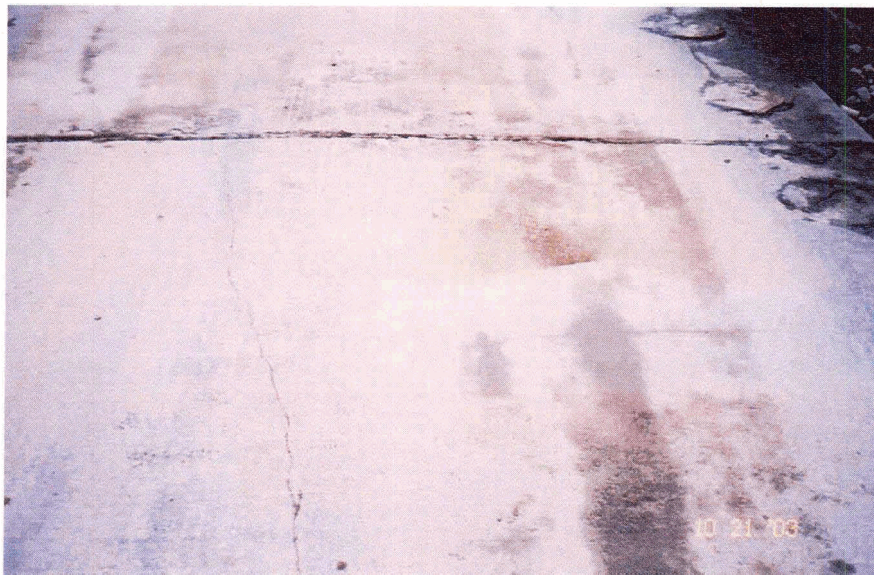
Figure 4.36 - Longitudinal Centre Crack on Top of Panel 8

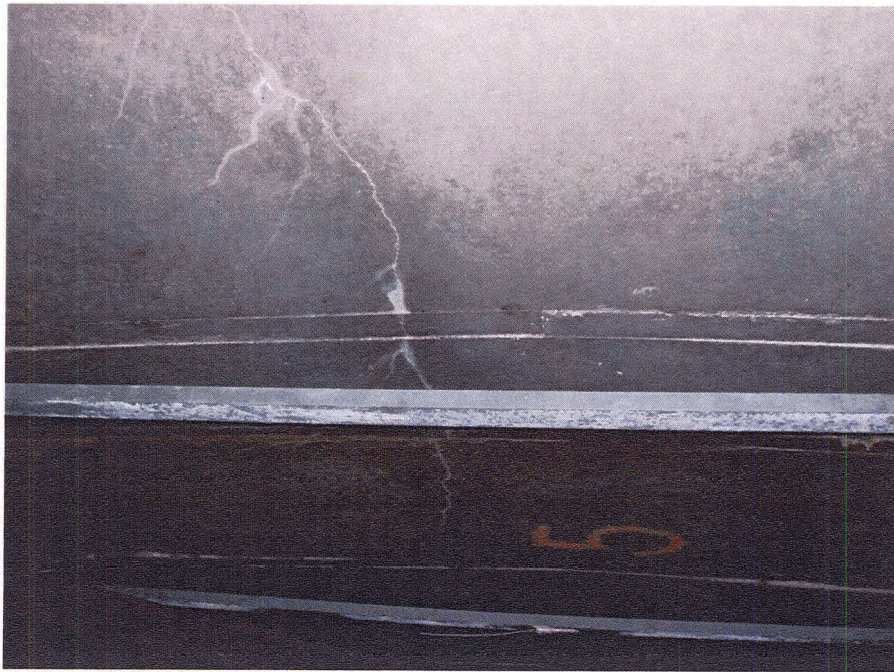
**Figure 4.37 - Longitudinal Centre Crack on Bottom of Panel 5
Strain Gauge 5 can be seen on Steel Strap in Background**

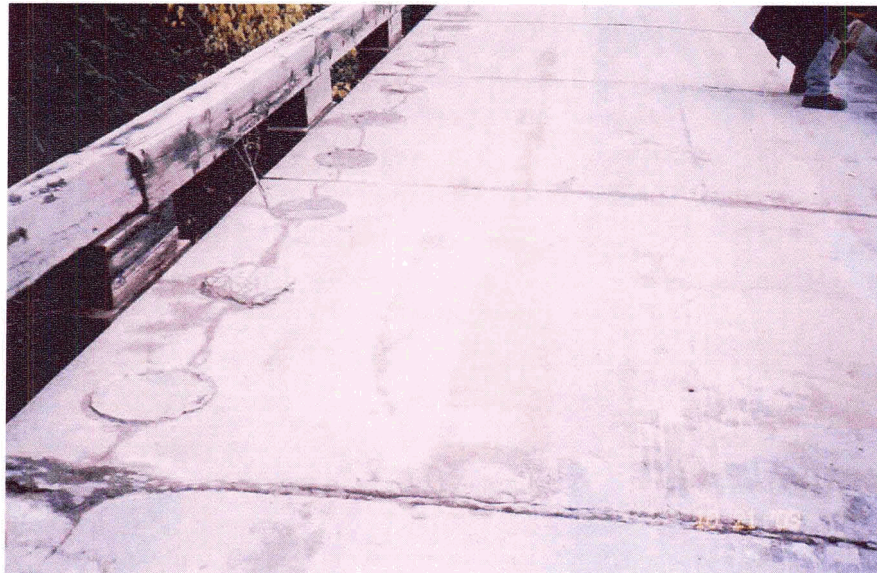
Figure 4.38 - Secondary Cracks at Grout Pockets

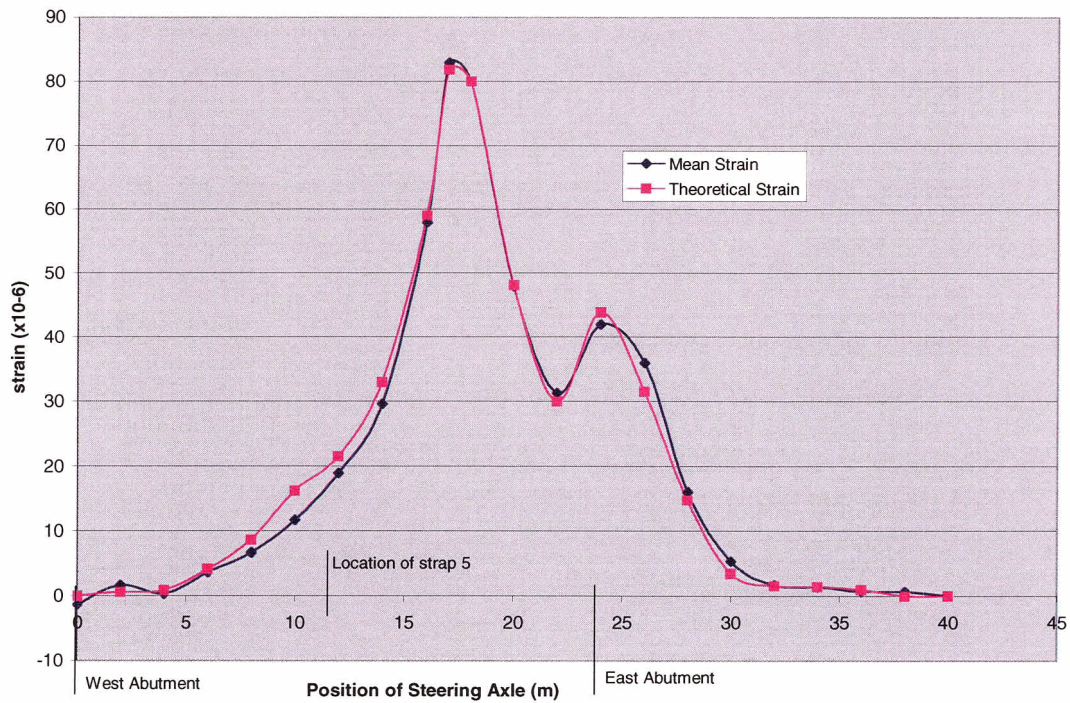
Figure 5.4 - Forestry Bridge Test Vehicle-Spectra for Strain in Arch Panel Strap Strain Gauge 5

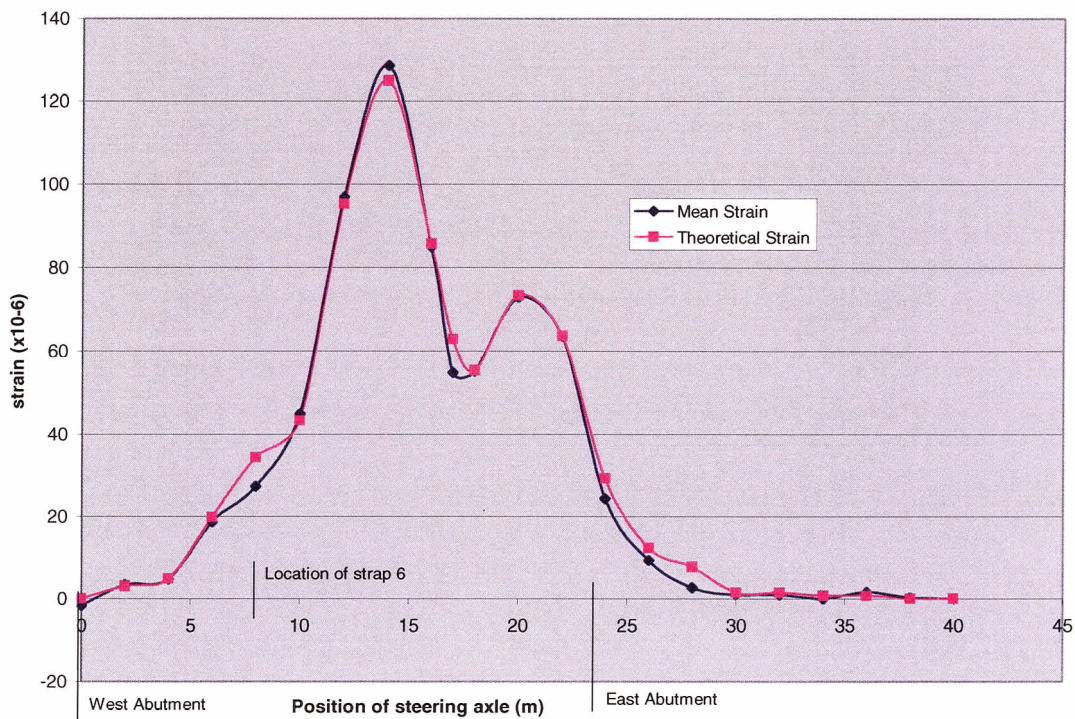
Figure 5.5 - Forestry Bridge Test Vehicle and Theoretical-Spectra for Strain in Arch Panel Strap Strain Gauge 6

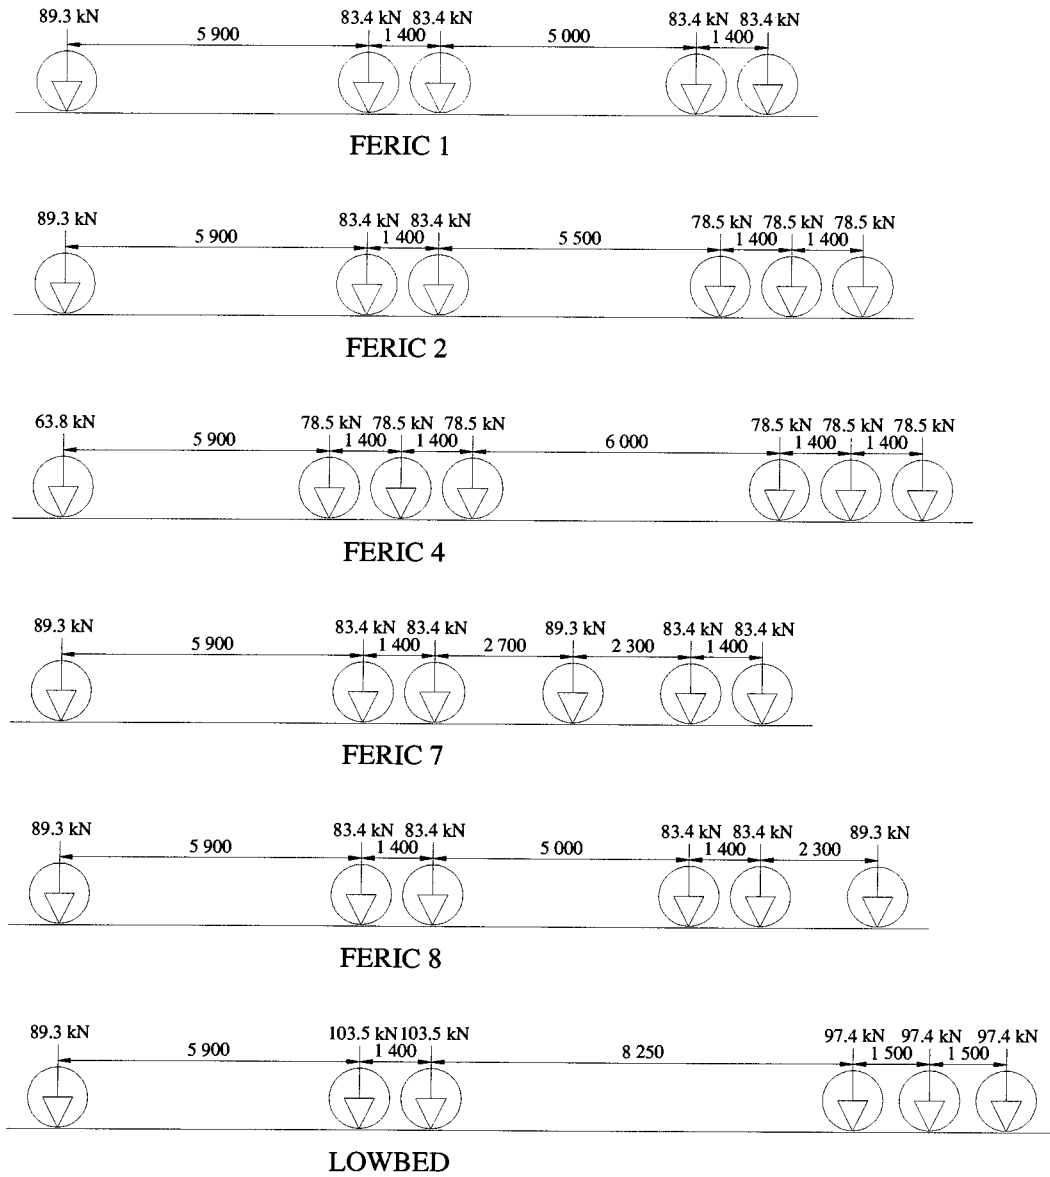
Figure 5.7 - Typical Vehicle Configurations

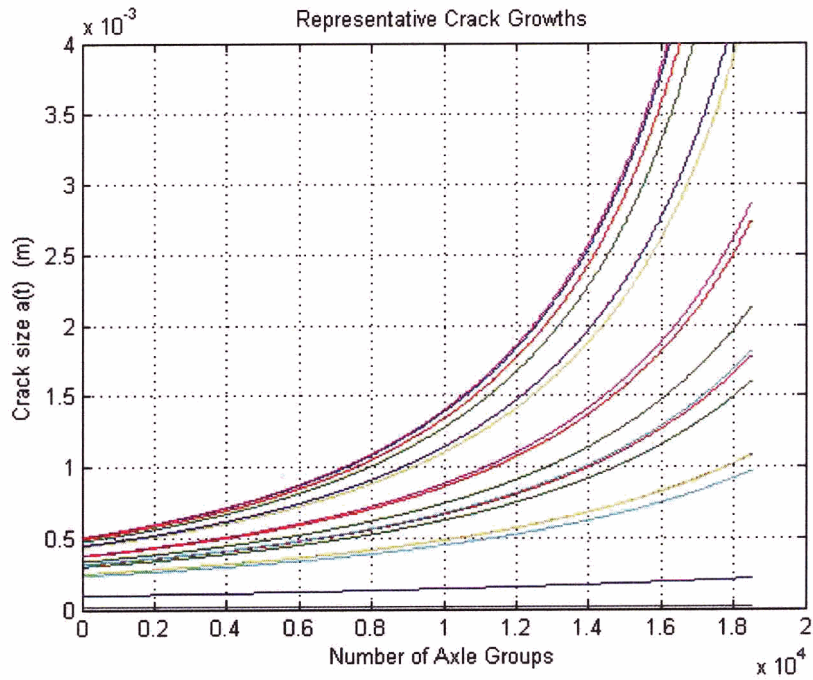
Figure 7.2 - A Representation of the Growth in the CMOD δ of $i = 1, \dots, 23$ Cracks

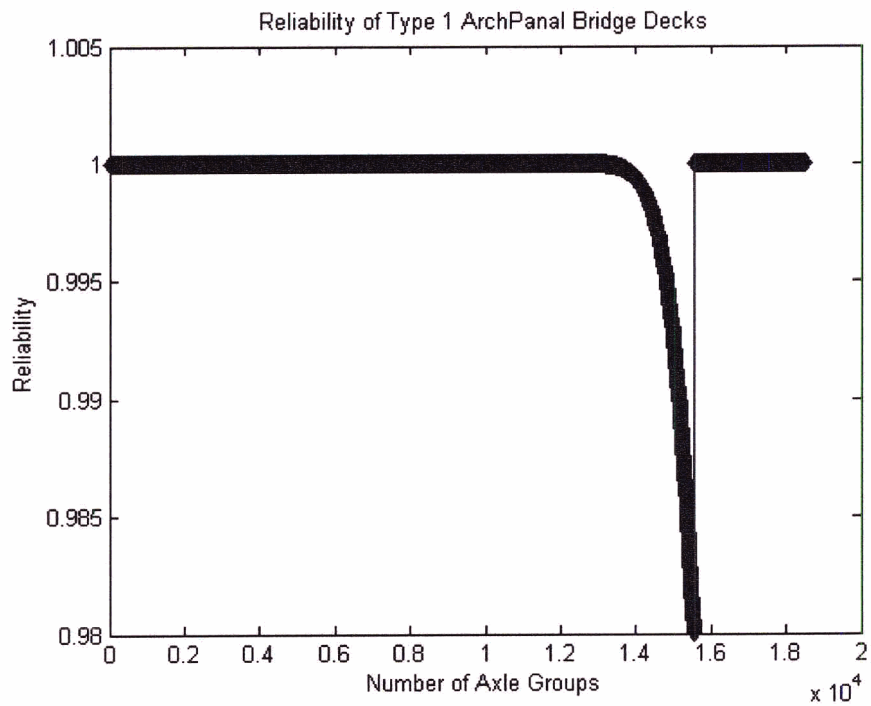
Figure 7.3 - For a Reliability of 0.98, an Inspection Should Take Place after Approximately 7 Years of Operation

This number illustrates in a graphic manner the power of the approach being suggested in this thesis of ensuring the safety of arch panel bridge decks in the future. The process also demonstrates one means of utilizing data collected from the monitoring of existing structures in order to estimate reliability and to assist in the establishment of parameters for future design.
