Bond Behavior of Cement-based Repair Materials Under Freeze-thaw and Cyclic
Loading Conditions

A Dissertation Submitted in Partial Fulfillment
of the Requirements for the Degree of

in the Department of Civil Engineering

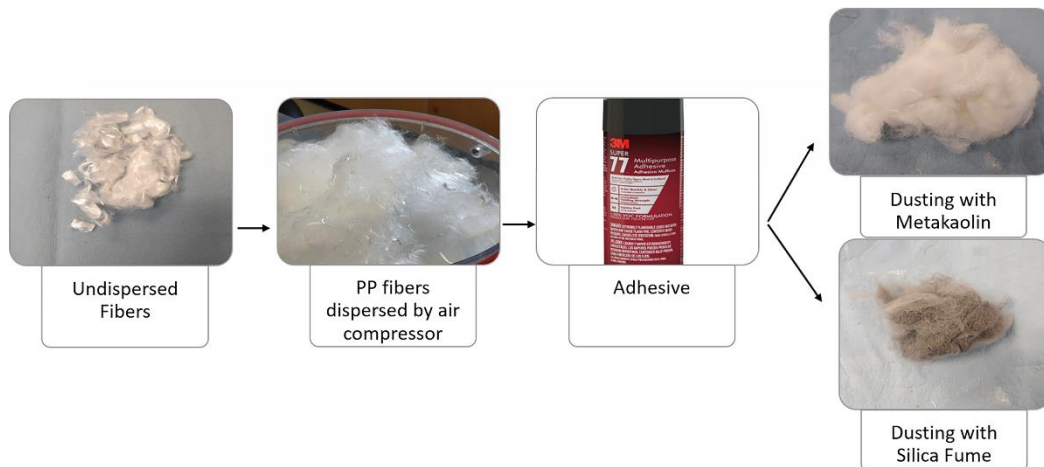
Figure 3 Chart showing the process of fiber preparation

A total of six mixes were prepared including control samples, with and without fibers. The fibers were coated with the help of an enclosed chamber. The chamber had a small opening fitted with a nozzle. Through the opening, the air was blown using an air compressor to keep fibers agitated. Using the air compressor, the fibers were first dispersed inside the chamber, next the multipurpose adhesive was sprayed, and the air compressor was used to coat the fibers as evenly as possible. Coated fibers were obtained by dusting the SCM over the fibers coated with adhesive. The air compressor was used again to distribute the SCM throughout the fibers inside the chamber. The basic procedure is illustrated in Fig. 3. To separate the fibers from the adhered mesh-like formations, the fibers were chopped to obtain filaments. Some samples were taken from the chopped fibers, and the length was measured to be ranging from 3 to 6 mm maintaining an aspect ratio between 100 and 200. It should be noted that this lab-based procedure does not guarantee the complete coating of all fibers. The unevenness of the coating might prove to be better in terms of binding with the mortar, however, this aspect requires further detailed investigation. The SCM content was estimated to be about 19.96% by weight as the percentage of the original untreated fibers taken for the coating procedure.

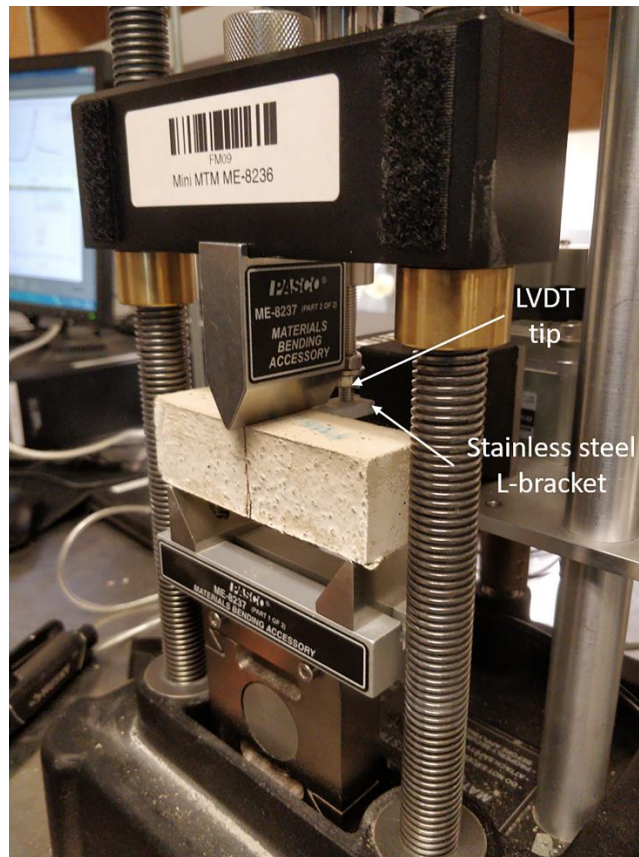
Figure 8 Arrangement of the displacement measuring set up for beams

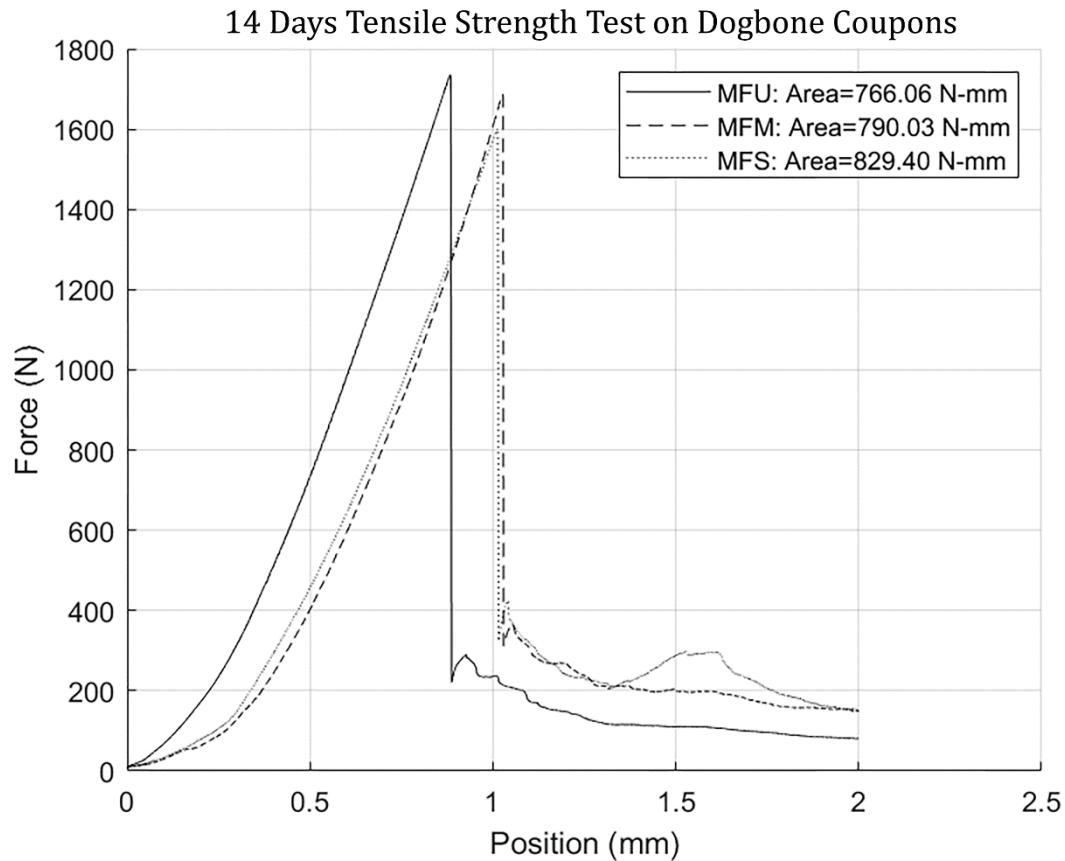
Figure 11 Load vs displacement curves comparing MFU, MFM, MFS

The area under the tensile curve (Fig. 11) represents the toughness of the specimens. The toughness of MFU, MFM, and MFS samples was 766.06 N-mm, 790.03 N-mm, and 829.40 N-mm respectively. Samples reinforced with treated fiber (including MFM and MFS) showed ductile behaviour and the toughness value is slightly higher than that of untreated fibers coupons (MFU). Albeit, this is not a significant improvement and may not be representative of all the samples. This aspect needs to be studied in future studies.

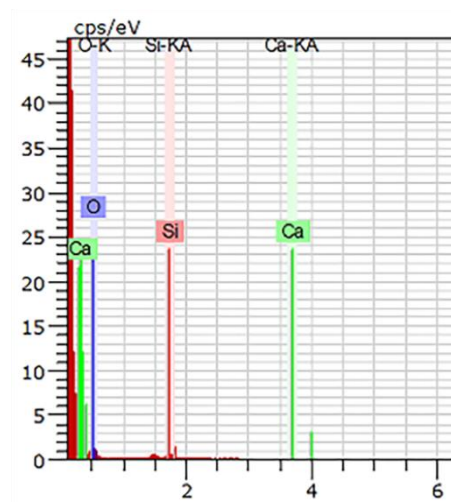
After the SCM coating procedure was carried out on fibers, they were analyzed under an SEM and energy dispersive X-Ray spectroscopy (EDS). The microscopy images revealed the presence of a varying concentration of SCM on the fiber surface. However, pozzolanic materials seem to be present throughout the surface. Since the effect of ITZ is progressive and is most significant in the first 15–20 μm closest to the reinforcement [38], even a small amount of coating can be sufficient to provide the desired results. The evenness of the coating was not visible using optical microscopy owing to the fine nature of the particles of the SCMs used; however, it was evident under the SEM. In Fig. 16 (a), the coating of metakaolin can be distinctly seen as brighter spots on the surface of the fiber. Bruker Quantax (EDS) System was used for X-ray spectroscopy to reveal the elements in the sample. The spectroscopy revealed peaks corresponding to elements such as silicon, oxygen, and calcium. The equipment demonstrates the ability to show the true spatial distribution of each element of interest in the given sample. The magnification level was set at 200x with an accelerating voltage of 15 kV and a working distance of 17.4 mm for the parent image. Using Fig. 16 (a) as the parent image, elemental mapping was done on it to reveal the positioning of the elements which showed spectrum peaks, as shown in Fig. 16 (b). The elemental mapping revealed the positioning of silicon (shown in Fig. 16 (d)) and oxygen (shown in Figure. 16 (e)) from the pozzolan (metakaolin) on the fiber surface. As indicated by the datasheet of metakaolin and other studies [80], it was inferred that the primary components in metakaolin were oxides of aluminum and silicon. Elements such as silicon and oxygen which corresponded to the peaks in Fig. 16 (b) were seen with their spatial distribution in Figs. 16 (d) and 16 (e), respectively. In Figs. 16 (d) and 16 (e), the distribution of the constituents of the SCM can be observed. Outline of the fibers in the parent image can be made out in the images showing elemental mapping, indicating the presence of SCM on the surface of the fiber.

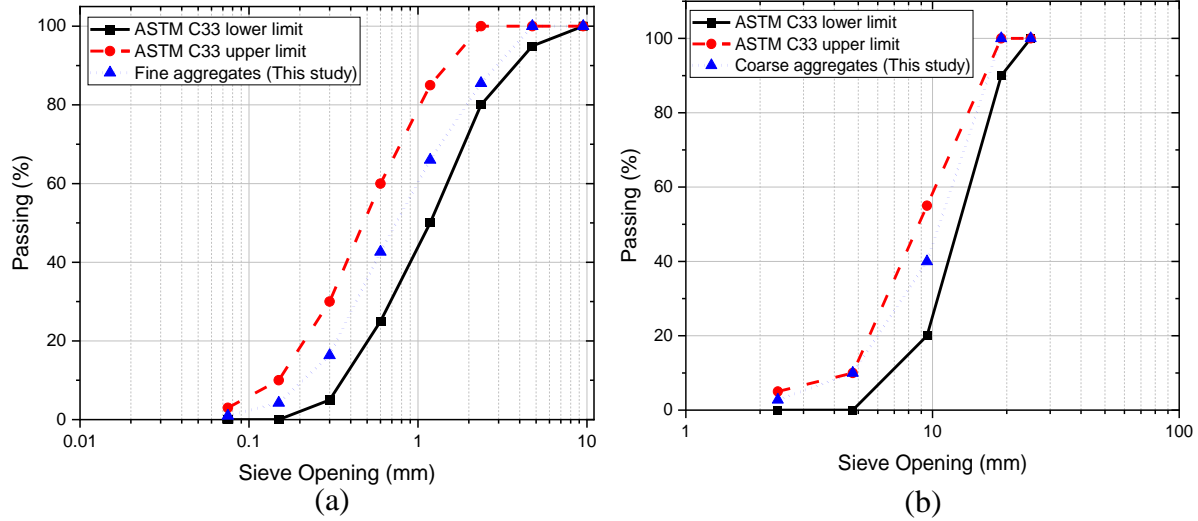
Figure 17 Gradation curves of aggregates of Mix S (a) Fine aggregate (b) Coarse aggregate

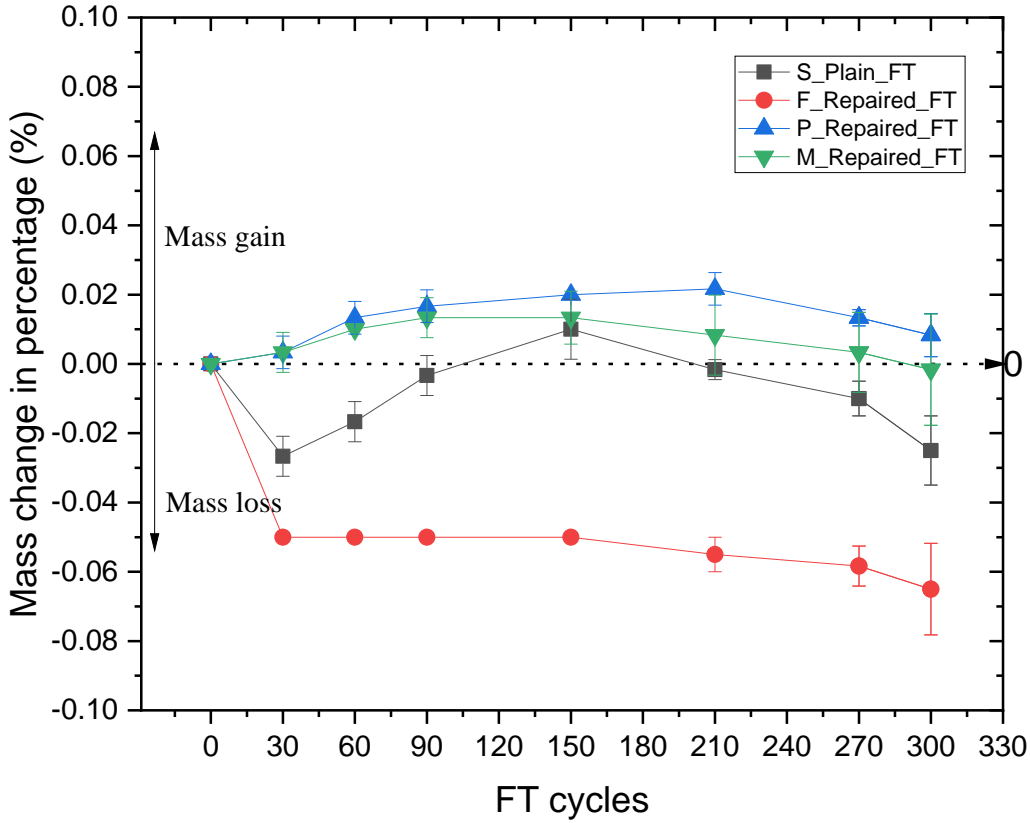
Figure 22 Mass loss of all mixes vs. FT cycles

From 0 to 300 cycles, mass loss of Mix F reached up to 6%, with Mix S (control mix) losing 2.5% mass, Mix M losing 0.17% mass, and Mix P gaining 0.8% mass, as shown in Fig. 22. The percentage mass loss of Mix F-repaired beams was the highest among all mixes, which matches the observation that Mix F had severe surface scaling. Mix M (cementitious repair mortar) showed little change in mass after 300 cycles, which could be due to the high strength of the material. According to the poromechanical theory [100], FT damage occurs when the hydraulic pressure associated with water freezing in pores exceeds the strength of concrete regardless of the effect of entrained air. The average compressive strength of Mix M (68 MPa) at 28-day is the highest among all the mixes which could be beneficial for FT resistance. Mix P (polymer-modified cementitious mortar), showed a mass gain of 0.8% after 300 cycles. As seen in Fig. 22, the average mass of Mix P experienced a gradual increase by approximately 0.02% from 0 to 210 FT cycles, after which mass starts to drop. It is suspected that from 0 to 210 FT cycles, ongoing cement hydration outpaced the frost damage and a similar phenomenon was observed regarding dynamic elastic modulus in another study [146].

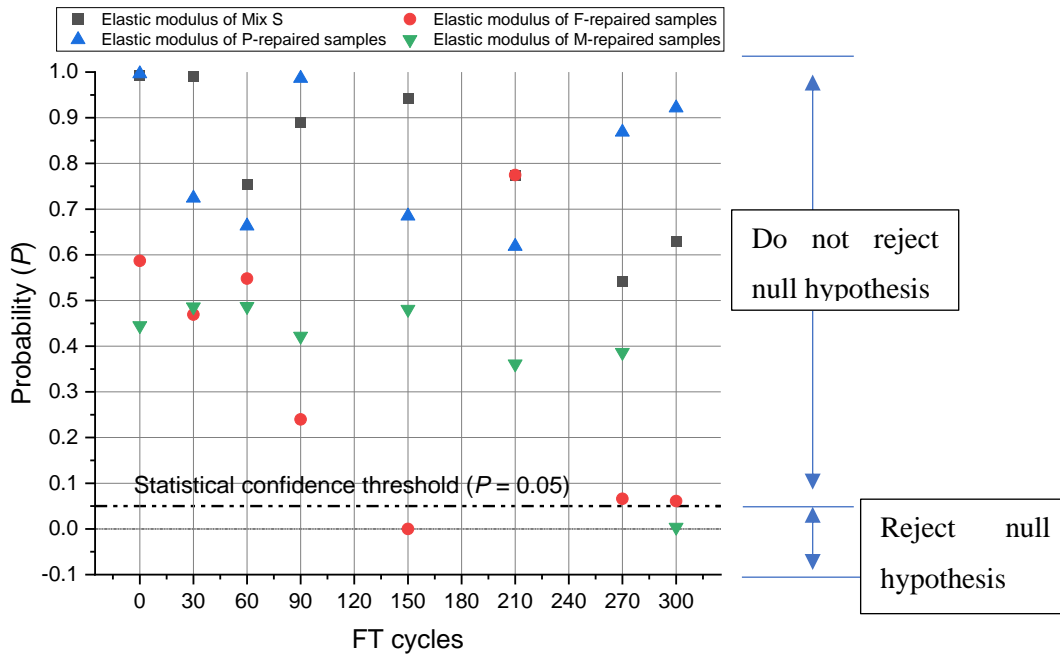
Figure 25 Probability P that the null hypothesis is true for each pair of different NDTs

ANOVA method was used to determine if there exists a statistically significant difference among the dynamic elastic moduli measured by three different NDT methods. The null hypothesis for ANOVA test is that dynamic elastic modulus values measured by three different NDT methods have no statistically significant difference. Fig. 25 summarizes the results of probability, P , that the null hypothesis is true. Considering a threshold of $P = 0.05$ (at a confidence level of 95%), comparisons where $P < 0.05$ means that the null hypothesis is rejected, and $P > 0.05$ means that the null hypothesis is not rejected.

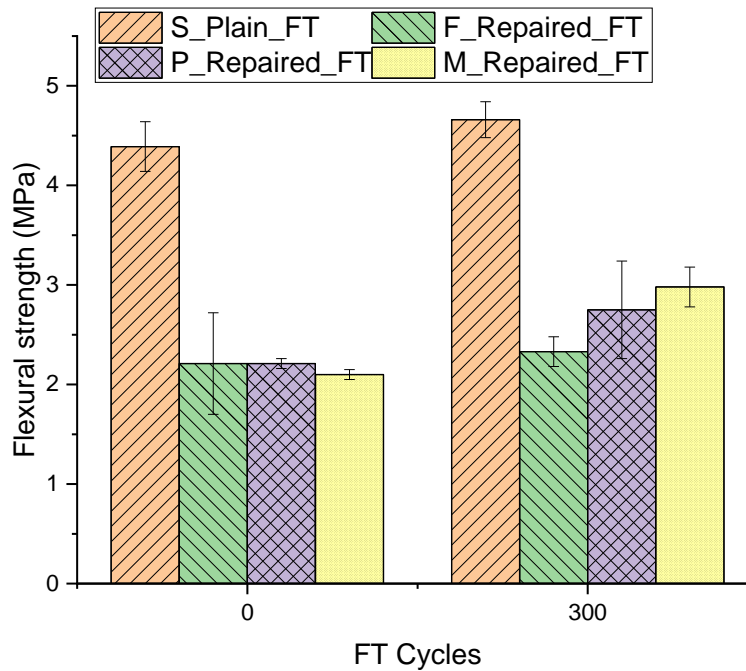
Figure 26 Flexural strength of repaired beams at 0 and 300 FT cycles

The bond between repair materials and substrate concrete was determined by performing flexural strength test on repaired specimens. Fig. 26 shows the average flexural strength results of 3 specimens per mix without FT exposure and specimens of each mix after 300 cycles of FT exposure. It can be observed that all mixes experienced an increase in strength after 300 cycles of exposure. Mix S, F, P, and M had an increase of 6.15%, 5.43%, 24.4%, and 41.9% in flexural strength, respectively. Authors hypothesize that this is most likely due to the continued cement hydration that compensated for any strength loss as a result of FT damage. Due to the time taken for the FT test and other NDTs, the flexural strength test on FT-damaged specimens was performed 4 months after testing specimens without FT damage. A similar phenomenon was reported by several researchers [146], [156] where dynamic elastic modulus even increased with increasing cycles of FT exposure. Zhou and Qiao [146] attributed the phenomenon to the ongoing cement hydration which outpaced the frost damage. Sun et al. [156] observed that the dynamic elastic modulus experienced a slight drop at the early stage after which the modulus values increased with increasing FT cycles. This is attributed to the decrease of pore size due to cement hydration that lowered the freezing point, which in turn enhanced the FT resistance of the materials.

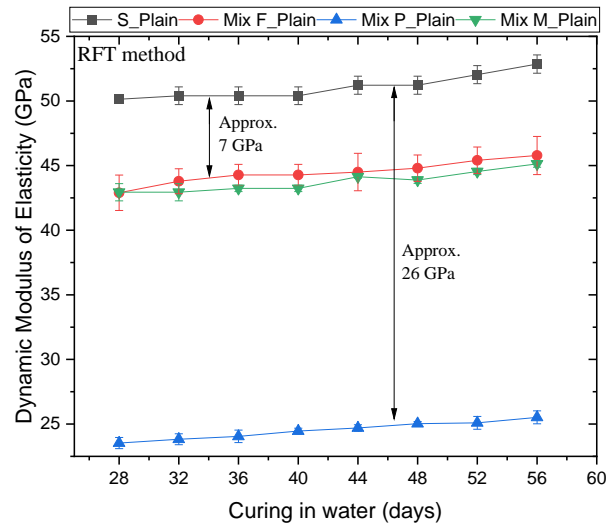
Figure 28 E_{dyn} measured from the transverse vibration of cylinders

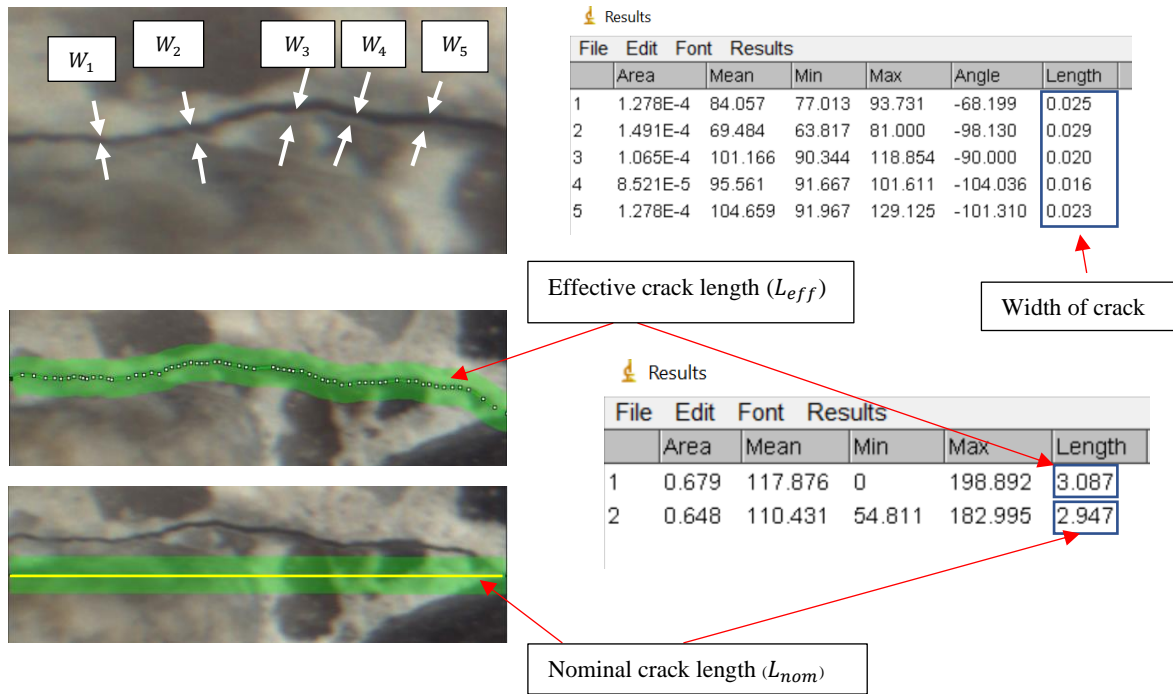
Figure 30 Image analysis using ImageJ software

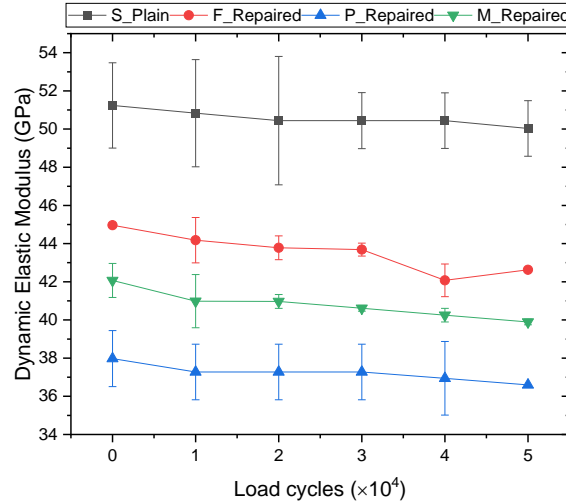
Figure 44 Change in dynamic elastic modulus as a result of flexural cyclic loading
