Sounding of subsurface concrete defects using frequency response of flexural vibration

Sean Blaney & Rishi Gupta

Blaney, S., & Gupta R. (2018). Sounding of subsurface concrete defects using frequency response of flexural vibration. *Cement and Concrete Composites*, 92, 155-164. <https://doi.org/10.1016/j.cemconcomp.2018.06.006>.

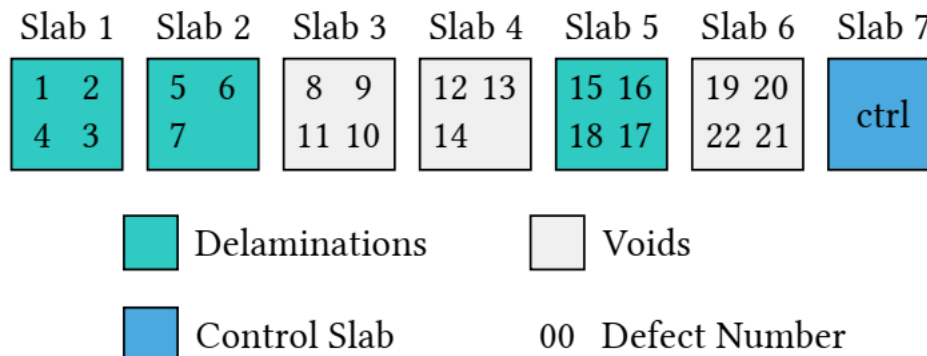
Figure 5: Defect numbering schemes for Table 1.

196 For the purposes of Table 1, defects are numbered starting in the upper
197 left hand corner of each slab in a clockwise fashion, starting from the number
198 one above the highest of the previous slab, as shown in Figure 5.

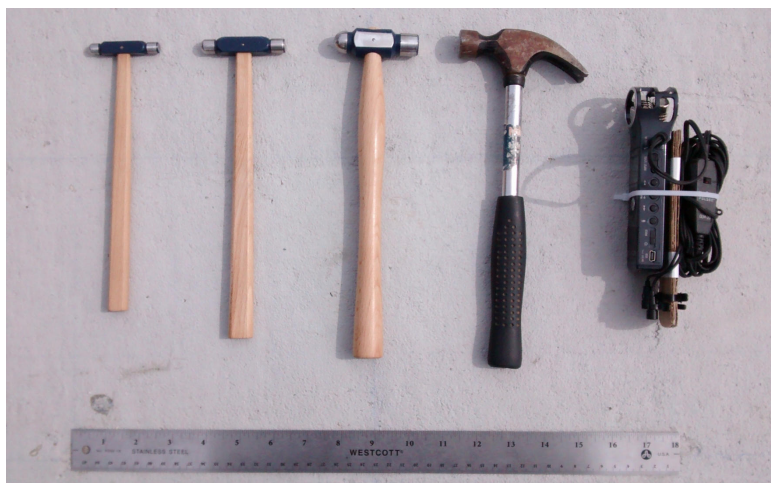
Figure 7: (Left to right) The 1, 2, 4, and 8 oz. hammers and Zoom H1 with OLM-20 mic. An 18 in (45 cm) ruler is shown for scale.

246 The four hammers were used in this study are shown in Figure 7. Three
247 ball-peen hammers with weights 1, 2, and 4 oz. (0.028, 0.057, 0.113 kg, re-
248 spectively) were used along with an an 8 oz. (0.227 kg) flat-head hammer.
249 The diameters of the roughly hemispherical ball-peen hammers are 8.9 mm,
250 11.2 mm, and 17.4 mm for the 1, 2, and 4 oz. hammers respectively. Ac-
251 cording to the methods of Sansalone and Streett [18], steel ball impactors
252 with diameters 8.9, 11.2, and 17.4 mm should have maximum excitation fre-
253 quencies of 32.7, 26.0, and 19.8 kHz respectively. However, a hammer head
254 has a noticeably higher mass in comparison with a steel ball of the same di-
255 ameter as the hammer head. The mass to contact stiffness ratio determines
256 the contact time for an impactor. Accordingly, the steel ball-peen hammers
257 have higher contact times and lower maximum excitation frequencies than

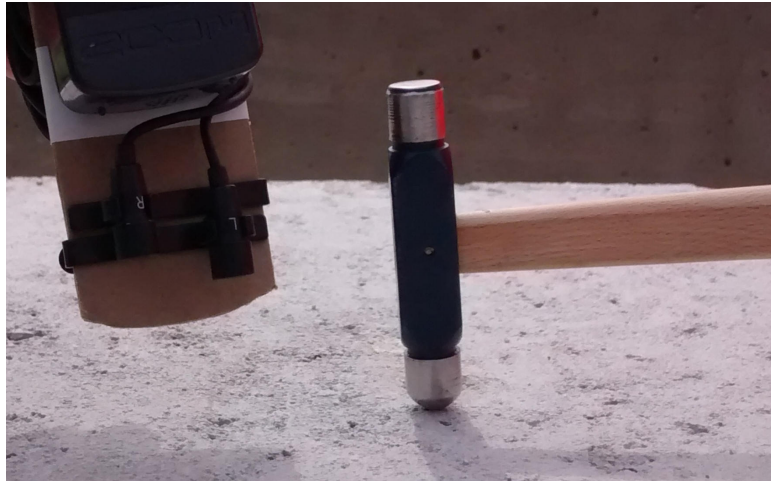
Figure 8: Hammer percussion test configuration.

258 steel balls of the same diameter. The microphone was hand-held at a lateral
259 distance of 56 mm or less from the impact location: less than 40 % of the
260 slab thickness as in an air-coupled impact echo test [11]. The configuration

261 of the hammer impact test is shown in Figure 8.

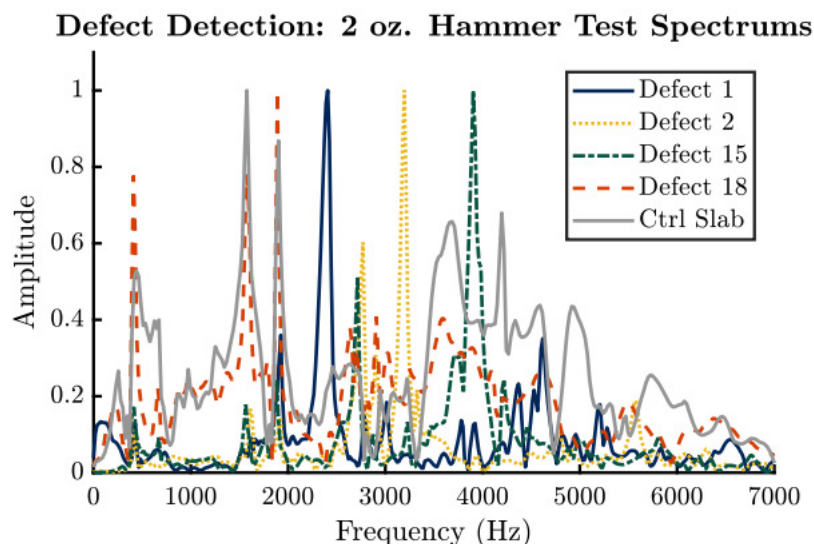
Figure 12: Frequency spectrums for 2 oz. hammer test showing detected and undetected defects spectrums along with the control slab spectrum.

342 demonstrated low frequency peaks in the vicinity of 400 Hz and 700 Hz, as
 343 well as a higher frequency peak between 12 and 15 kHz. The lower peaks are
 344 to be expected from the flexural vibration of the entire slab, and the higher
 345 peaks are possibly caused by compressive vibration of the slab (of the type
 346 exploited by impact echo methods). The exact forms of the response signals
 347 for defects and the control slab depended on excitation methods (hammer,
 348 speaker, or chain) and parameters (impactor size, mass, or excitation signal).
 349 A comparison of the frequency spectrum for defects that are detected
 350 and another that is not, along with the frequency spectrum of the control
 351 slab is shown in Figure 12 for the 2 oz. hammer test, as recorded using the
 352 Zoom H1. The spectrums have been normalized by their maximum value for
 353 the purposes of Figure 12 as the varying absolute amplitudes of the different

354 spectrums make the comparison visually difficult otherwise. Similarly, the
 355 frequency in Figure 12 has been limited from 0 to 7 kHz to frame the peaks
 356 of interest appropriately.

357 The frequency spectrums for Defects 1, 2, and 15 in Figure 12 have a most
 358 prominent peak that indicates a dominant flexural mode of vibration, and
 359 stand in stark contrast to the shape and form of the control slab frequency
 360 spectrum. Less prominent peaks in these spectrums may correspond to other

361 modes of vibration or overtones. Importantly, the most prominent peaks in
362 these three microphone-recorded spectrums have a mean percent difference
363 of 5 % from those measured using the contact accelerometer. Deeper defects
364 and those with smaller lateral size have higher frequency peaks than shallower
365 defects with larger lateral size. Spectrums from the other hammers show the
366 same trends as those in the 2 oz. hammer test.

367 Conversely, the frequency spectrum for Defect 18 shown in Figure 12 has
368 significant similarity to the control slab spectrum. There are peaks near 400
369 Hz, 1.6 kHz, and 1.9 kHz, and there is no other dominant peak to indicate the
370 kind of flexural vibration associated with a subsurface defect. A comparison
371 between the frequency spectrum for Defect 18 and the control slab is not
372 adequate to say that a defect has been detected.

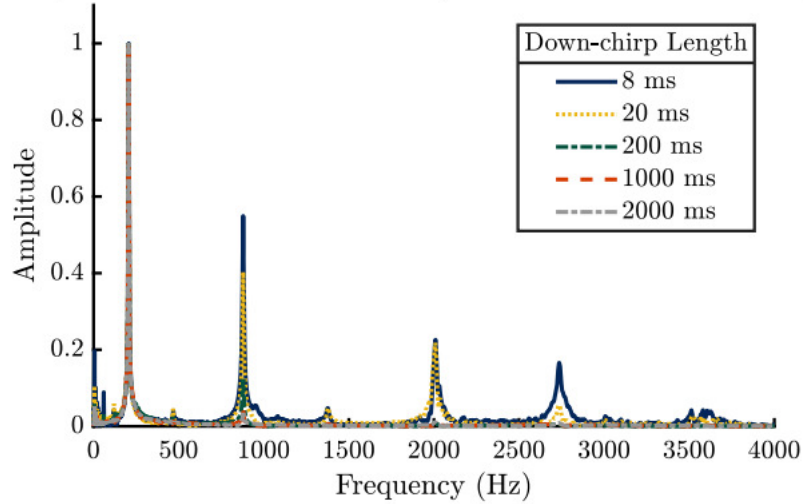
Figure 13: Normalized down-chirp spectrums for the glass speaker test showing peaks associated with modes of vibration with no nodal diameters.

423 Up-chirp speaker signals appear to generate some kind of noise peaks in
424 neighborhood 5.6 and 8.0 kHz. These peaks become more pronounced as the
425 length of the up-chirp increases. Figure 13 shows frequency spectrums for
426 down chirps for the glass disc showing the peaks associated with first four
427 modes of vibration with zero nodal diameters.

428 Amplitudes in Figures 13 and 14 are normalized by the largest value in
429 each spectrum to make the plots easier to view (the amplitude is also plot-
430 ted on a logarithmic scale in Figure 14 for this purpose). Figure 14 shows
431 a comparison of the 1000 ms up- and down-chirp signals for the glass disc.
432 From Figure 14, it can be observed that the noise in the vicinity of 5.6
433 kHz can be found in both the up-chirp and down-chirp signals. The noise
434 in the neighborhood of 8.0 kHz appears to be exclusive to the up-chirp signal.
435

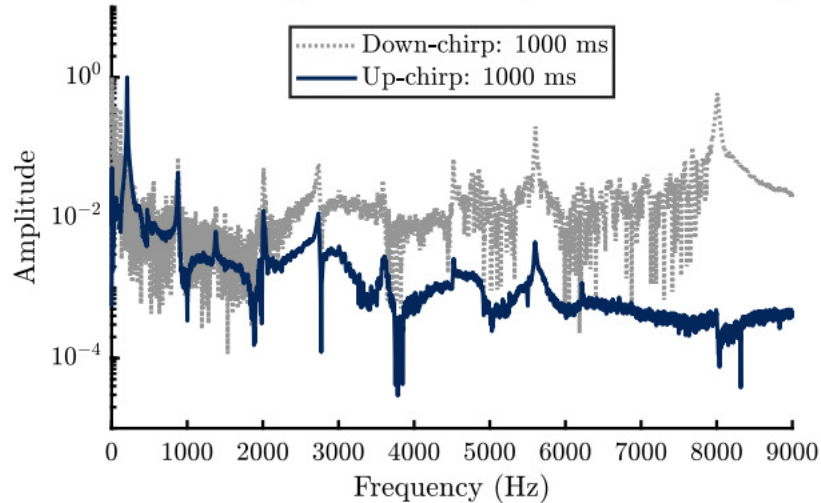
Figure 14: Comparison of normalized 1000 ms up- and down-chirp spectrums for the glass disc speaker test.

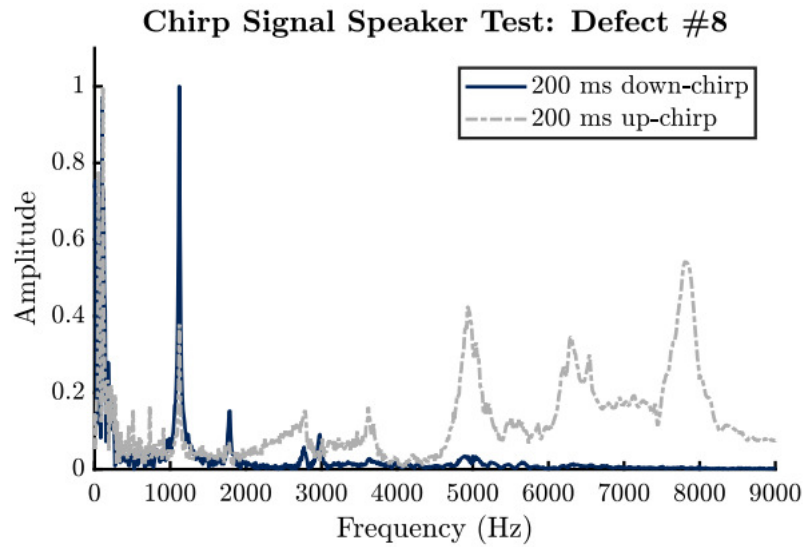
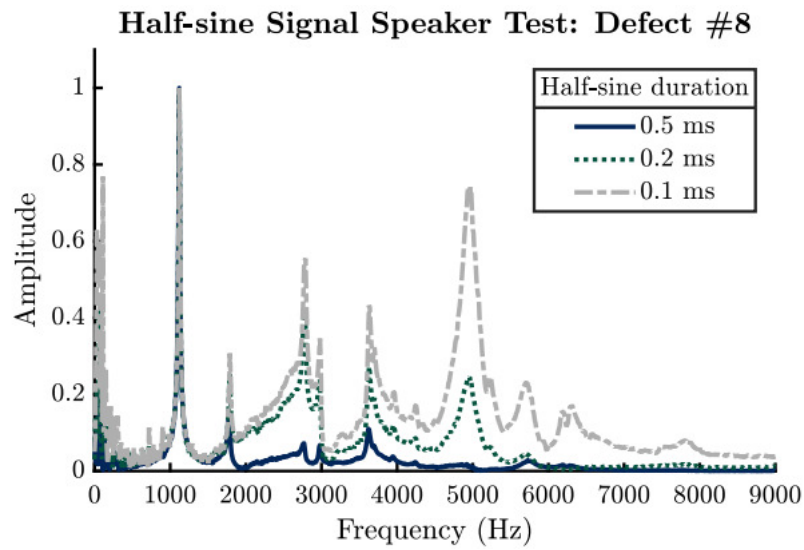
Figure 15: Frequency x-axis ranges are set to best display features of interest. (a) Comparison of normalized 200 ms up- and down-chirp spectrums for the concrete speaker test of defect #8. (b) Comparison of normalized spectrums for half-sine “bump” signals of different lengths for speaker test of defect #8.

For impact signals, longer signals produced less noise but were limited in detection of defects that exhibited higher resonant frequencies. For example, normalized frequency spectrums for the signals tested above defect #8 are shown in Figure 15. To avoid interference from the frequency content of the excitation signal itself, all audio for the speaker is carefully selected to use only the part of the overall signal that corresponds to the response that follows the excitation signal.

453 As shown in Figure 15, there is a clear resonance peak that indicates
 454 defect detection at roughly 1120 Hz and other peaks that may be caused by

455 noise, other modes of vibration, or overtones. Up-chirps of longer duration
456 like the 200 ms signal spectrums shown have significant noise in the 5–6 and
457 8 kHz range as was observed in the glass disc test. The noise in the 5–6
458 kHz range also appears in the spectrums for the shorter duration half-sine
459 signals. The speaker used is very inexpensive and has a thin injection molded
460 plastic casing. It is possible that this particular signal and duration produce
461 some vibration of this speaker casing that causes the noise observed, but
462 more investigation is required to determine the exact cause of these noise
463 peaks with certainty. The low frequency noise (below about 300 Hz) appears
464 to be at least somewhat related to the ambient conditions (primarily wind
465 and nearby traffic and construction). The low frequency of this noise is not
466 in a range that would be associated with concrete specimens and type of
