Introduction

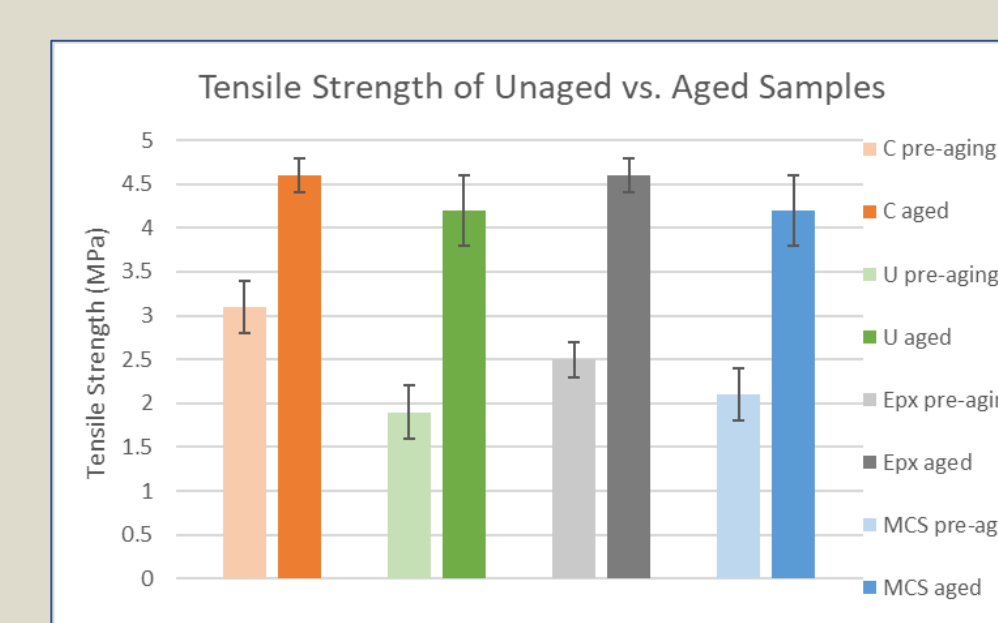
Figure 3: Comparison of tensile strengths before and after aging. For each column pair, the aged strengths are on the right.

- Initial tensile strengths were 3.1±0.3MPa, 1.9±0.3MPa, 2.5±0.2MPa, and 2.1±0.3MPa for the control, uncoated, epoxy and MCS samples, respectively.
- After degradation, tensile strengths were 4.6±0.2MPa, 4.2±0.4MPa, 4.2±0.4MPa, and 4.6±0.2MPa for the control, uncoated, epoxy, and MCS samples, respectively.
- For the same order, these correspond to strength increases of 48.3%, 121.1%, 84.0%, and 100.0%. (see **Figure 3**). Continued curing during the wet/dry procedure is likely the cause of these increases.
- Only the epoxy samples were able to provide reinforcement after the concrete broke (see **Figure 4**). For the unaged samples, this was roughly 600N±200N, and for the aged samples, this was around 500N±200N.

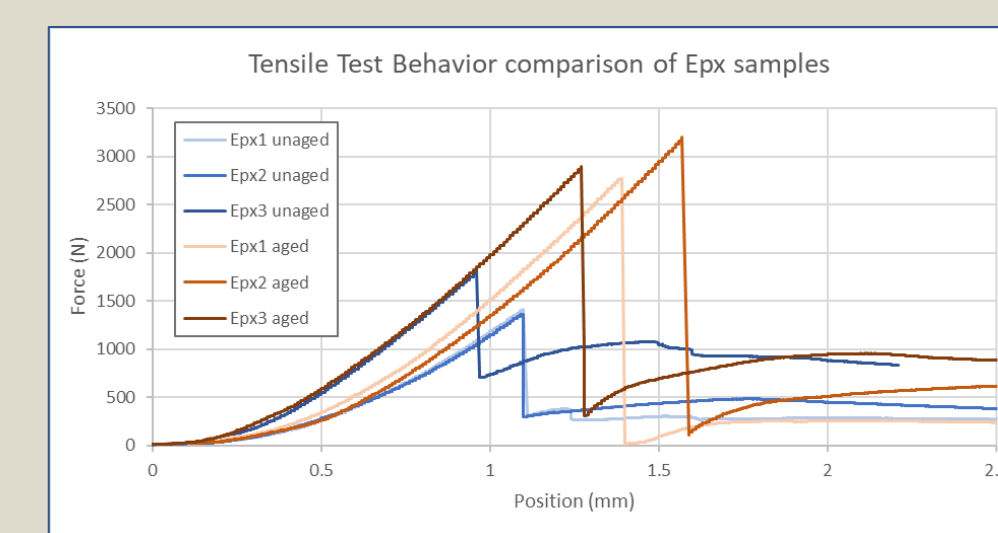
Figure 4: Tensile behavior of epoxy samples. Note the strength post-breakage.

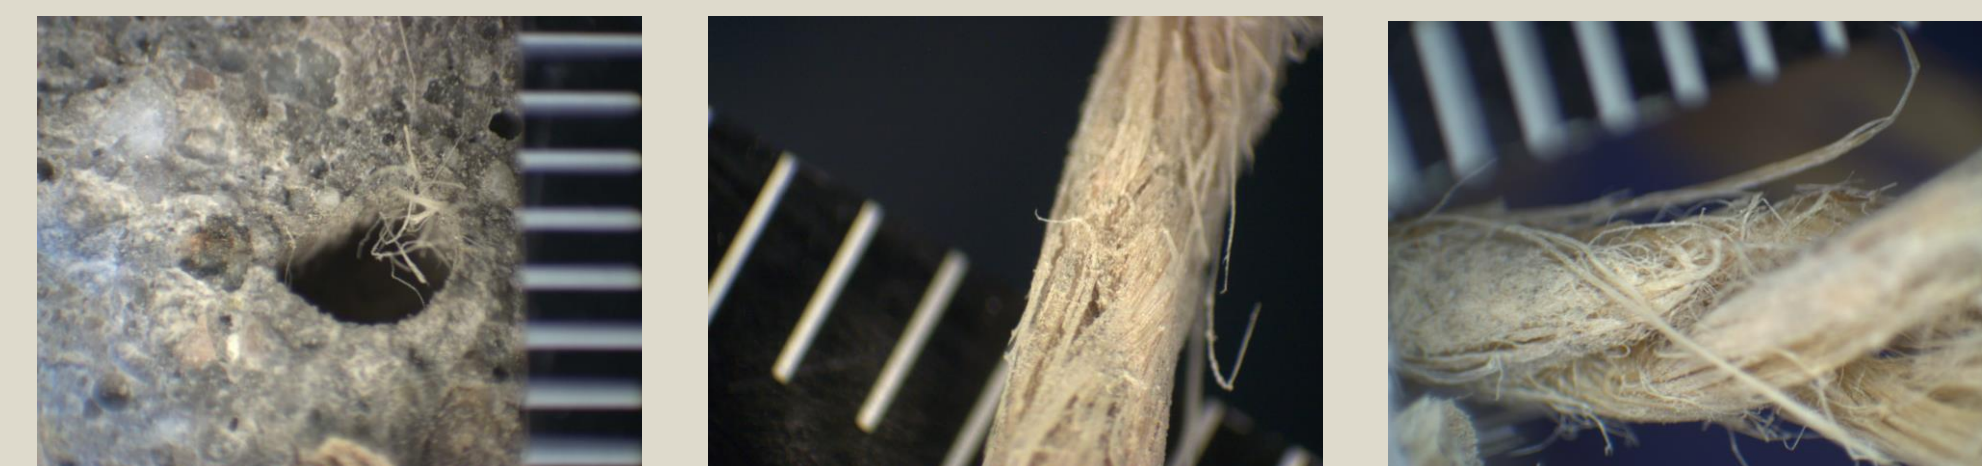
Figure 5: From left: twine hole, unaged twine, aged twine. (Agustines, 2022).

- For the uncoated samples, some fibers at the surface bonded with the concrete but these tended to detach from the twine (see **Figure 5**, left).
- Other than a slight loosening of the twine, wet/dry cycling didn't have a big effect (center, right).

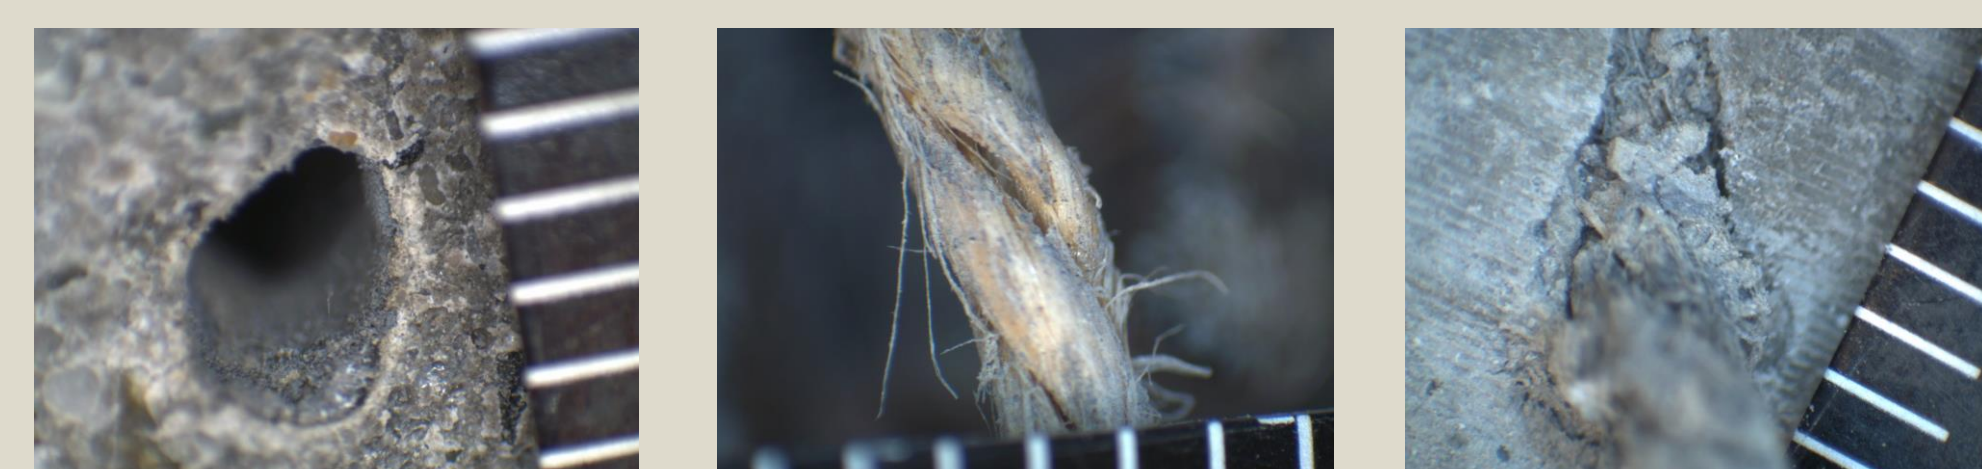
Figure 6: From left: twine hole, unaged twine, pullout sample (Agustines, 2022).

- For MCS-coated twine, microscopy revealed that the silica fume coating mostly stuck to the concrete (see **Figure 6**, left, center) allowing the twine to slip free. This was not changed due to the wet/dry cycling.
- The concrete only stuck to the surface of the coating (right).

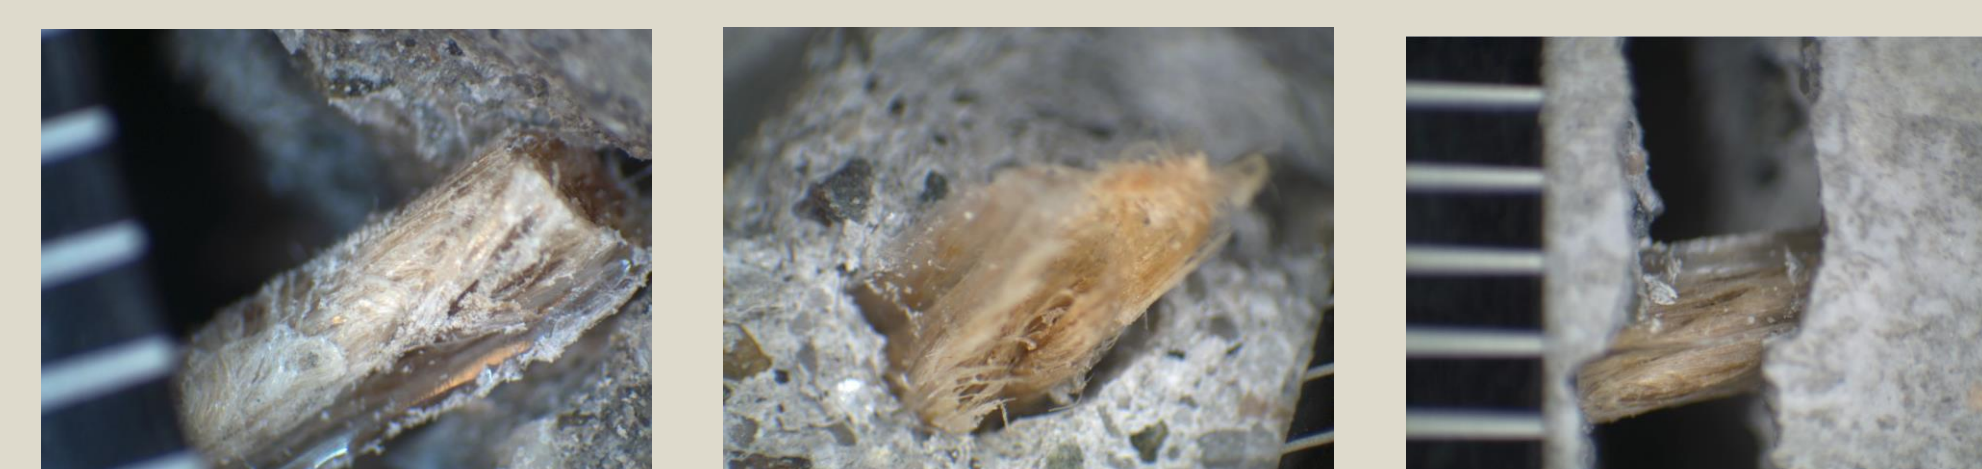
Figure 7: From left: unaged twine, broken aged twine, aged twine (Agustines, 2022).

- For the epoxy-coated twine, microscopy showed that the epoxy coating tended to be shaved off during tensile testing (**Figure 7**, left), and that it likely penetrated beyond the twine surface (center).
- The twine was not visibly impacted by the aging procedure (center, right).

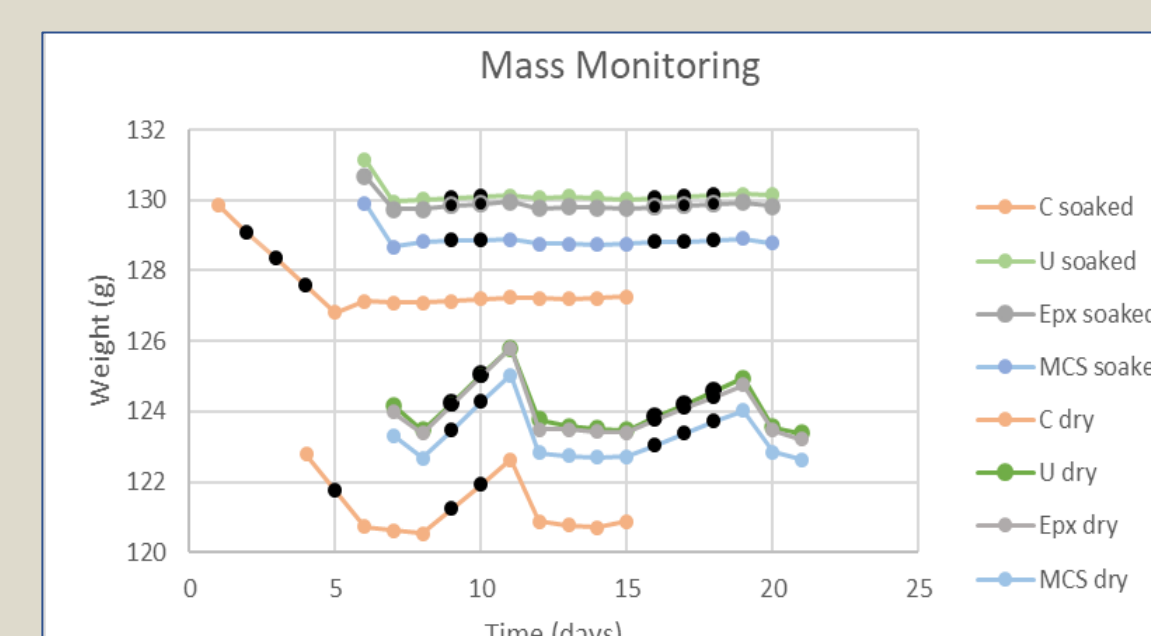
- The wet phase didn't fully soak the samples.
- The FRC samples absorbed less water during the 2nd air drying period.

Figure 8: Mass monitoring graph. Soaked weights are above, dry weights below. Blackened areas are interpolations.

- Wet/dry cycle: 4h in tap water, 18h in an oven at 60 C, and air drying/cooling time in between. 8 cycles using the oven and 2 using air (over weekends).
- Weighed samples before and after wetting to track changes (mass monitoring).

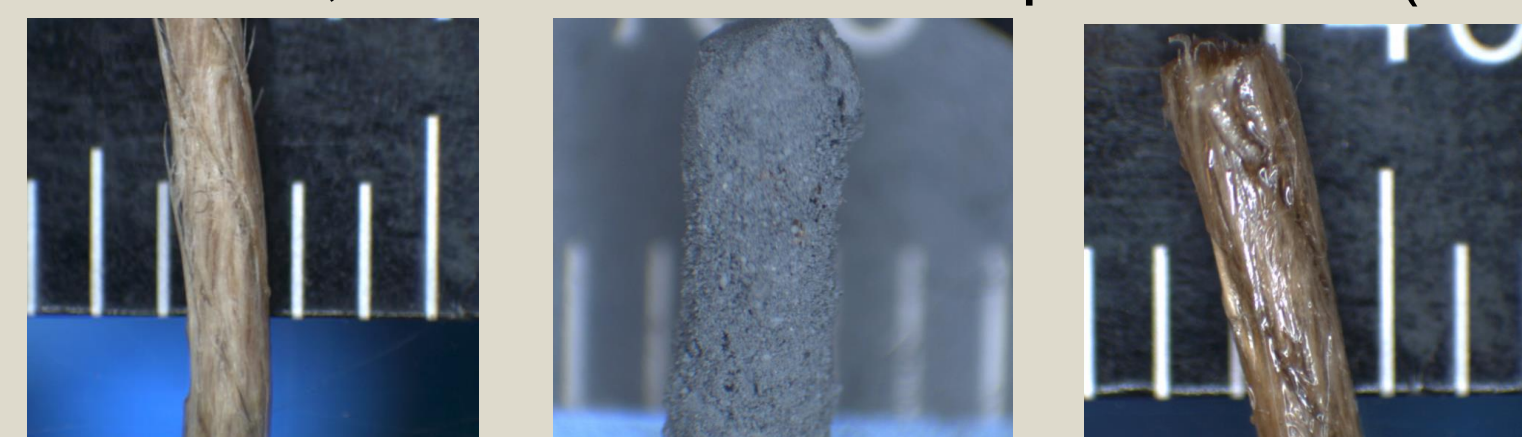
- 3 batches of 3 cm strands: uncoated, epoxy coated, and methyl cellulose and silica fume (MCS) coated (see **Figure 1**). Methyl cellulose is a biodegradable adhesive, and silica fume is a pozzolanic ("cement-like") material.

Figure 1: From left: uncoated twine, MCS-coated twine, and epoxy-coated twine. Scale in mm. (Agustines, 2022)

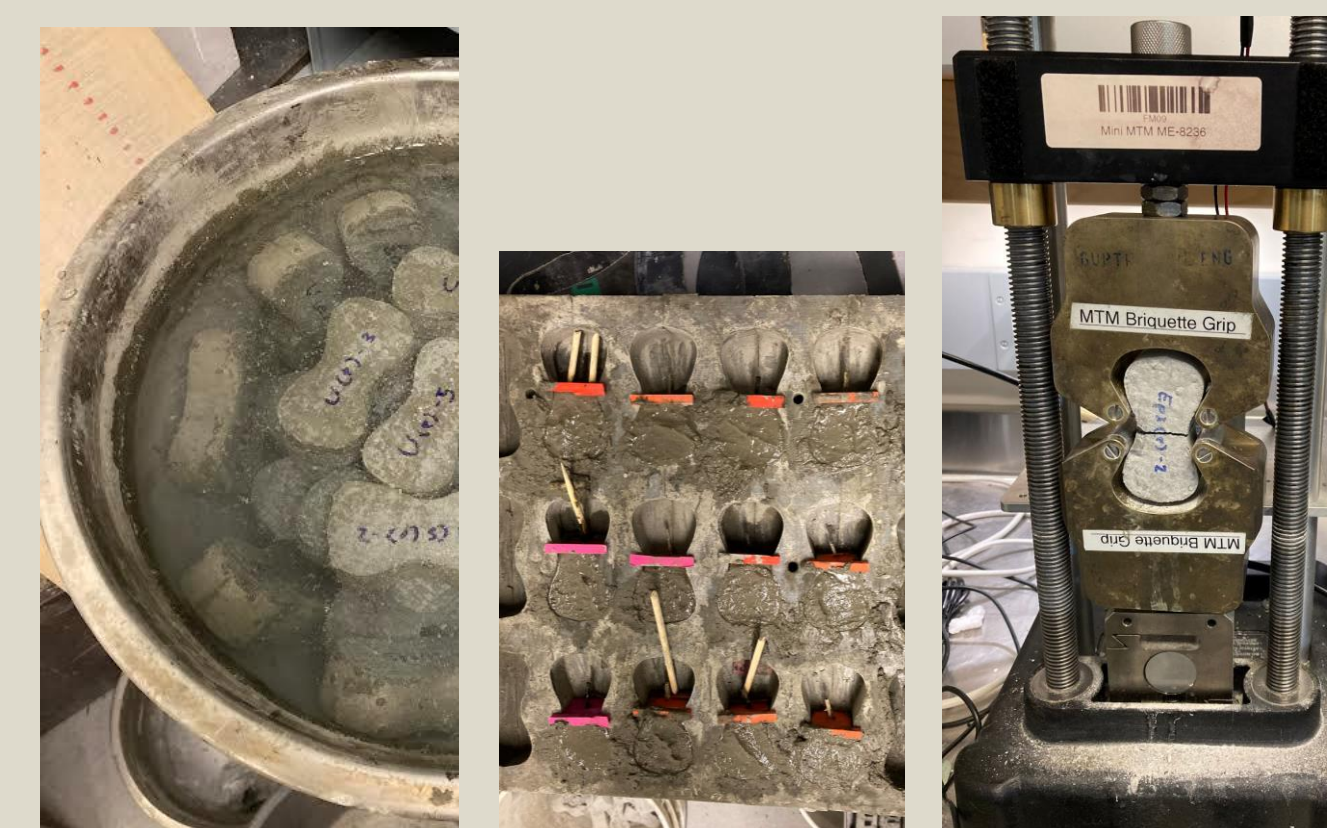
- "Dog bone" samples cast according to the ASTM C307-18 standard.
- 4 categories (6 samples each): control, uncoated, epoxy, and methyl cellulose silica (MCS) (see **Figure 2**).
- 10-11 fibers oriented lengthwise per sample.
- Half dog bones (3 per category) with 1 fiber half-embedded (see **Figure 2**).
- Cured for 28 days in water.

Figure 2: From left: curing dog bone samples, half dog bone samples, and the tensile testing setup (Agustines, 2022).

- Tensile testing of aged and unaged dog bones (see **Figure 2**) for comparison.
- Microscopy of half dog bones and tested samples to examine fibers and coatings.
