Failure Process Analysis of Landslide Triggered by Rainfall at Volcanic Area:
Fangshan Landslide Case Study

Weiwei Gu, Zinan Li, Cheng Lin, Faming Zhang, Menglong Dong, Yukun Li, and
Chang Liu

2022

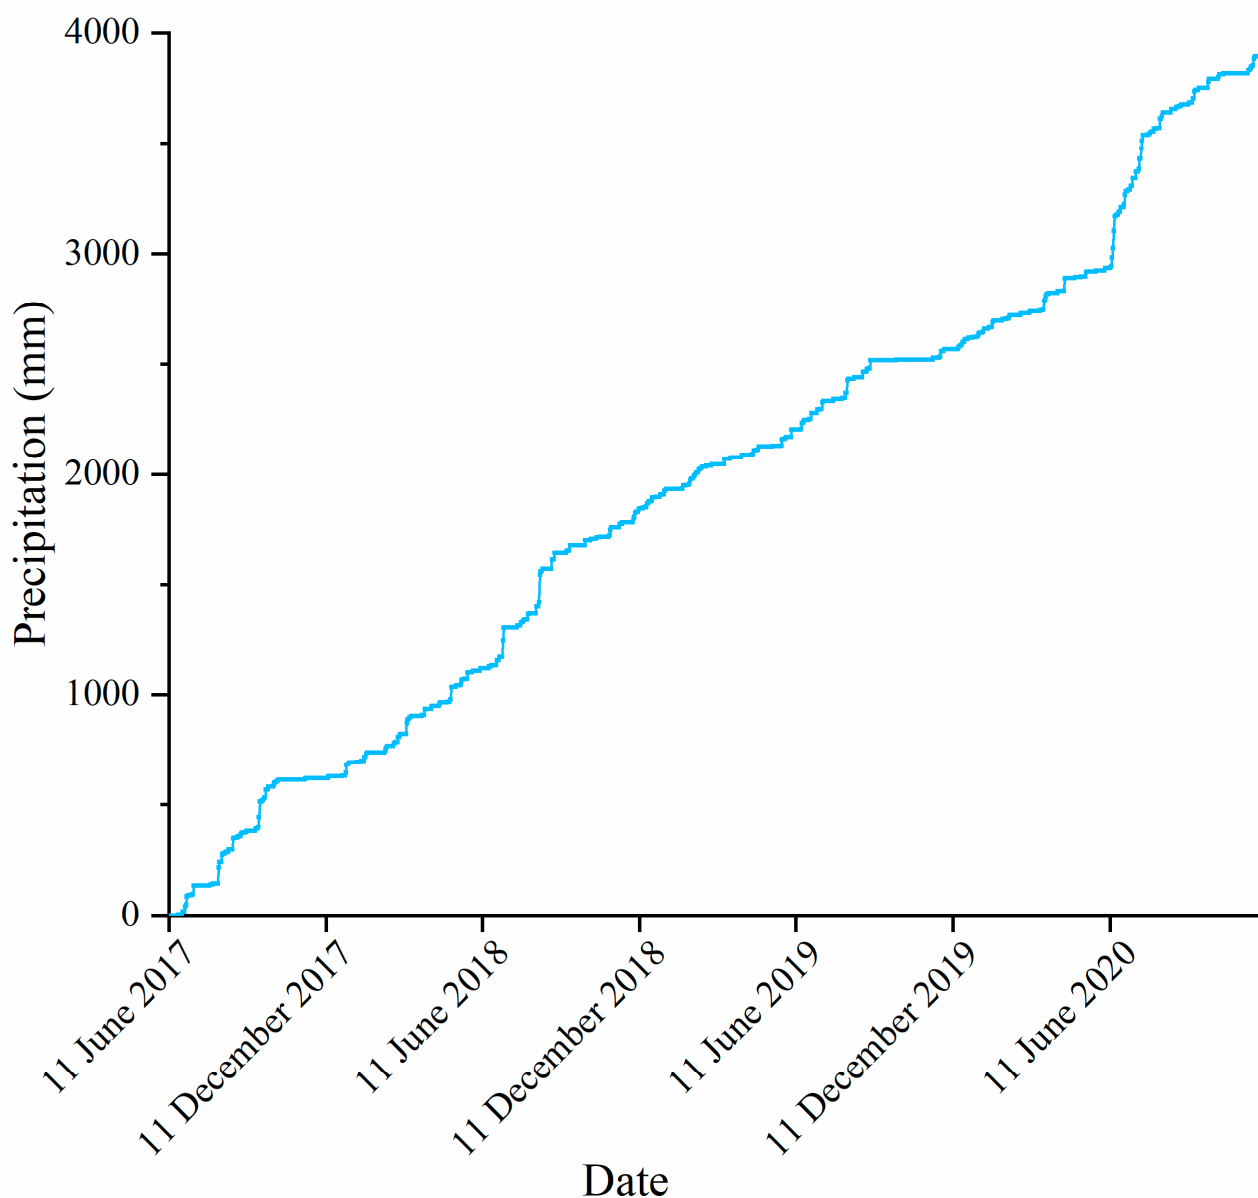
Figure 2. Cumulative rainfall in Nanjing from 11 June 2017 to 12 December 2020.

Impacted by the 2015–2016 El Niño event, heavy precipitation occurred many times in Nanjing in 2016. The precipitation from 30 June 2016 to 8 July 2016 was in total 498 mm [17], exceeding the historical record. Figure 2 shows the cumulative rainfall in Nanjing from 11 June 2017 to 12 December 2020.

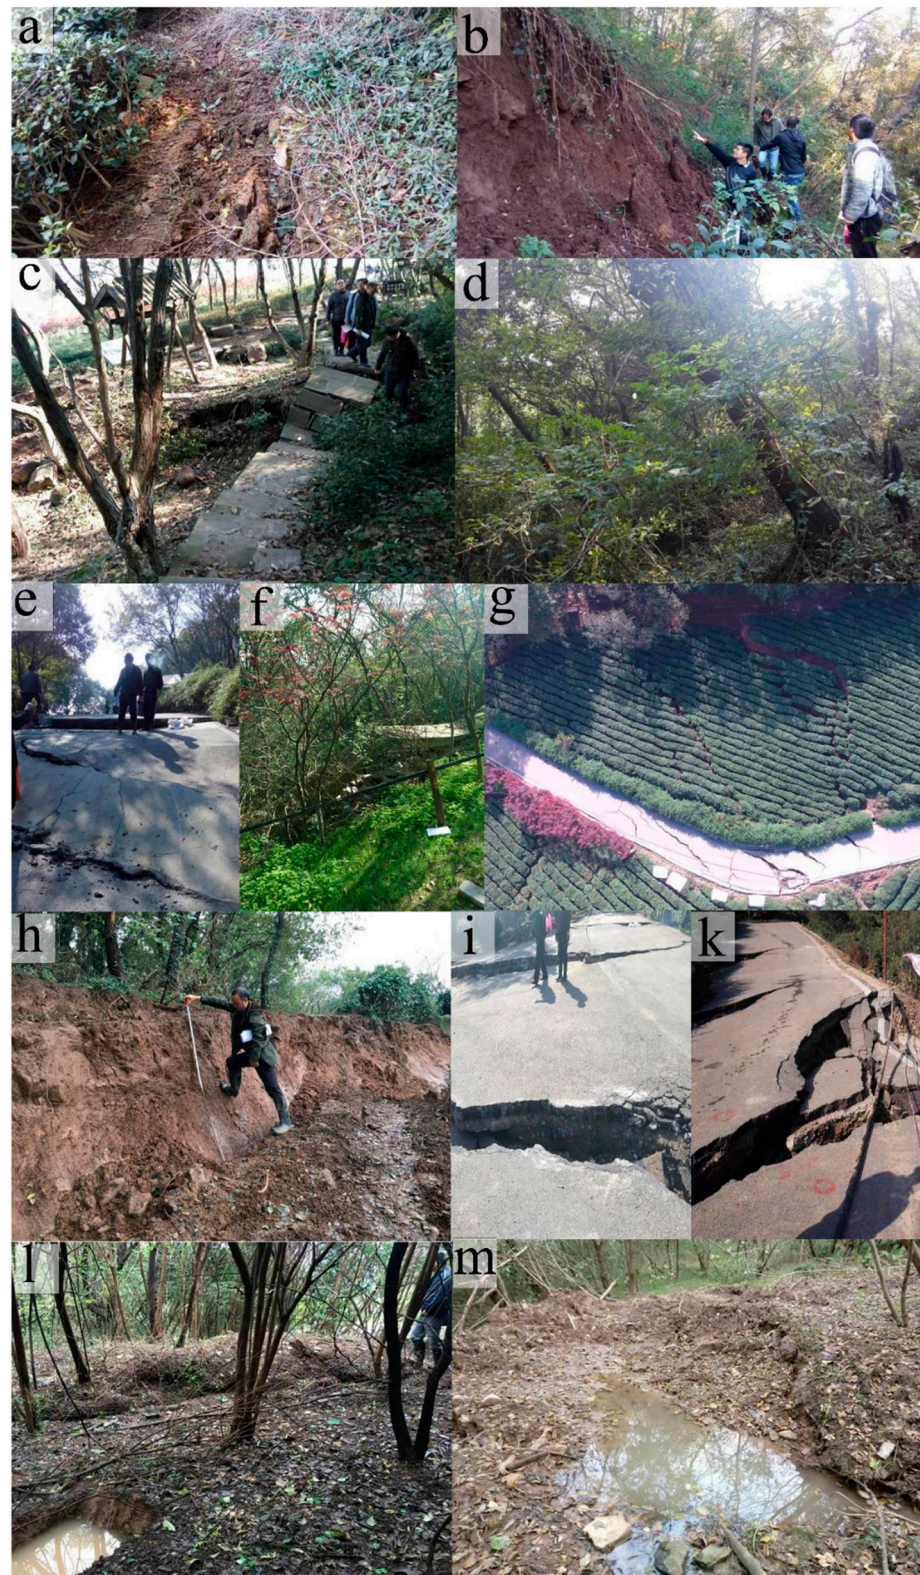
Figure 4. (a) Scarp on the trailing edge of landslide, photographed 23 September 2016; (b) scarp on the trailing edge of landslide, photographed 3 November 2016; (c) broken mountain road; (d) toppled trees; (e) cracks on Dlinglin Road; (f) deformation of retaining wall; (g) groove on the northwest side of landslide; (h) subsidence of groove [16]; (i) cracks on Zulong Road; (k) cracks on Dinglin Road; (l) front shear outlet; (m) groundwater flowing out of the surface, their positions are shown in Figure 5.

The boundary of region I is clear. At the trailing edge, a 0.5 m scarp was found on 23 September 2016, and the scarp height increased to 3.5 m (Figure 4b) after the shallow soil landslide formed. The mountain road fractured (Figure 4c), and the mountain trees toppled (Figure 4d). On the southeast side, a large number of tensile and shear cracks occurred in Dinglin Road. The maximum height difference of the road is 1.5 m (Figure 4e), and the retaining wall on the side of the road was uplifted by extrusion (Figure 4f). On the northwest side, a groove (Figure 4g) with a width of approximately 20 m formed, and the subsidence depth was 2 m (Figure 4h). In the middle of region I, cracks and deformation were observed in many places along Zulong Road (Figure 4i) and Dinglin Road (Figure 4k). At the leading edge of region I, several front shear exits were observed, accompanied by soil and road uplift (0.3–1.2 m), and a large number of swelling cracks were observed (Figure 4i). The soil at the leading edge was saturated, and groundwater flowed on the surface (Figure 4m). According to the geophysical profile (Figures 8–10) and the data from the deep displacement monitoring points of the landslide before treatment (P1–P6), it was concluded that the sliding surface of the shallow surface soil landslide was mainly developed in the layer of gravelly soil or at the interface between the gravelly soil and strongly weathered mudstone, at a depth of 8–15 m. The sliding surface of the deep mudstone rock landslide was mainly developed at the interface between the strongly weathered mudstone and moderately weathered mudstone or in the layer of strongly weathered glutenite, which is an interlayer of the strongly weathered mudstone.

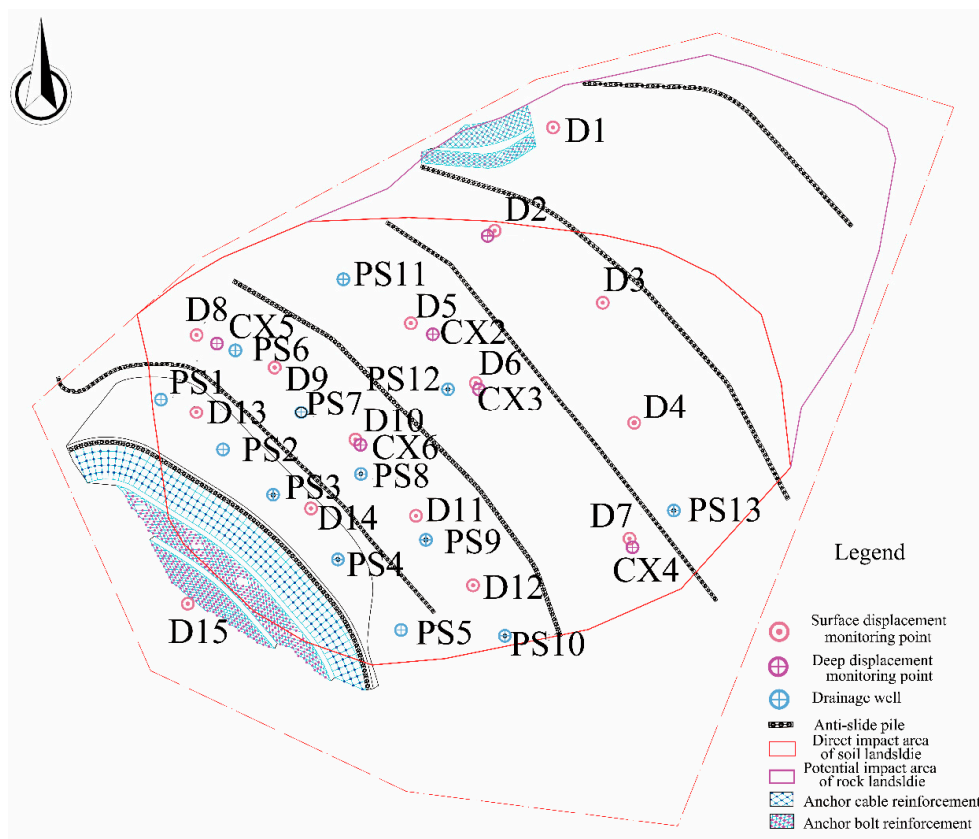
Figure 6. Treatment of the Fangshan landslide and location of monitoring points.

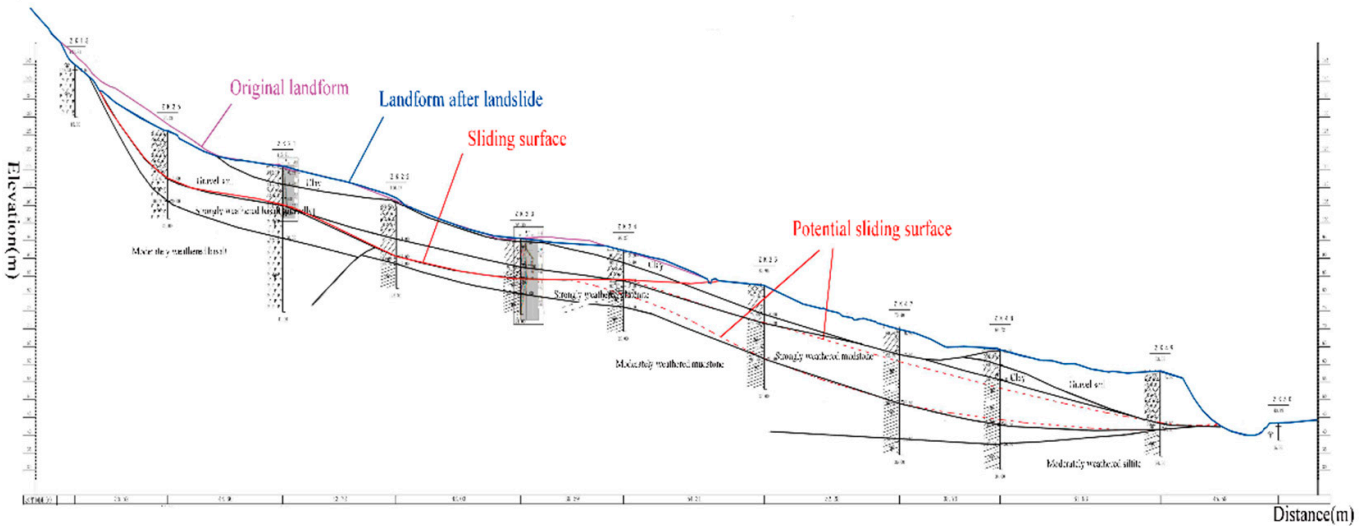
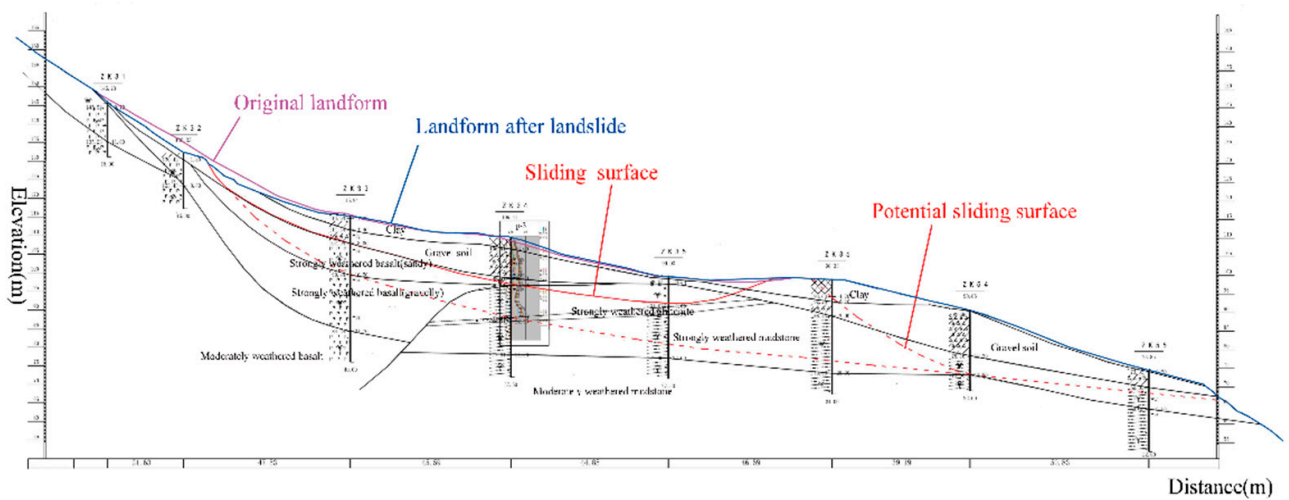
(a) Section 1-1

(b) Section 2-2

(c) Section 3-3

Figure 11. Geophysical profiles of the Fangshan landslide.

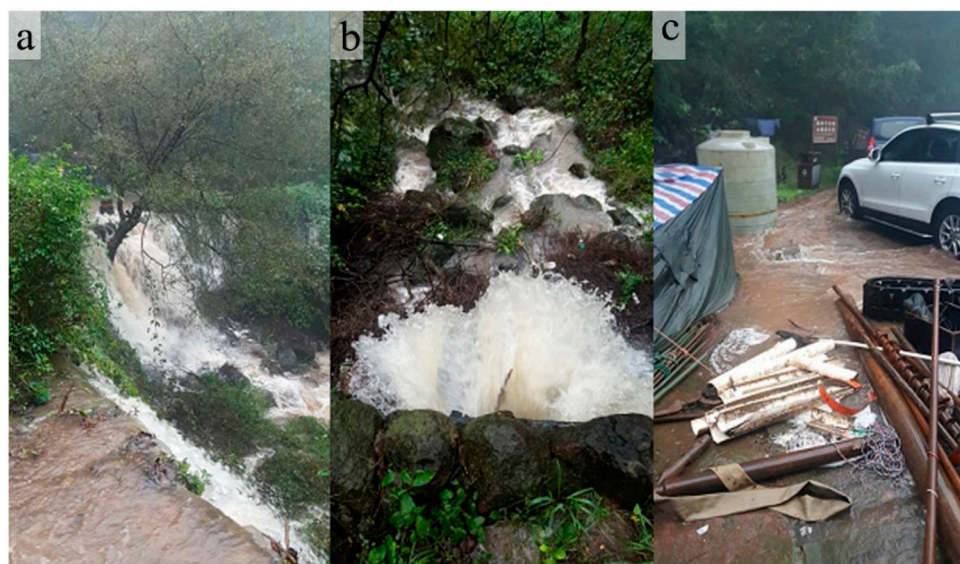
Figure 12. (a–c) were surface floods taken during the rainy season.

Surface floods often occurred in the study area during the rainy season (Figure 12), and it is meaningful to investigate the hydrogeological conditions of each layer to examine the failure process of such rainfall-induced landslides that occur in volcanic areas. The samples for variable head permeability test were sampled perpendicular to the soil sample level, some from drilling holes (Figure 7), some from the same type of layer exposed. Combined with experience from surrounding projects and previous studies [16] and water pressure testing drilling holes, Table 1 shows the results of permeability coefficients used in the design of landslide treatments, which showed that the hydraulic conductivity of each rock layer in the study area varied greatly, up to four orders of magnitude. Specifically, gravelly soil and strongly weathered basalt (sandy and gravelly) formed by the volcanic eruption have high permeability, and clay and mudstone formed by natural deposition have poor permeability, which corresponds to aquifers and relative aquicludes. From surface to underground, the layers include the following: (1) Clay: low permeability, relative aquiclude; (2) Gravelly soil: high permeability, aquifer. (3) Clay: low permeability, relative aquiclude. (4) Strongly weathered basalt (sandy): high permeability, aquifer. (5) Strongly weathered basalt (gravelly): high permeability, aquifer. (6) Strongly weathered mudstone: low permeability, relative aquiclude. (7) Strongly weathered glutenite: high permeability, aquifer. (8) Moderately weathered mudstone: low permeability, relative aquiclude.

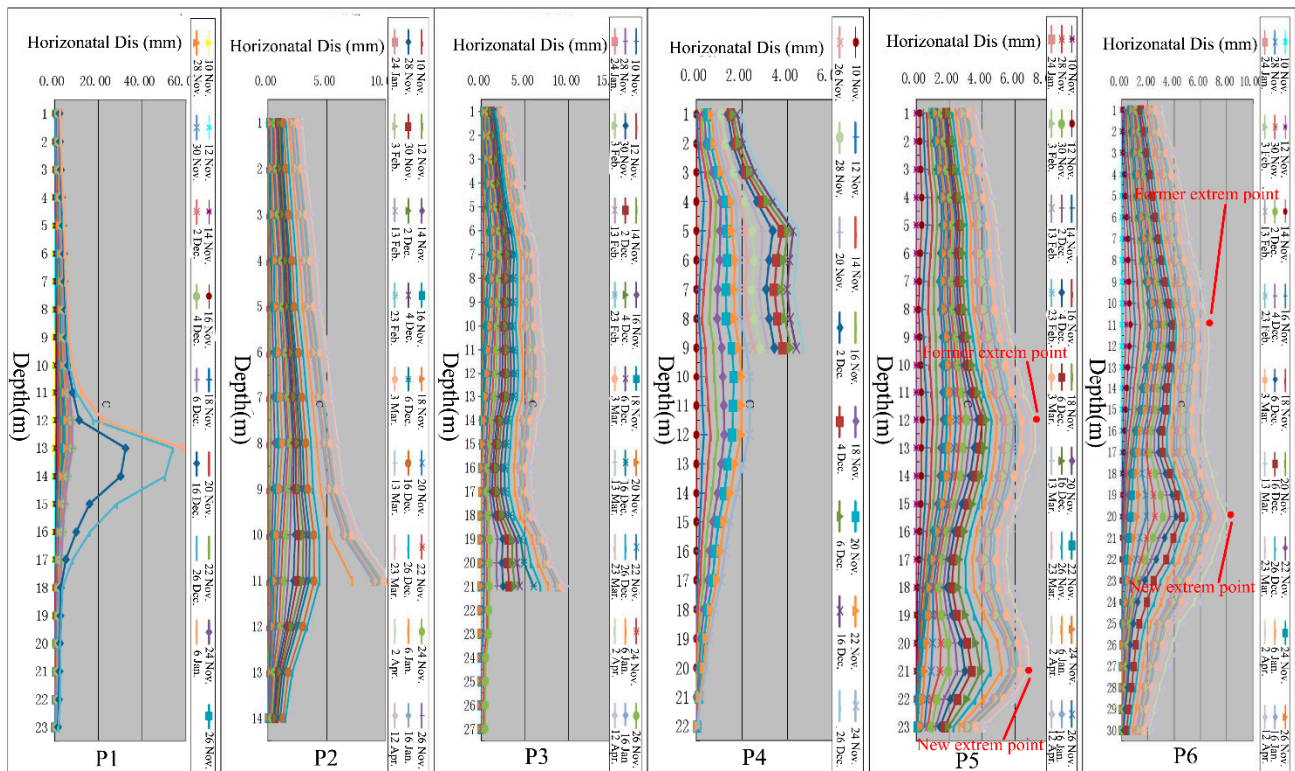
Figure 13. Monitoring of deep horizontal displacement before landslide treatment, from 10 November 2016 to 12 April 2017.

Figure 13 shows the deep monitoring data of P1–P6 from 10 November 2016 to 12 April 2017 (stage 2). The first large deformation of each deep displacement monitoring point appeared on P4, with its pipe of monitoring broken on 26 November 2016. And then, P1 and P2 monitoring points appeared largely deformed, with their monitoring pipes broken on 6 January 2016. Before the broken pipes of P1, we can clearly see a sharp increase appeared on 16 December 2016, which did not appear in other deep monitoring points at that time, combined with their location, the start of the exciting soil landslide was from the middle of the landslide, and gradually formed to the trailing edge of the landslide. Moreover, according to P5 and P6, which are located in region II, we can conclude that before 26 November 2016, the maximum displacement depth of point P5 was 12 m, and the maximum displacement depth of point P6 was 11 m. However, due to the continuous movement of the existing landslide and the influence of factors such as rainfall, under this geological structure type, the sliding depth migrated deeply. After 26 November 2016, at a depth of 21 m at point P5 and a depth of 20 m at point P6, a new maximum extreme value point of monitoring displacement curve appeared. As of 12 April 2017, the value of the

new maximum extreme value points exceeded or matched the displacement value of the previous maximum extreme point. That being said, the new maximum extreme value at the deeper depth of P5 and P6 appeared after the shallow landslide, which showed that after the apparent sliding of P1, P2, P3, and P4, the deep sliding points of P5 at depth of 21 m and P6 at depth of 20 m began to develop. This indicates that the shallow soil landslides led to the formation of deep rock landslides.

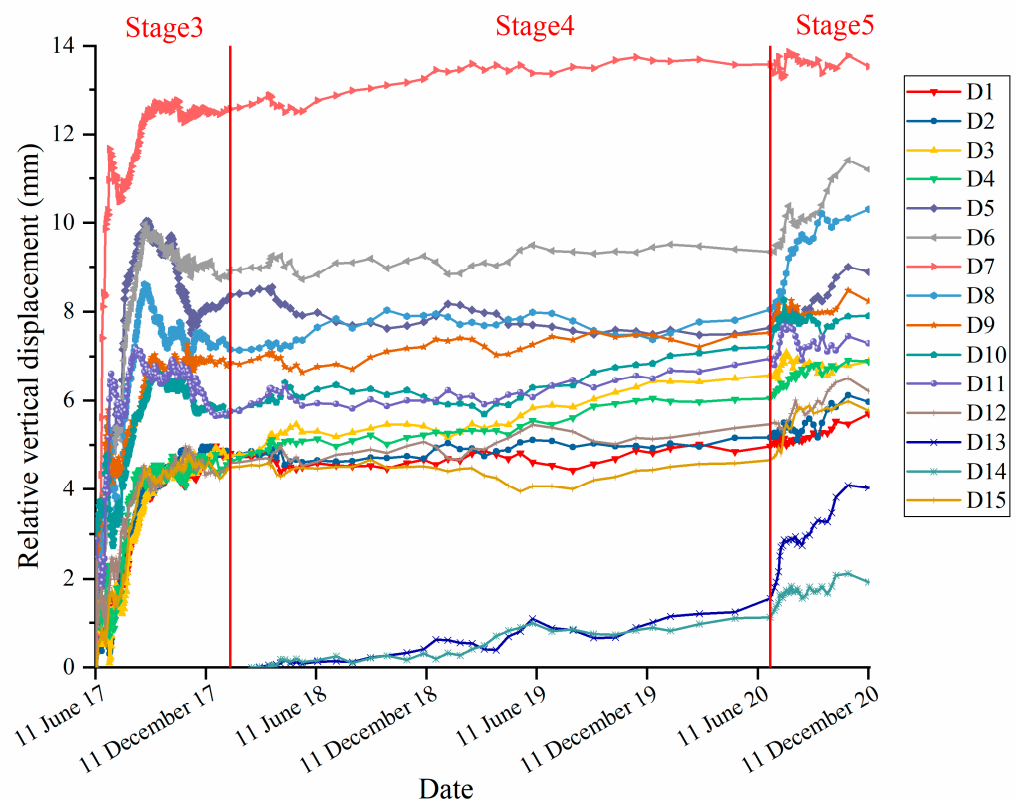
Figure 14. Cumulative vertical displacement monitoring data of 15 surface displacement monitoring points from 11 June 2017 to 12 December 2020. Their positions are shown in Figure 6.

Figure 14 shows the cumulative vertical displacement monitoring data of the 15 surface displacement monitoring points from 11 June 2017 to 12 December 2020. Figure 15 shows the cumulative monitoring data of six deep horizontal displacement monitoring points of the Fangshan landslide from 11 June 2017 to 12 December 2020. Figure 16 shows the details of the maximum displacement depth of each deep horizontal displacement monitoring point (CX1–CX6). Considering the surface displacement monitoring data and deep dis-

placement monitoring data of the landslide together, it was concluded that the landslide deformation trend during the period from 11 June 2017 to 12 December 2020, corresponding to the three periods previously divided: (1) Stage 3 (11 June 2016 to 21 January 2018) was the continuous sliding stage of the landslide, when the whole landslide slid outward at a relatively high rate. (2) Stage 4 (21 January 2018 to 2 July 2020), the landslide was basically stable. (3) Stage 5 (from 2 July 2020 to 12 December 2020), the landslide reactivated, and the whole landslide slid outward at a relatively low rate and eventually became stable. In stage 3, the monitoring curves of surface displacement monitors D5, D6, D7, D8, D10 and D11 and deep displacement monitors CX2, CX3, CX4 and CX5, whose displacements were relatively large, all exhibited obvious rebounds. The rebound occurred because during this period, the anti-slide piles were installed, and the downward-moving sliding body was blocked by the anti-slide piles, resulting in a small amount of uplift. The start of stage 5 was consistent with the time when the drainage well became damaged in early July 2020. Under the influence of continuous rainfall, the rise in groundwater level exceeded the control value because of the damage to the drainage wells, and the landslide began to slide outward again. Figure 17 shows the variation in groundwater level from 18 July 2020 to 9 August 2020. Compared with Figure 16, Figure 17 shows that when the water level of SP4 dropped from 105.7 m on 18 July 2020 to 99.534 m on 6 August 2020, the deep horizontal displacement of the landslide tended to be stable. Combined with the previous survey information, when the water level of the observation well exceeded the normal value, the existing water level was higher than the existing sliding surface position. It appeared that the rise in groundwater level caused by rainfall was the main factor leading to the reactivation of the Fangshan landslide.

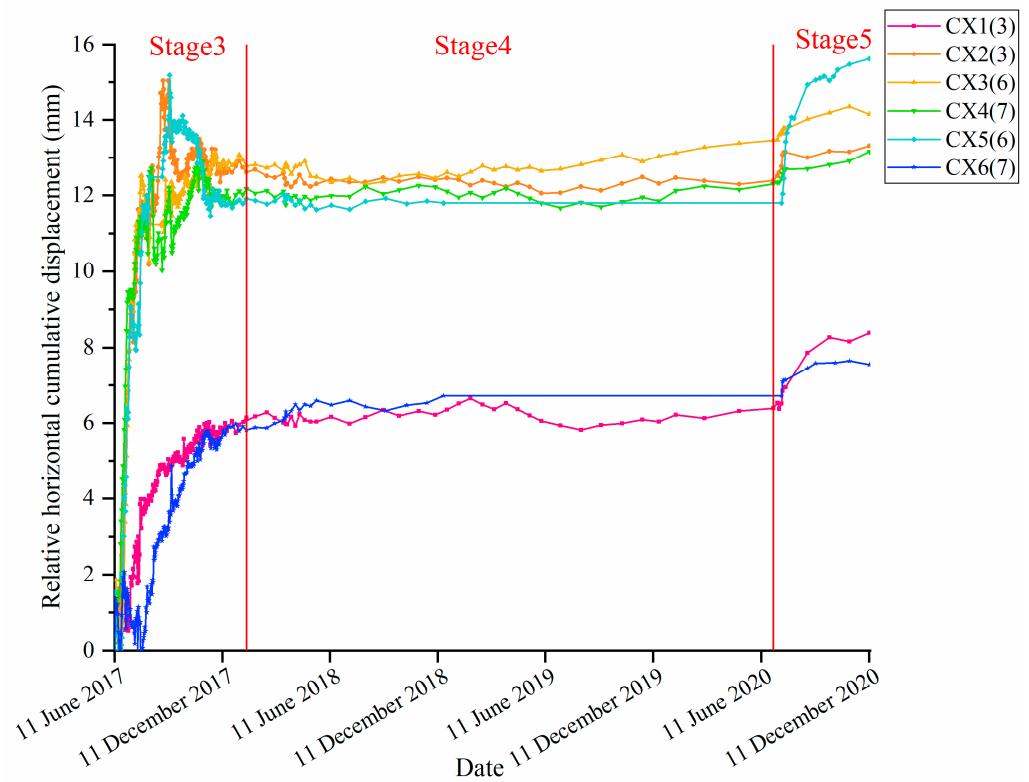
Figure 16. Detailed horizontal displacement deformation data of the maximum displacement depth of each deep horizontal displacement monitoring point. (Since the displacement values of CX5 and CX6 monitoring points from 11 August 2018 to 21 December 2018 are very small and close to stability, the two monitoring points did not continue monitoring from 21 December 2018 to 16 July 2020).

Since there were no long-term groundwater level monitoring data collected, to further explore the correlation between the rainfall and landslide displacement, according to the displacement change trend of the landslide and the distribution of the monitoring points, the surface displacement monitoring point D6 and deep displacement monitoring point CX3, which indicated relatively large displacements and were located in the middle of the landslide, and the surface displacement monitoring point D2 and deep displacement monitoring point CX1, which indicated relatively small displacements and were located in the front of the landslide, were selected for correlation analysis with the cumulative rainfall from 11 June 2017 to 12 December 2020. Because the changes in surface displacement and deep horizontal displacement were caused by the movement of the landslide, the cumulative incremental displacement was calculated by taking the absolute increment value in the correlation analysis. Considering the trend of deformation and the frequency of monitoring, the displacement of the missing data was determined by linear interpolation. Due to the seasonal changes in rainfall, the monthly displacement and the cumulative change in rainfall were selected to calculate the correlation between the monthly changes in rainfall and displacement and the percentage of monthly rainfall and displacement of the total change from 11 June 2017 to 12 December 2020. According to the calculation results in Figure 18, although the total displacement of the landslide had obvious differences among stage 3, stage 4 and stage 5, the deformation trend always maintained a high correlation with rainfall variation.

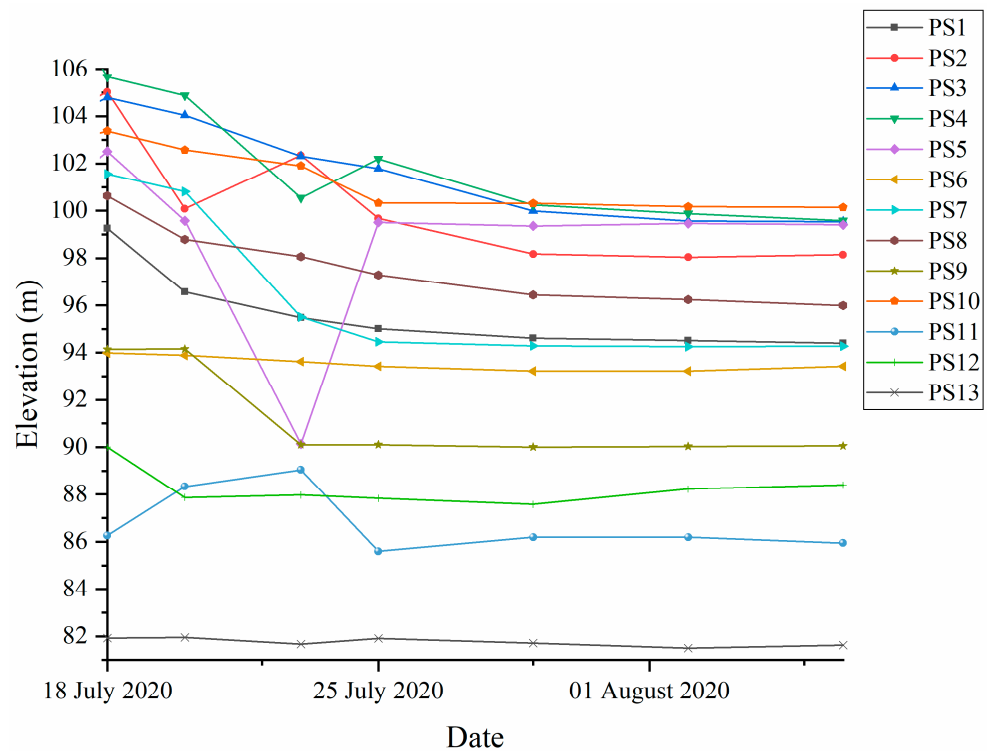
Figure 17. Variation of groundwater level from 18 July 2020 to 9 August 2020. The wellhead elevations of PS1, PS2, PS3, PS4, PS5, PS6, PS7, PS8, PS9, PS10, PS11, PS12 and PS13 are 114 m, 114.5 m, 116.5 m, 117.5 m, 115 m, 104.5 m, 109.5 m, 112 m, 109.5 m, 107 m, 90 m, 95 m and 90 m, respectively.

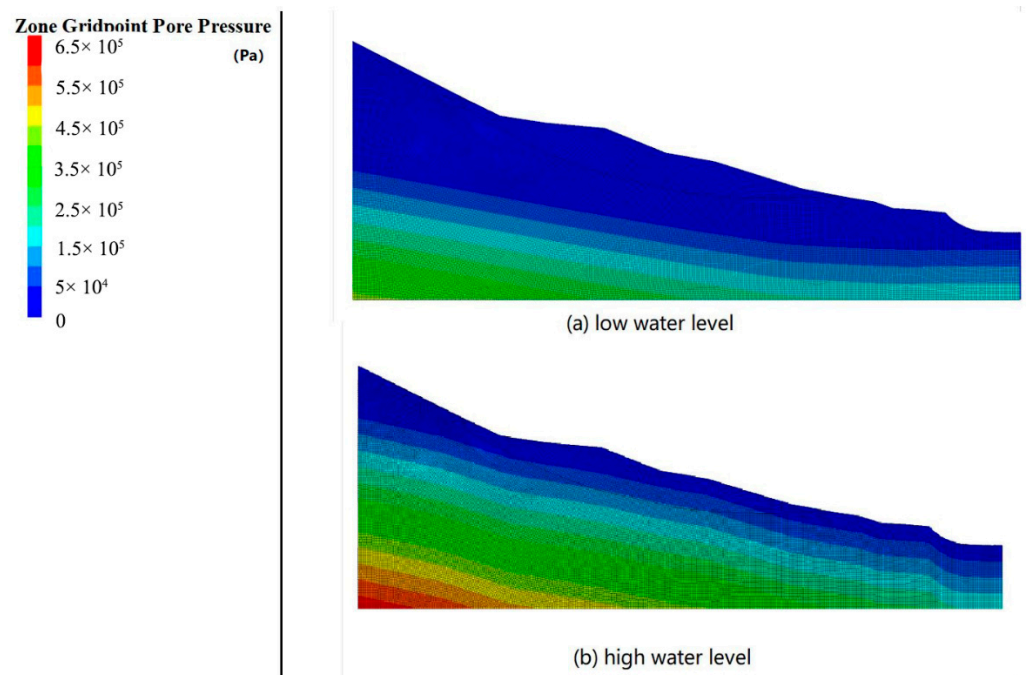
Figure 21. The numerical model of the profile.

First, the water level line was assigned to the model by means of pore water pressure, and the mechanical parameters were assigned to the corresponding layer. After that, the model was calculated to be stable with the pore water pressure of the low water level (Figure 21a) (the maximum unbalanced ratio was less than 1×10^{-5}), and then the pore water pressure was replaced by the pore water pressure of the high water level (Figure 21b), the corresponding layer parameters were changed, and the model was iterated for 52,000 steps.
