Landslides, stratigraphy, and surficial geology of the Hydraulic map sheet (NTS 93A/12),
British Columbia, Canada

A thesis submitted in partial fulfillment of the requirements for the degree of

MASTERS OF SCIENCE

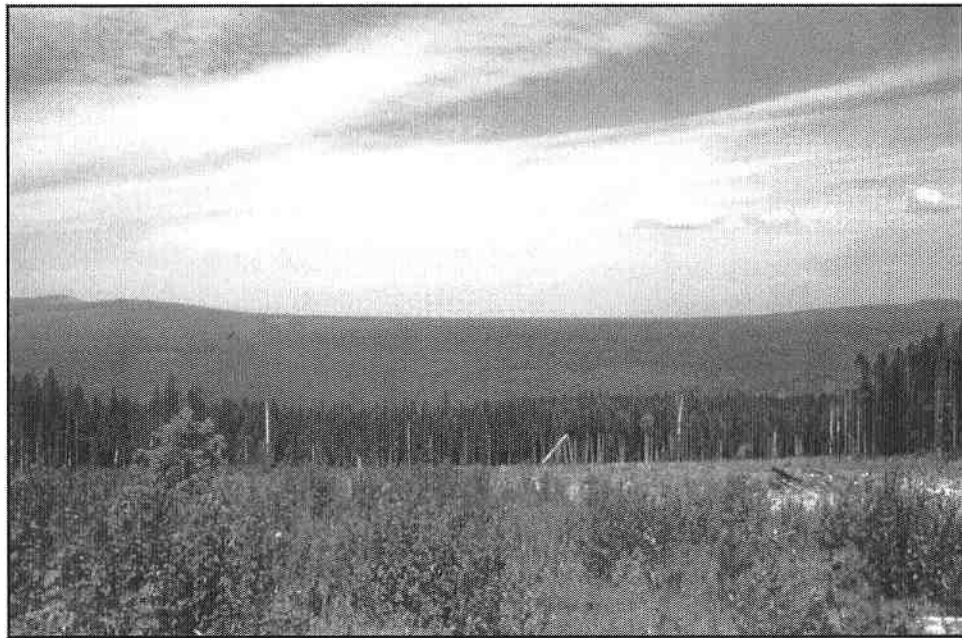
Figure 2.2. View northwest, towards the Quesnel River valley, of typical gently rolling topography found on the plateau.

The study area lies on the eastern edge of the Interior Plateau at the boundary of the Quesnel Highlands and the Fraser Plateau (Holland 1976). Local topography is characterized by a gently rolling plateau with an average elevation of 940 m asl (Fig. 2.2). Two major valleys trending east-west dissect the plateau and contain the Quesnel and Cariboo rivers. Both valleys average 280 m in depth and 1.5 km in width (Fig. 2.3).

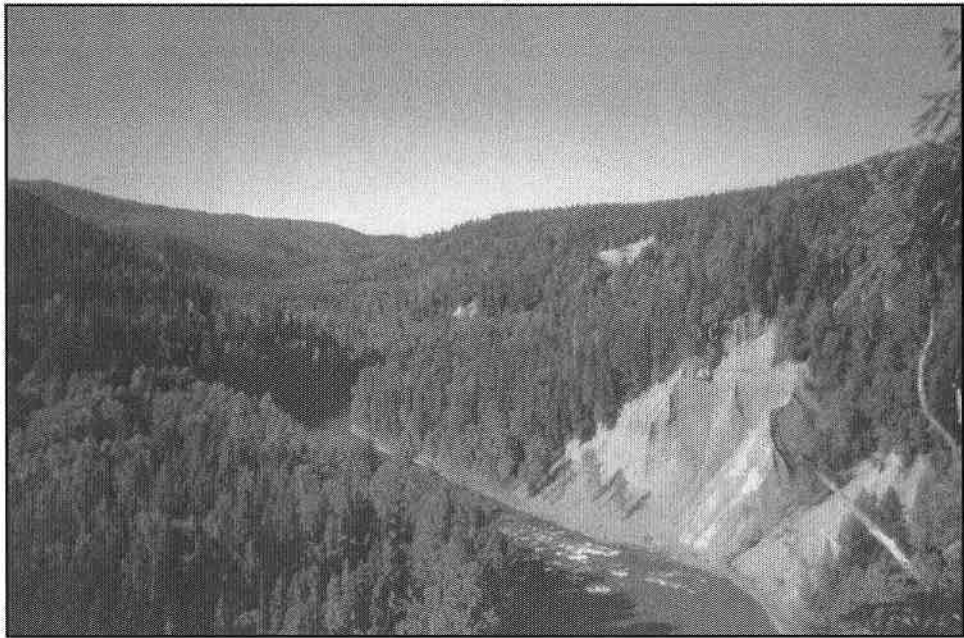
Figure 2.3. View southwest down the Cariboo River valley, looking into the Quesnel River valley.

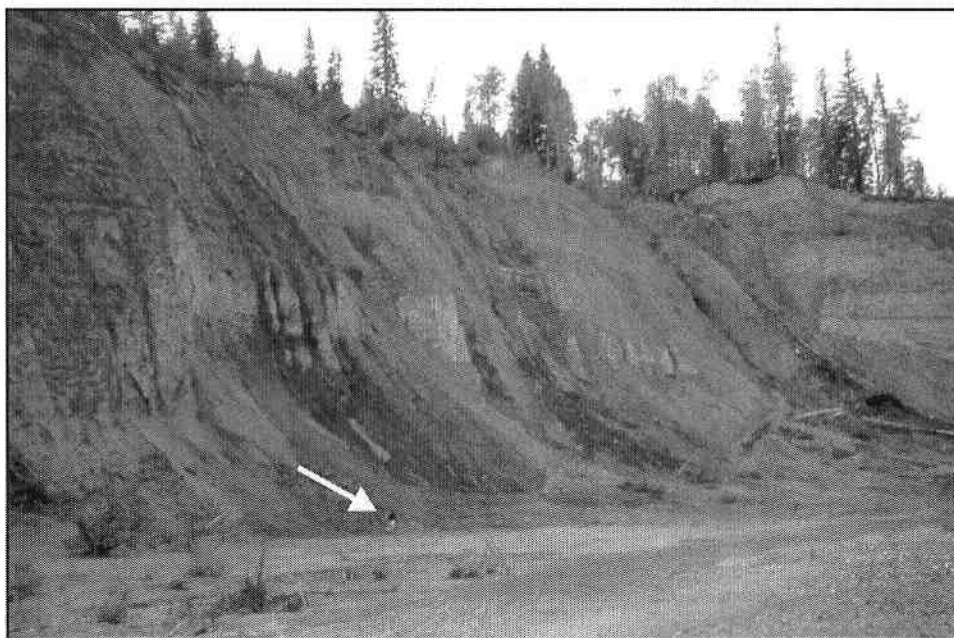
Figure 2.7. Typical Fraser advance-phase glaciolacustrine sediment found throughout the Quesnel River valley (section AJB01-L6). The exposure is approximately 60 metres high and consists entirely of interbedded silt, clay and sand (unit D). Note person standing at base of exposure for scale, just left of centre.

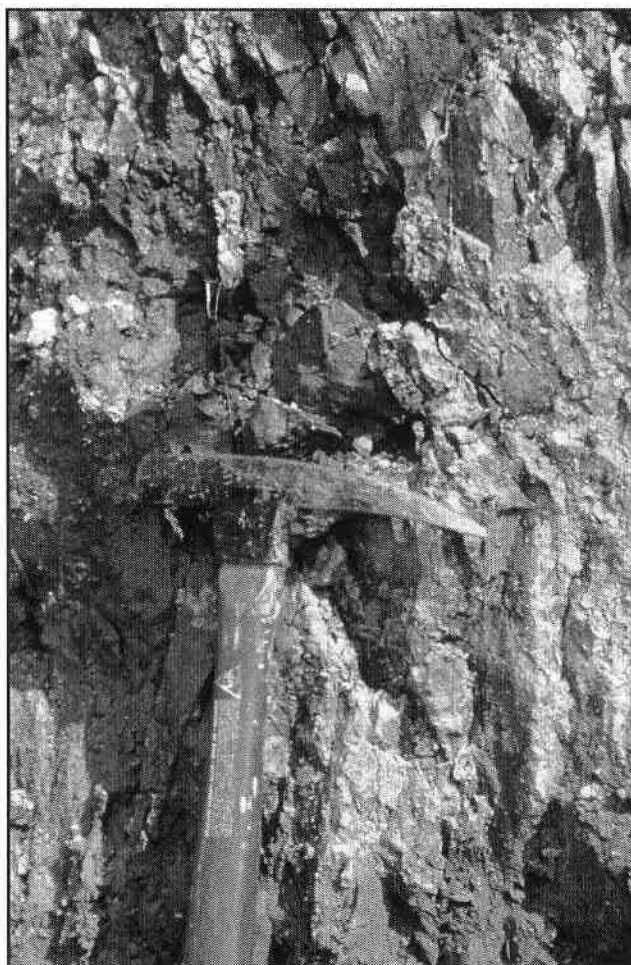
Figure 2.9. Fraser Glaciation till (unit G) exposed in the headscarp of a landslide (section AJB01-L5).

The youngest till (*unit G*) is found high on valley slopes as well as covering most of the plateau. It is a well-compacted, silty clay diamicton that has a matrix that becomes clay-rich towards the base of the unit where it overlies *unit F*. It exhibits moderate fissility and jointing (Fig. 2.9). Clast content is approximately 30%. Faceted and striated clasts are abundant. At most sites, *unit G* is approximately 10 m thick though it may be substantially thicker (e.g. Fig. 2.4, section AJB01-S9).

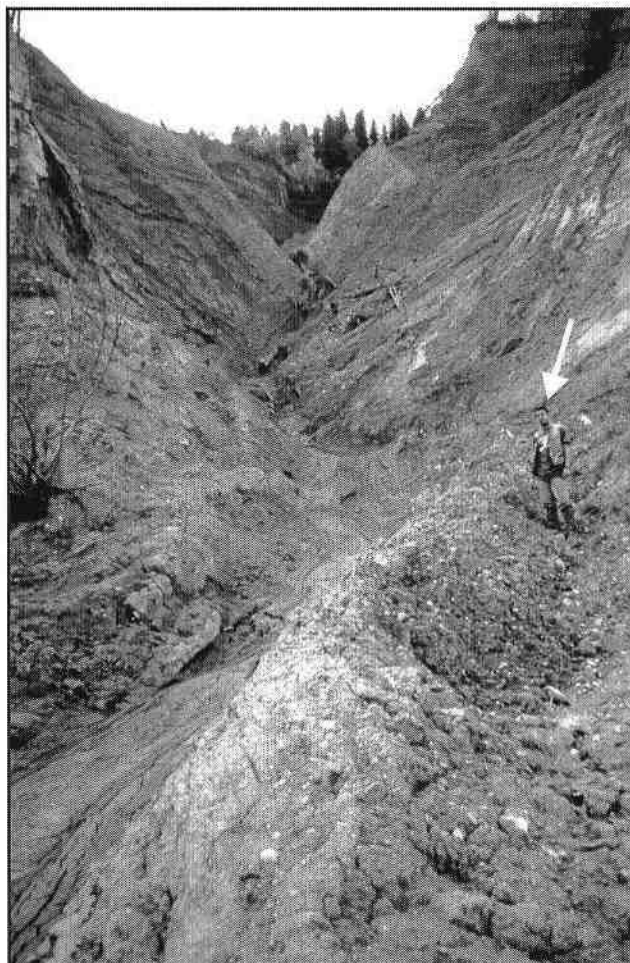
Figure 2.13. Gully formed in unit D that periodically delivers debris to the Quesnel River (section AJB01-L5). Note person for scale.

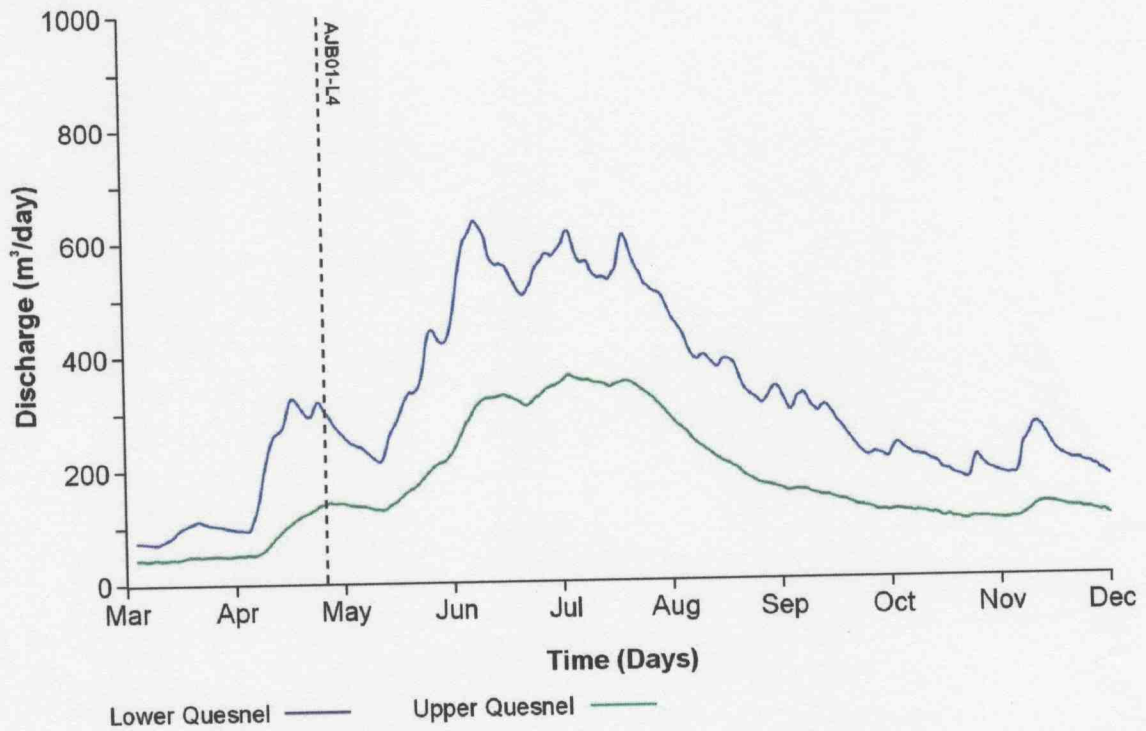
Figure 2.18. River discharge for 1996 for the upper and lower Quesnel River Data was collected at Environment Canada stations 08KH001 and 08KH006, respectively.

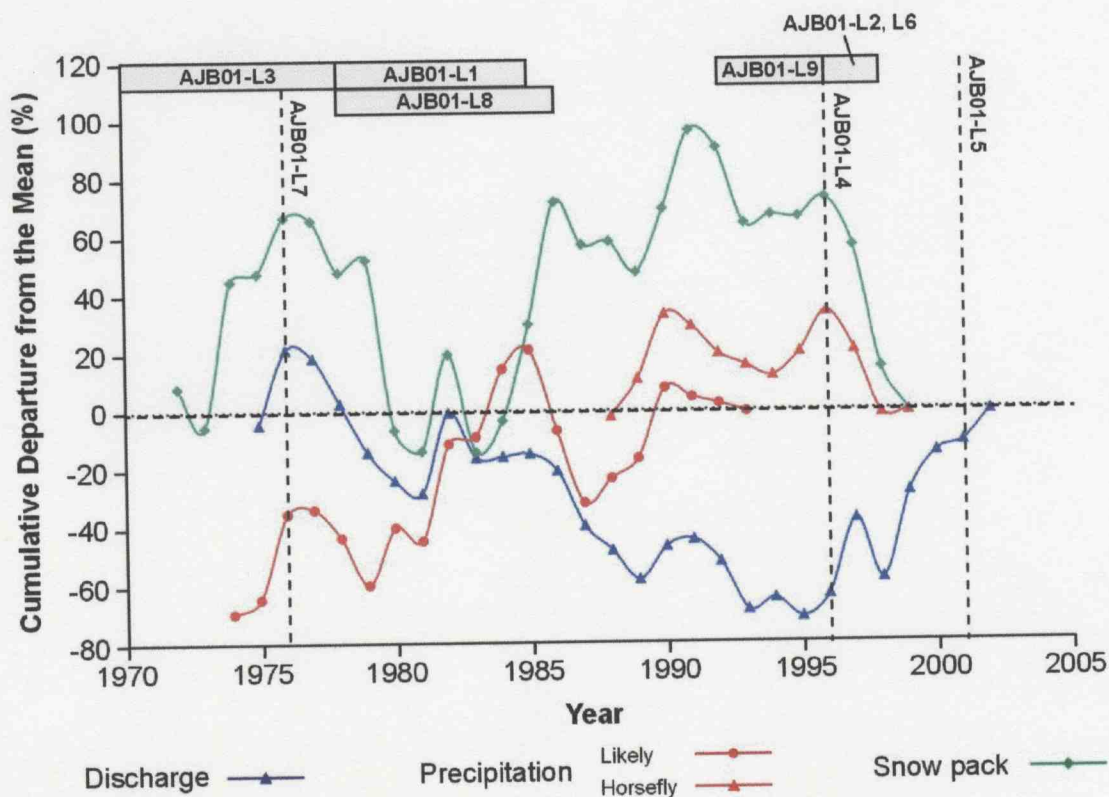
Figure 2.19. Yearly, cumulative departure from the mean for 3 factors influencing regional landslide activity. Landslide ages are indicated as either a year (dashed line) or an age range (shaded box). Data was collected from Environment Canada stations as follows: discharge, 08KH006; snow pack, 1C24; precipitation at Likely, 1094616; precipitation at Horsefly, 1093600.

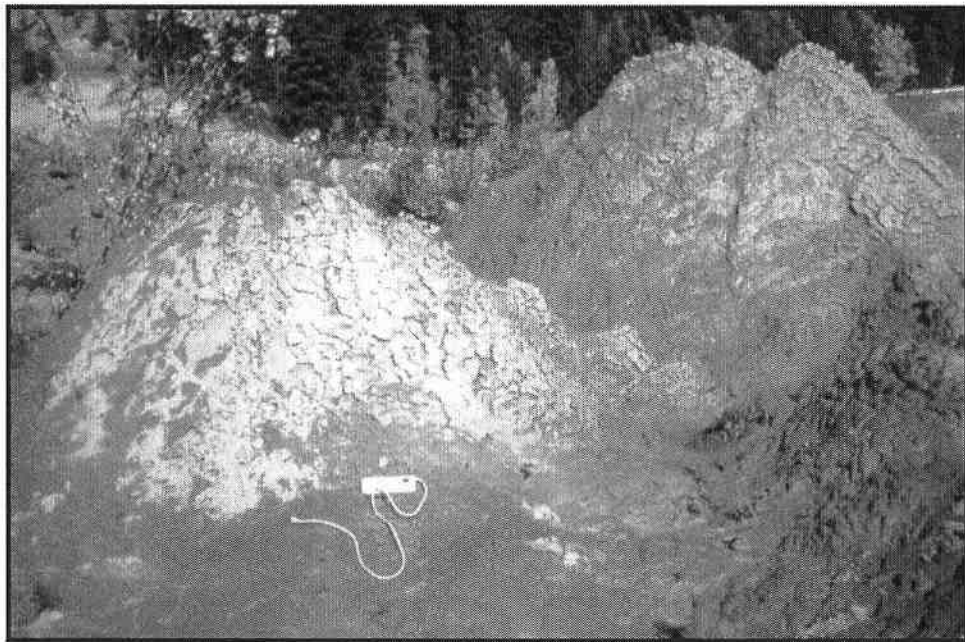
Figure 3.5. Close-up of weathered clay blocks that create the hummocky surface on a portion of the foot. The power bar in the foreground is 25 cm in length.

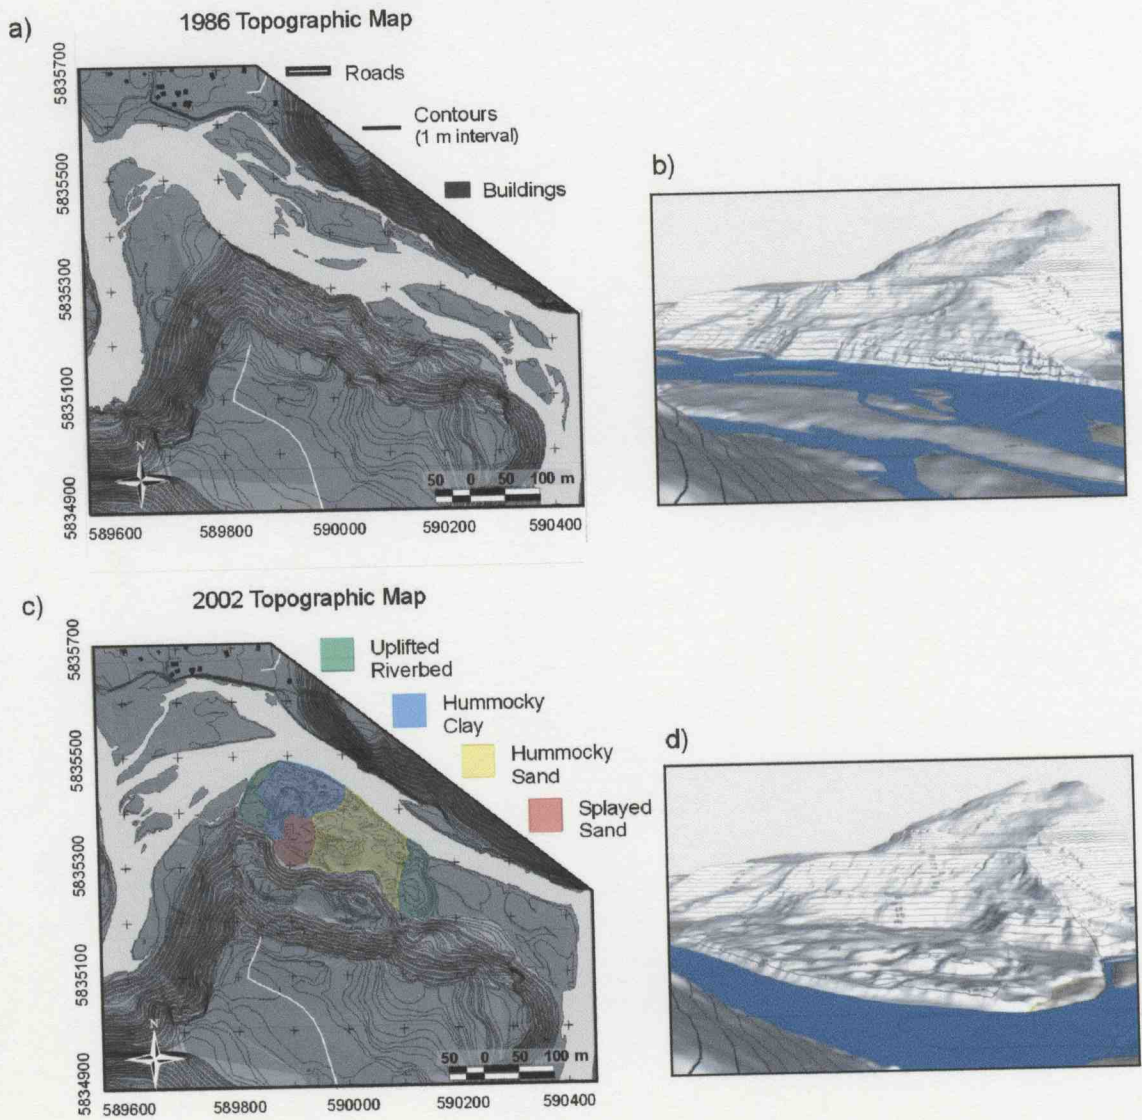
Figure 3.6. Digital terrain models of the Quesnel Forks Landslide and surrounding area: a) pre-failure shaded relief map; b) pre-failure 3D oblique view to southeast; c) post-failure shaded relief map with morphological division of foot (see section 3.6.2); and d) post-failure 3D oblique view to southeast.

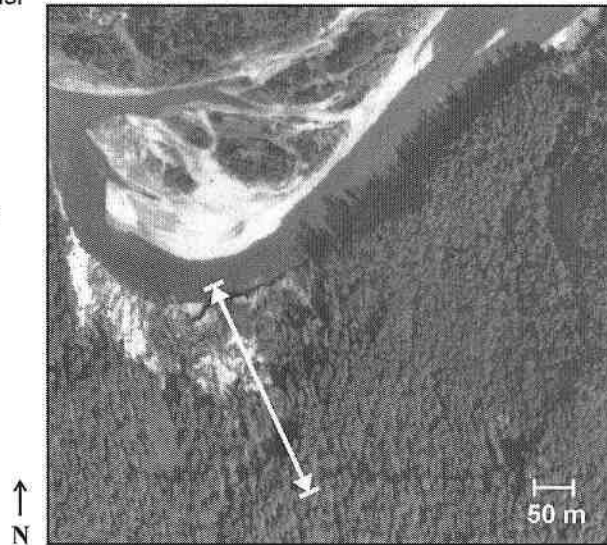
The landslide is located on the south side of the Quesnel River on an outer, erosive bend. From airphoto, it appears to be a reactivation of a much larger landslide. In addition, found within the western side scarp is a thick unit of colluvium that contains large buried trees that all point into the valley's centre. All stratigraphic units, with the exception of unit 1, dip into the valley side, which may also support an earlier failure. The active landslide is composed of several smaller slumps that subsequently turn into flows. Similar to landslide L1, transverse ridges can be found adjacent to slumped blocks. Thick, pre-slide vegetation covers much of the upper, active slide where as little vegetation, pre- or post-slide, is found on the lower active portion of the slide. The western side of the slide is much more active and is made of highly saturated silt and clay.

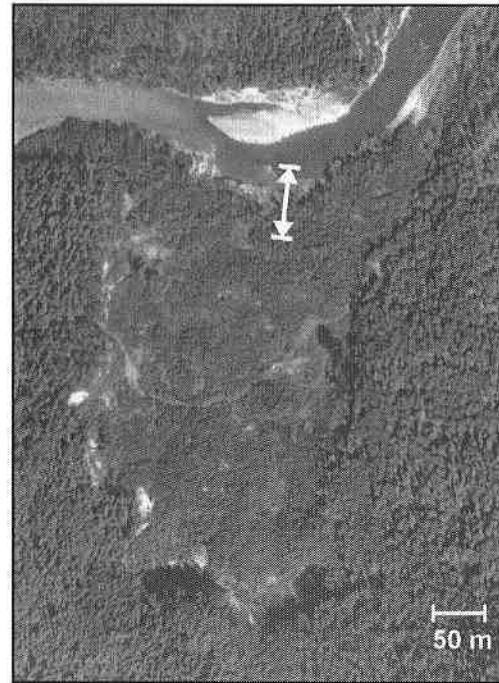
The landslide is located on the south side of the Quesnel River on an outer, erosive bend. At this location, a large landslide occurred in the spring of 1976 that blocked the river for several hours. Though the majority of the landslide appears to be stabilized, the toe continues to erode. The most recent activity is the reactivation of the toe where slumping and toppling of material from the earlier slide occurs.
