Current State of Modern Rammed Construction: A Case Study of First Peoples House After 7 Years Exposure

# Current State of Modern Rammed Construction: A Case Study of First Peoples House After 7 Years Exposure

Allan Kailey<sup>1, a</sup> and Gupta Rishi<sup>1, b</sup>

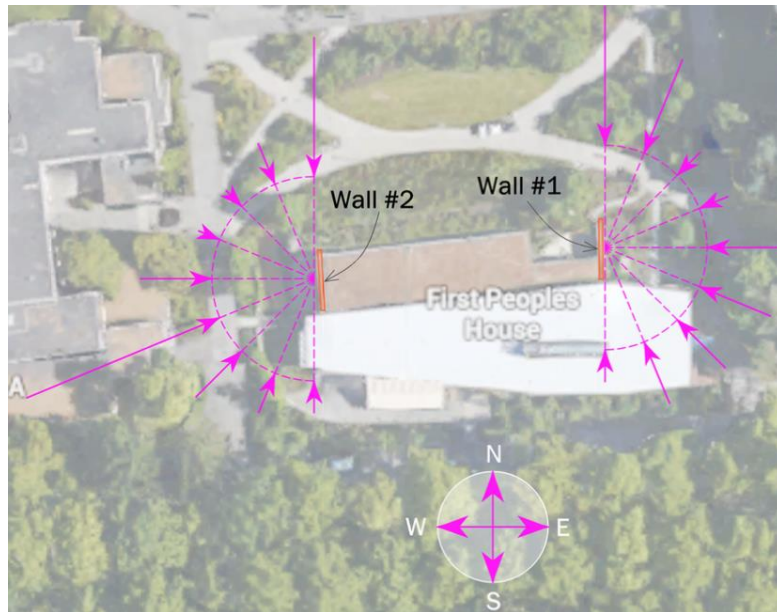
**Figure 2. Location of rammed earth walls with historical wind data**

The FPH consists of two SRE walls that are situated on the eastern most and western most faces of the building corresponding to the main and rear pedestrian entrances (Figure 2). Both walls are 500mm thick, and exterior-interior sections have a 100mm thick central cavity for insulation. Internal steel reinforcement is used for added strength. The outside visible surface area of Wall #1, the eastern most wall, is approximately 9.98m x 3.53m. It is shielded by shrubbery and an adjacent wall that extends from the main entrance. Half of this wall is an exterior-exterior wall and the other half is an exterior-interior wall. The western most wall, Wall #2, has an outside visible surface area of 10.00m x 3.39m. It is a fully exterior-interior wall with little protection from the environment.

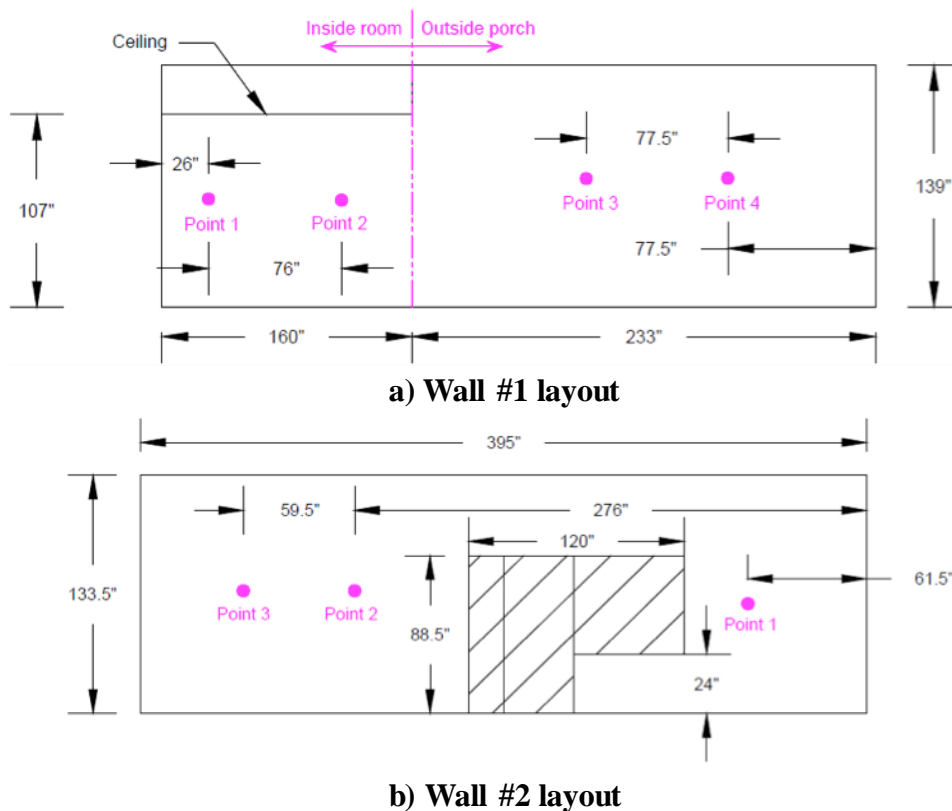
**Figure 3. Wall layouts, view looking at outside surface**

Points were marked on the outside surface of each wall, according to Figure 3, where measurements would be taken. The same points were marked on the inside surface using physical measurements from a datum. Steel reinforcement is greatest near the foundation and roofline. Locating the points half way up each wall targets the minimum strength, and equally distributing them along the length of the wall captures it's entirety. The one less point on Wall #2 was due to having to work around doors and windows.

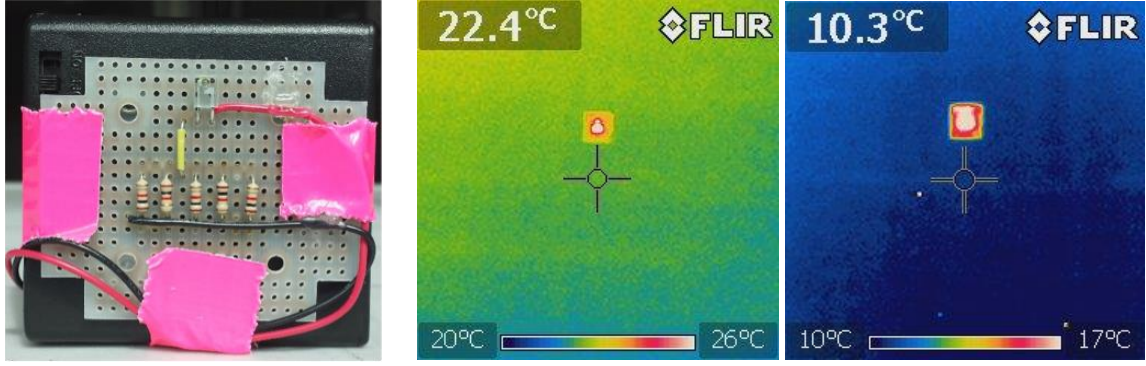
Duct tape has a similar emissivity to SRE and so, it was impossible to locate the marked points on the camera display. A battery powered infrared emitter (frontal dimensions 6.35cm x 6.67cm) was built exclusively for this project to overcome the issue (Figure a). The circuit itself emitted a significant amount of heat and so, it was placed approximately 6 inches above each point as to not skew the readings. The infrared emitter could be clearly identified in the display (Figure b).

b) Infrared image of Wall #1, Point 1 inside (left) and outside (right)

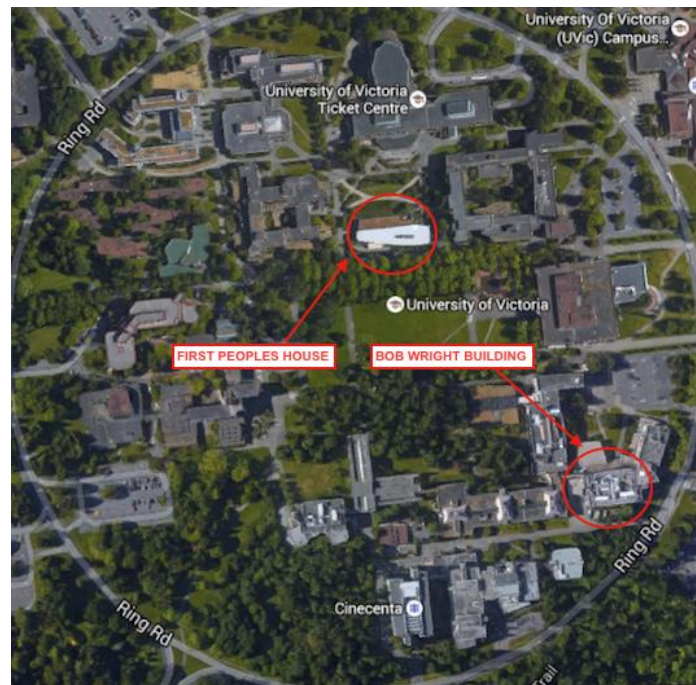
**Figure 13. Orientation of First Peoples House with respect to wind data collection**

The results from the NDT tests encourage an investigation into environmental effects that might cause certain sections of a wall to deteriorate faster than others, both structurally and aesthetically. Wind direction and magnitude are predicted to have the greatest effect on these parameters. Wall #1 and Wall #2 are located on opposite faces of the building; they are exposed to entirely different wind directions. Wind direction and wind speed data was obtained from the nearest wind station (WMO ID: 71783) located at 48°27'25.200" N latitude, 123°18'16.600" W longitude [13]. This location corresponds to the Bob Wright Building on campus, as shown in Figure. Data was obtained from

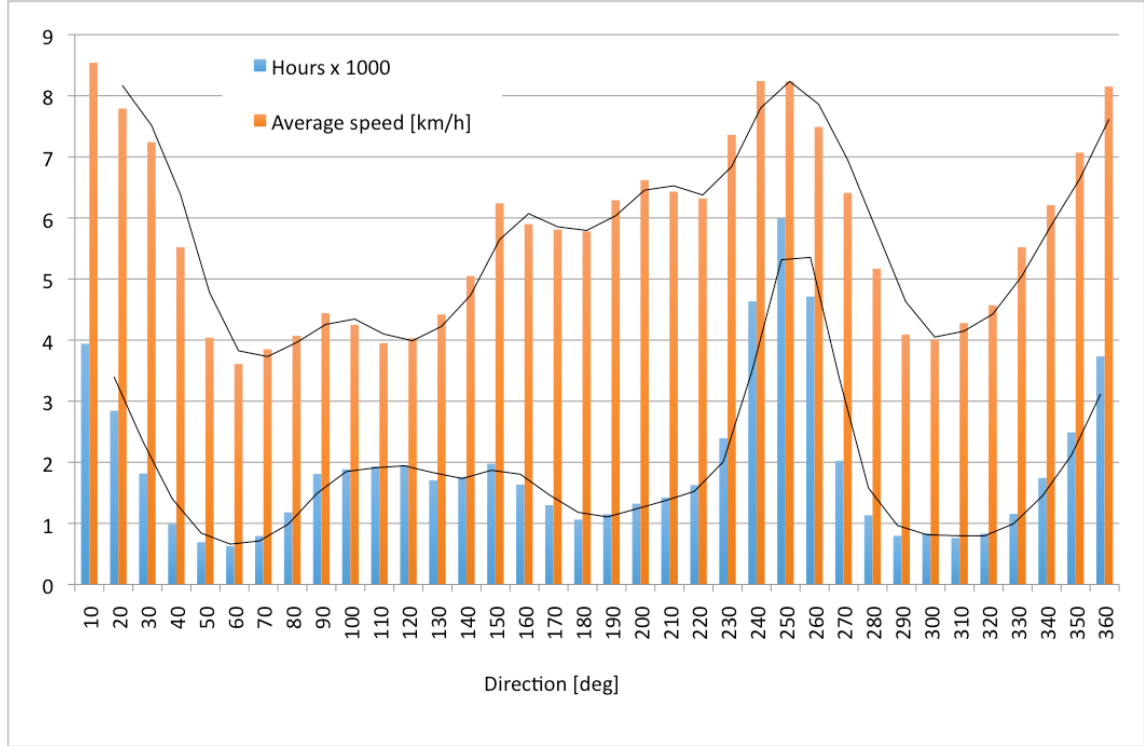
**Figure 14. Number of hours and average wind speed recorded between 2008-2015**

Total wind hours and wind speed is plotted per direction in Figure. Wind direction is expressed in degrees, where  $360^\circ$  means a wind blowing from the geographic North Pole. The largest number of hours observed with respect to the greatest wind speed is seen between  $240^\circ$ - $270^\circ$ .
